REDISCOVERING TIVOLI: AN ARCHAEOLOGICAL INVESTIGATION
INTO WILLIAM R. DAVIE'S PLANTATION HOME

Honors Thesis
Curriculum in Archaeology
University of North Carolina at Chapel Hill

2020

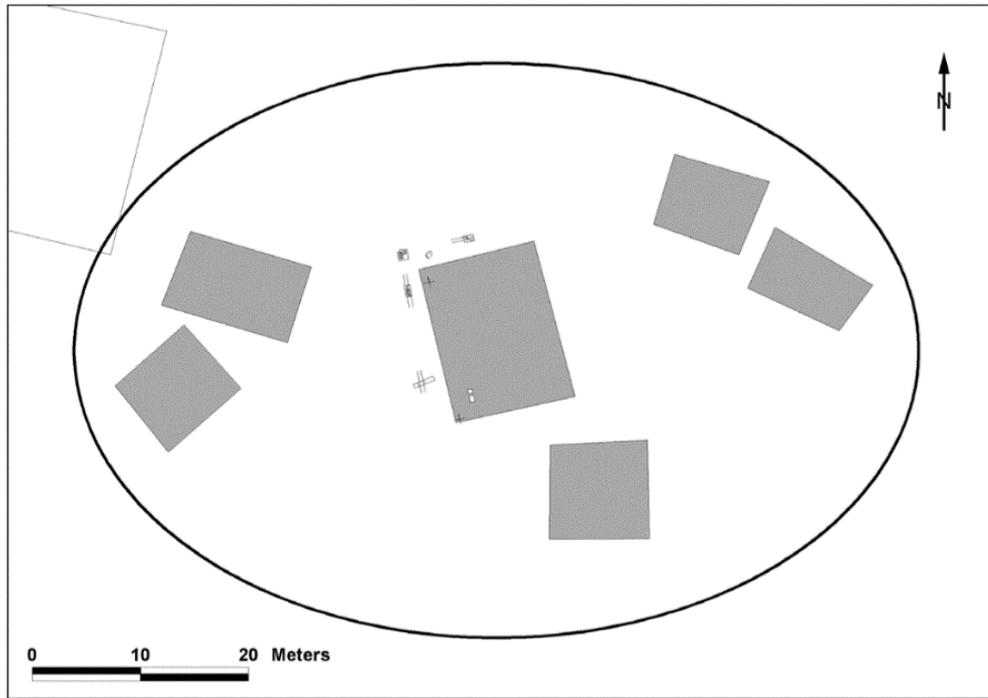
Figure 7. Close-up of the shapes of the soil anomalies examined in the 2004 investigation, as shown in Figure 6. Courtesy of the UNC RLA.

The investigation began with a metal detector survey, which revealed numerous cut and wrought nails. The excavators also observed a low mound which contained brick fragments. After probing it, the excavators hypothesized that it could have been a chimney fall (Davis and Riggs 2004: 13). They then began probing every two meters, and west of the preserved chimney fall, they discovered bricks *in situ* about 20 cm below the surface. They did not fully expose the bricks, but by probing they determined that they covered an area measuring about 50 cm by

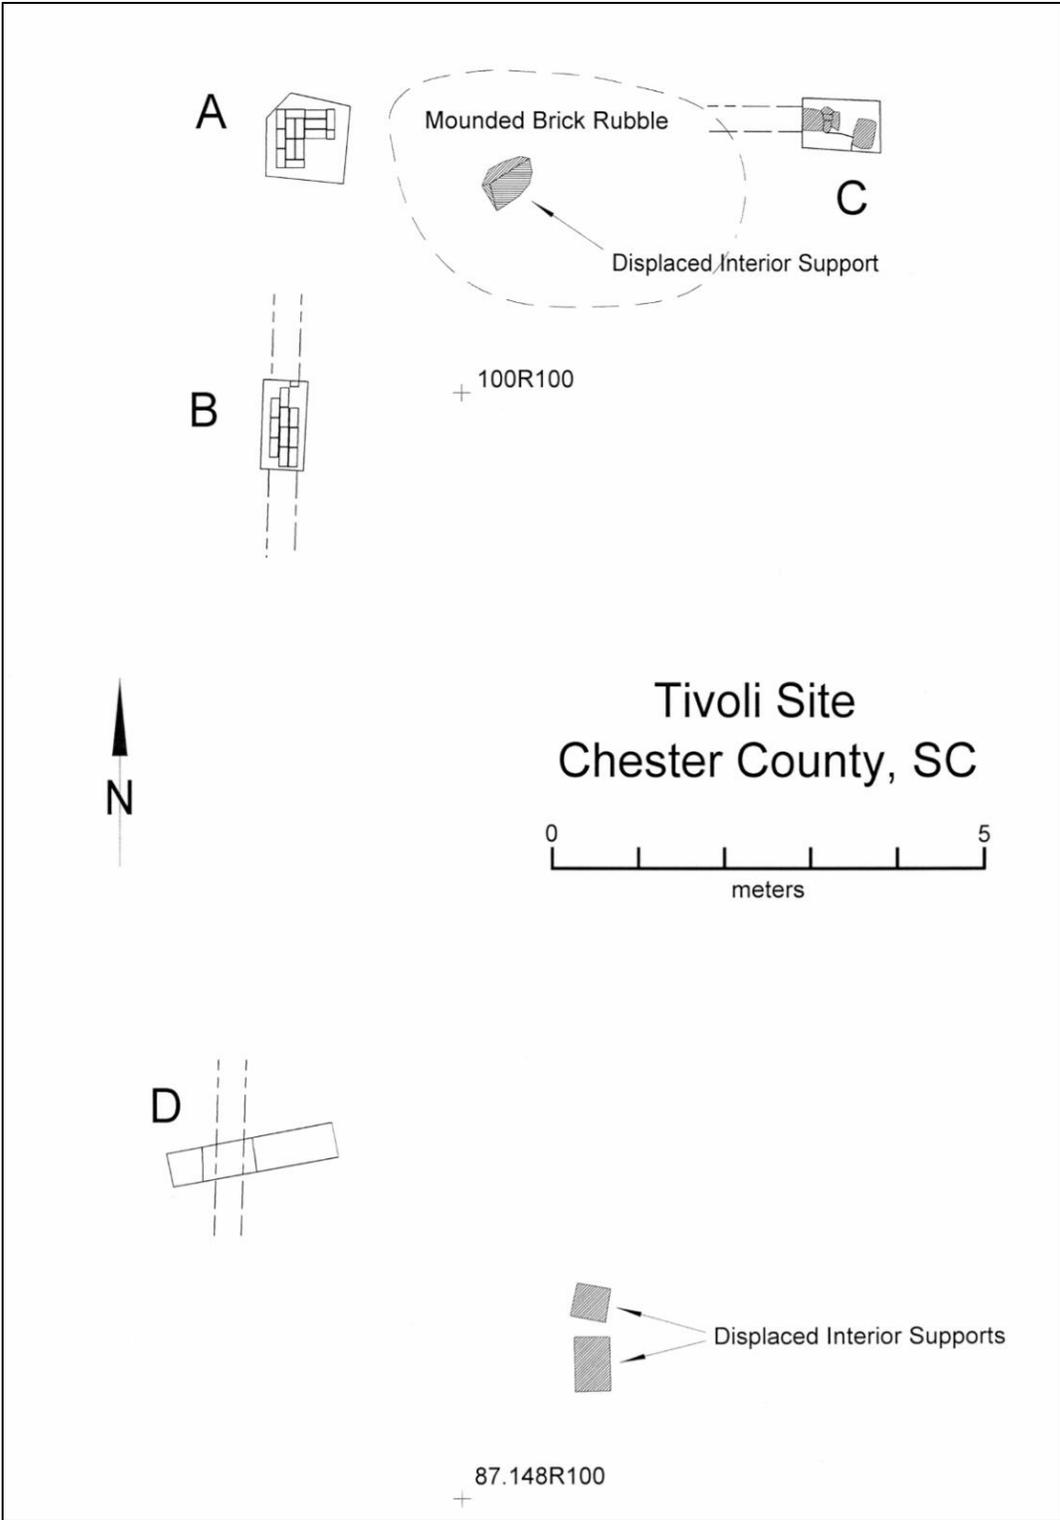
Figure 8. Map of 38CS299 showing areas of excavation in 2004 and identified archaeological features. Courtesy of UNC RLA.

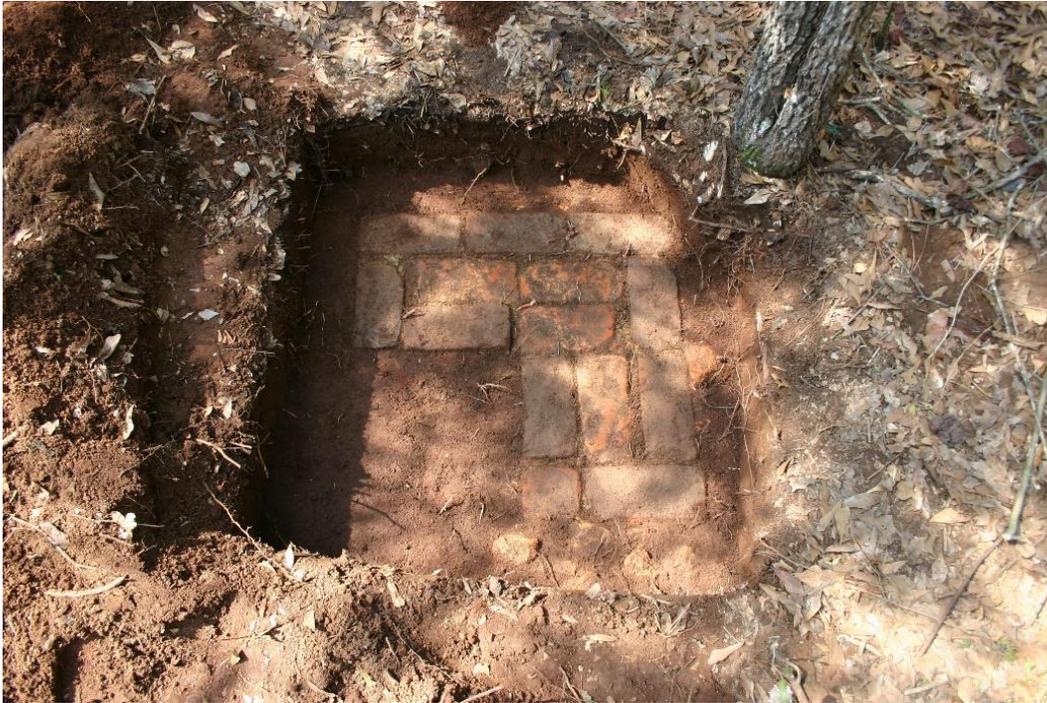
Figure 9. Test Unit A, view to the west, from Davis and Riggs (2004). Courtesy of UNC RLA.

The goal of excavation then became to expose the brick footer and also search for additional footers. A 0.9 m by 0.9 m test unit was excavated and designated Test Unit A (Figures 8 and 9). They probed a line west of Test Unit A going at 10-15 cm intervals, but found no additional brick footers. Using this same method to the south, they uncovered an “alignment of foundation bricks three bricks wide and four bricks long” (Davis and Riggs 2004: 14). The test unit excavated measured 0.5 m by 1 m by 12 cm deep and was called Test Unit B (Figure 10).

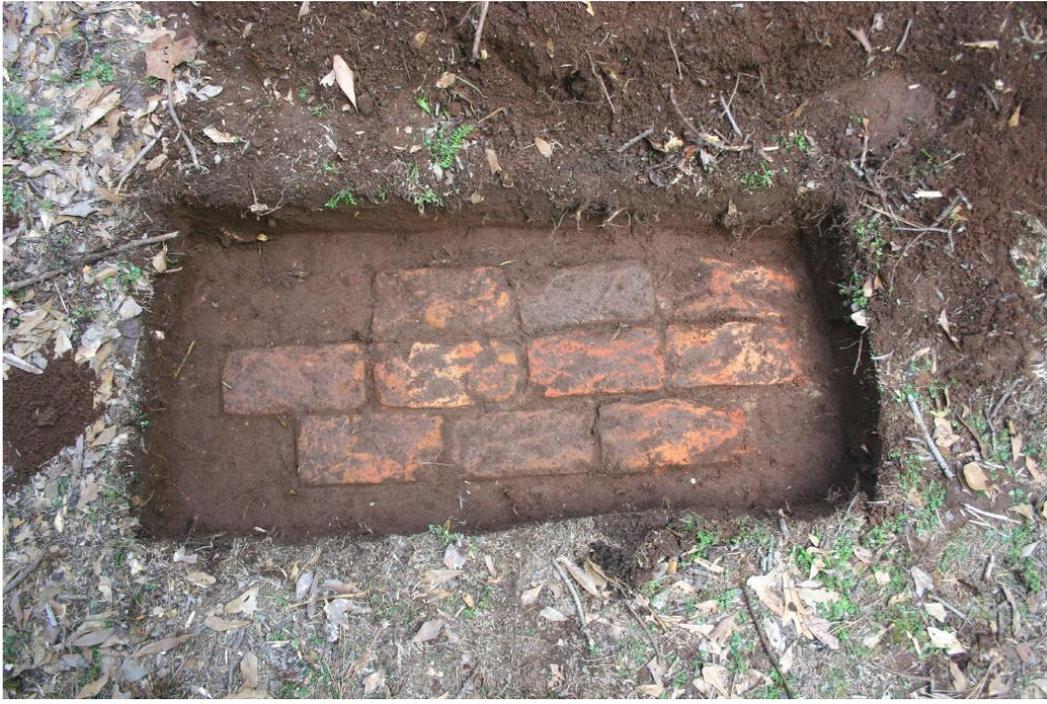
Figure 10. Test Unit B, view to the east, from Davis and Riggs (2004). Courtesy of UNC RLA.

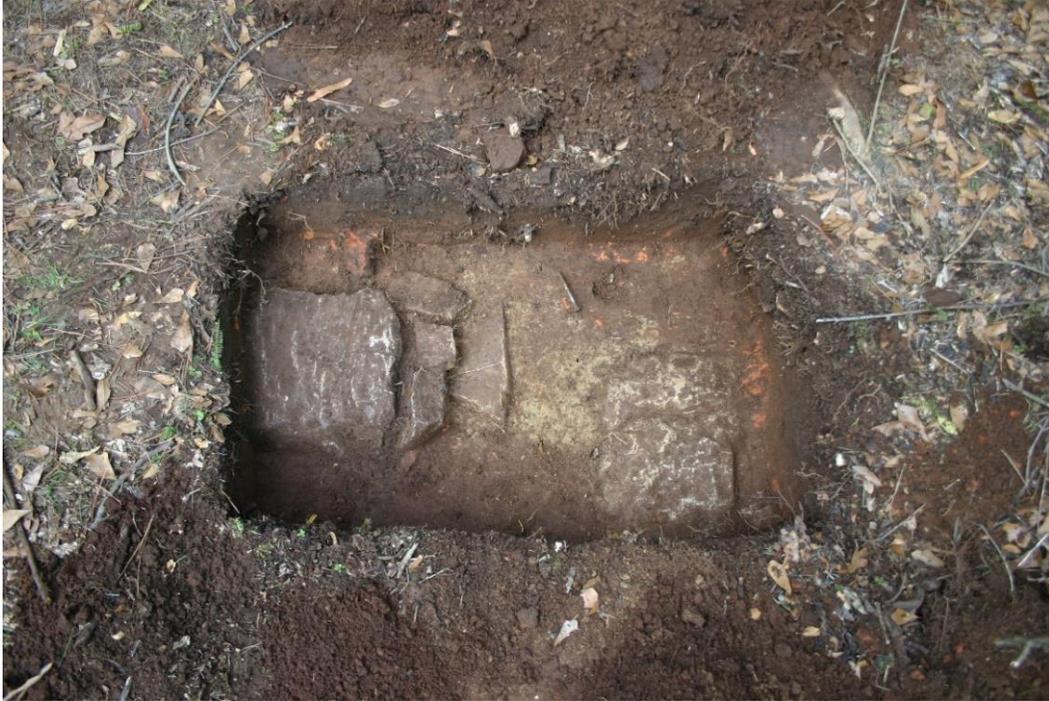
Figure 11. Test Unit C, view to the north, from Davis and Riggs (2004) . Courtesy of UNC RLA.

The excavators then probed east of Test Unit A and found a section of stones resting *in situ* in what they deemed to be a foundation trench about six meters out. Their excavation here measured about 0.6 m by 0.9 m by 16 cm deep, and was called Test Unit C (Figure 11).

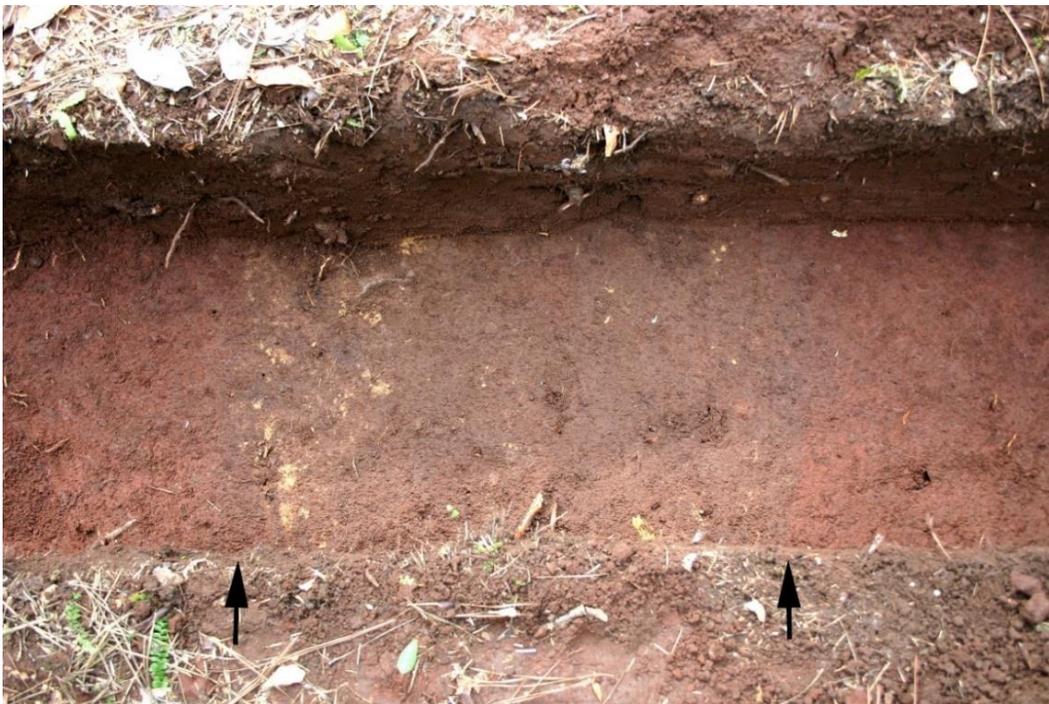
Figure 12. Close-up of Test Unit D. Note the mottled soil and the sand mortar present. Arrows represent the trench edges. From Davis and Riggs (2004); view to the south. Courtesy of UNC RLA.

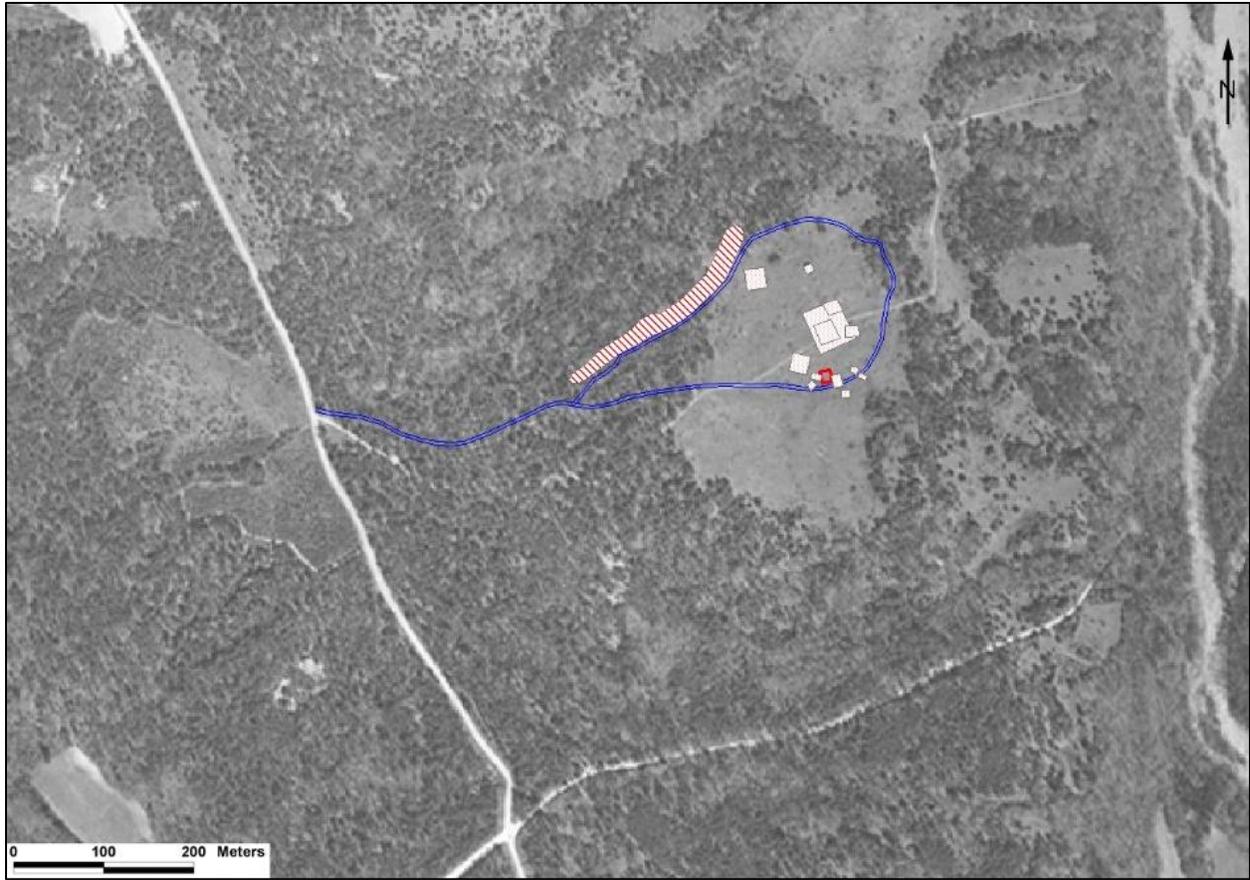
Figure 13. The areas investigated by the 2006 RLA Field School. 38CS299 is the small area outlined with solid red, and 38CS301 is the larger area filled in with red stripes. The blue line depicts an abandoned roadbed. Photo courtesy of UNC RLA.

The findings from the limited 2004 investigation prompted a much larger site investigation in 2006, coinciding with the 250th anniversary of Davie's birth (Figure 13). The primary research goals were to expose the foundation of the building, which would help in understanding its "size and configuration," and to obtain a collection of artifacts associated with the site that could show the date of construction, the time of occupation, and the status of the people who occupied the structure (Davis and Riggs 2005).

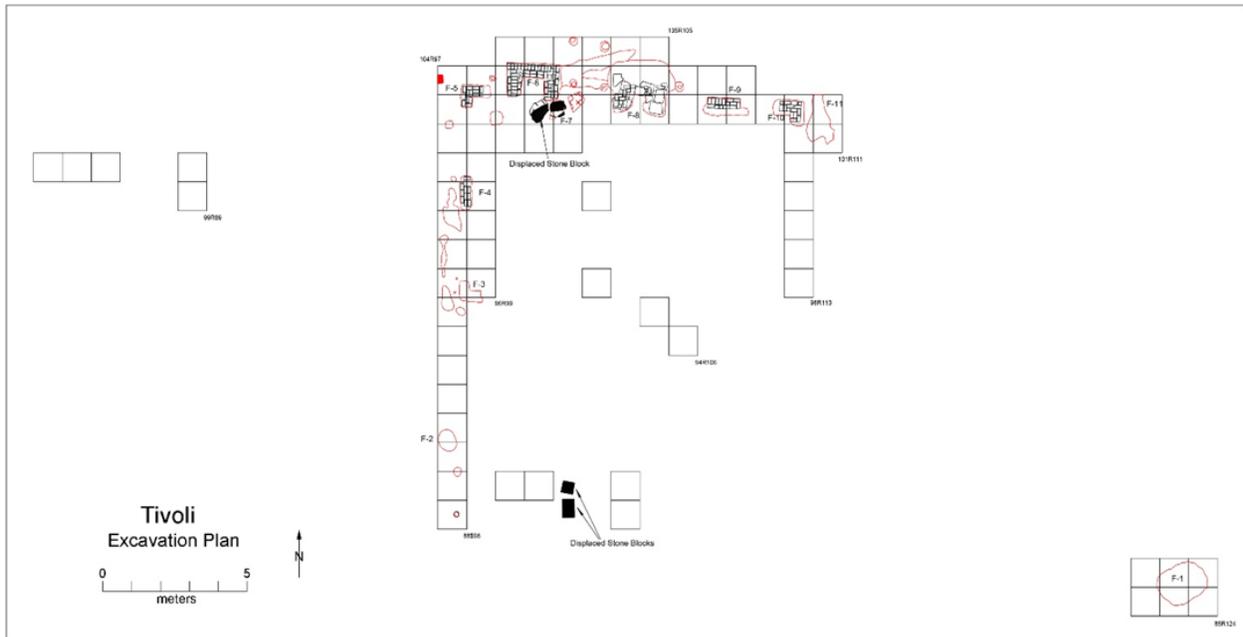
Figure 14. Complete plan of 2006 excavation units at 38CS299, with architectural remains and other features (outlined in red). Courtesy of UNC RLA.

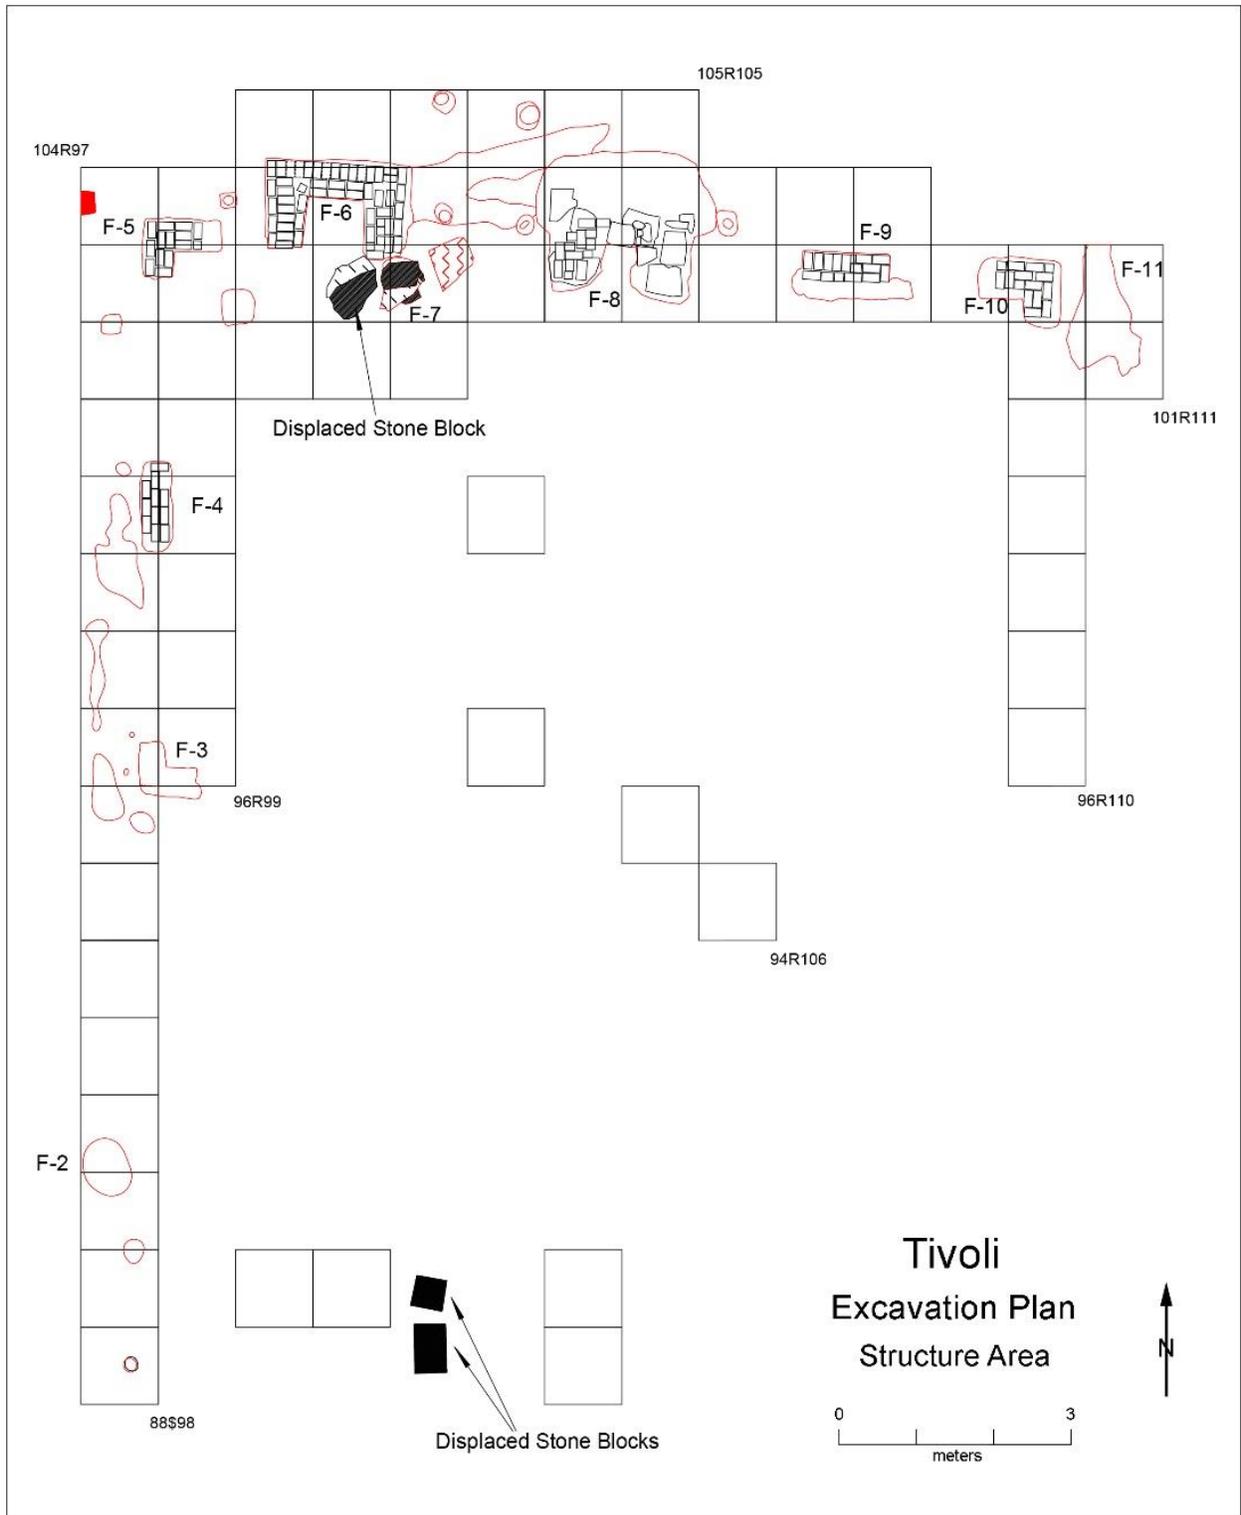
Figure 15. Portion of the 38CS299 excavation plan showing architectural remains and other features (outlined in red). Courtesy of UNC RLA.

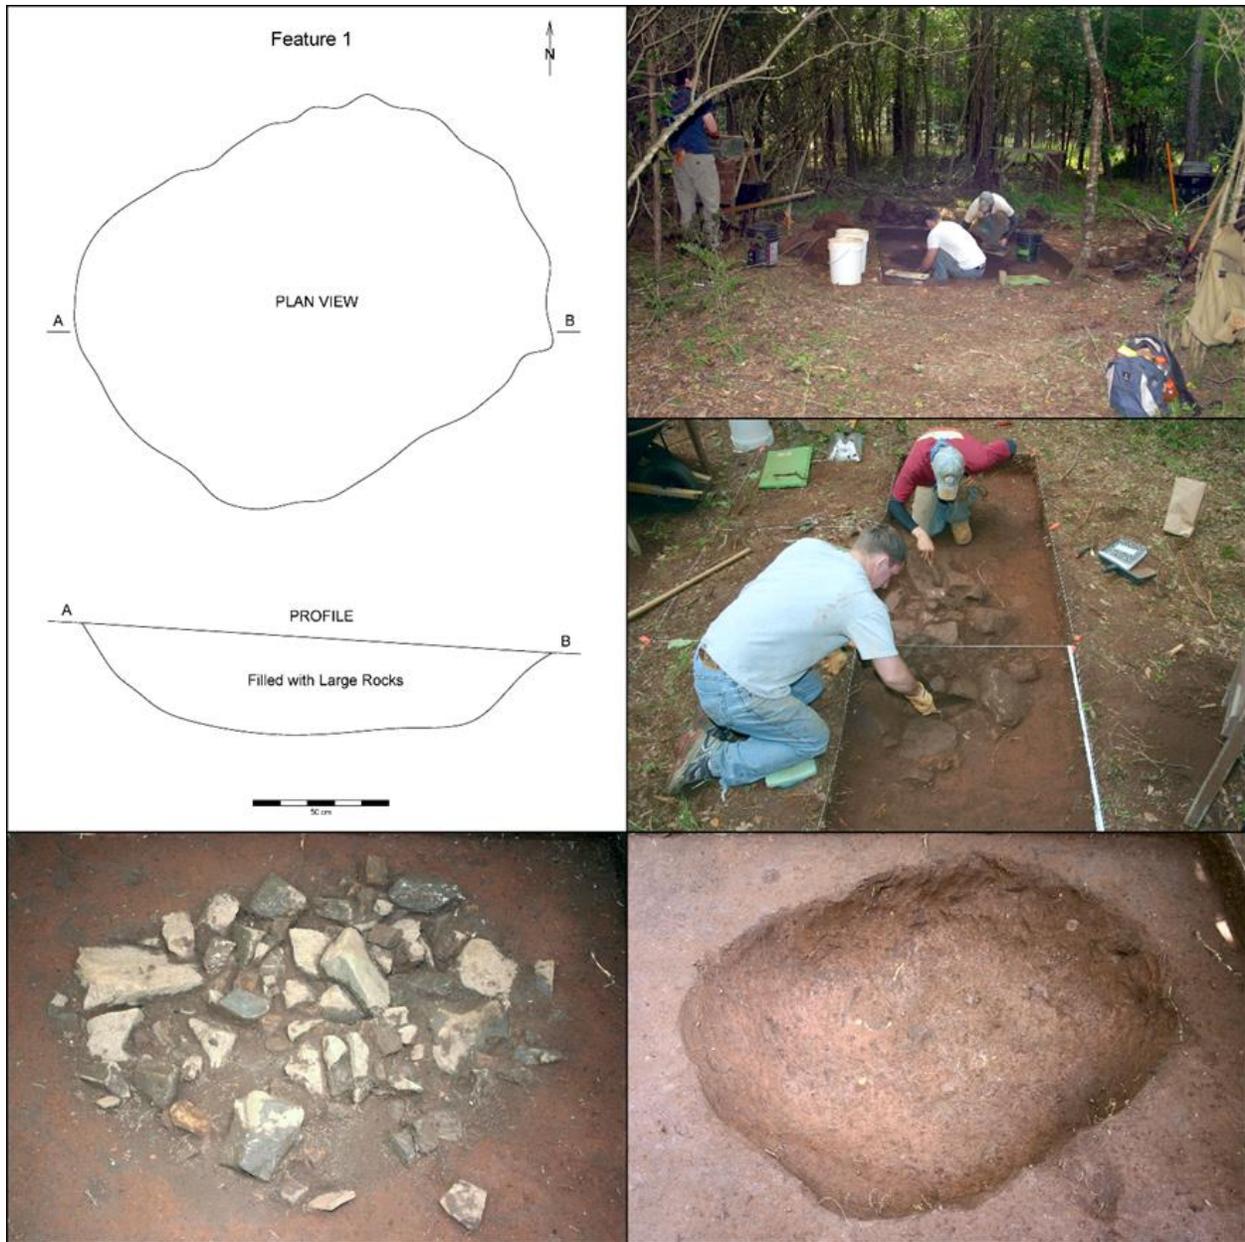
Figure 16. Feature 1 plan and profile drawings (top left); top of rock-filled feature prior to excavation (bottom left); feature being excavated (top right and center right); and excavated feature. Courtesy of UNC RLA.

southeast of the main structure site where the building foundations were found. The feature was 1.67 m long (measuring NE-SW) and 1.27 m wide (measuring NW-SE). The depth of this feature varied throughout, but was in the range from 33 to 53 cm below the surface, with the outer edges of the feature being higher than the center. The fill in Feature 1 transitioned down from a dark reddish brown (Munsell 5YR 3/3) silty loam down to a wet clay. Artifacts excavated from Feature 1 include 315 rocks and an indeterminate amount of brick fragments. Excavators originally hypothesized that Feature 1 might be a filled-in well, due to its distance from the house, but after finding that the rock fill did not continue to 1 m below the surface, this hypothesis was rejected.

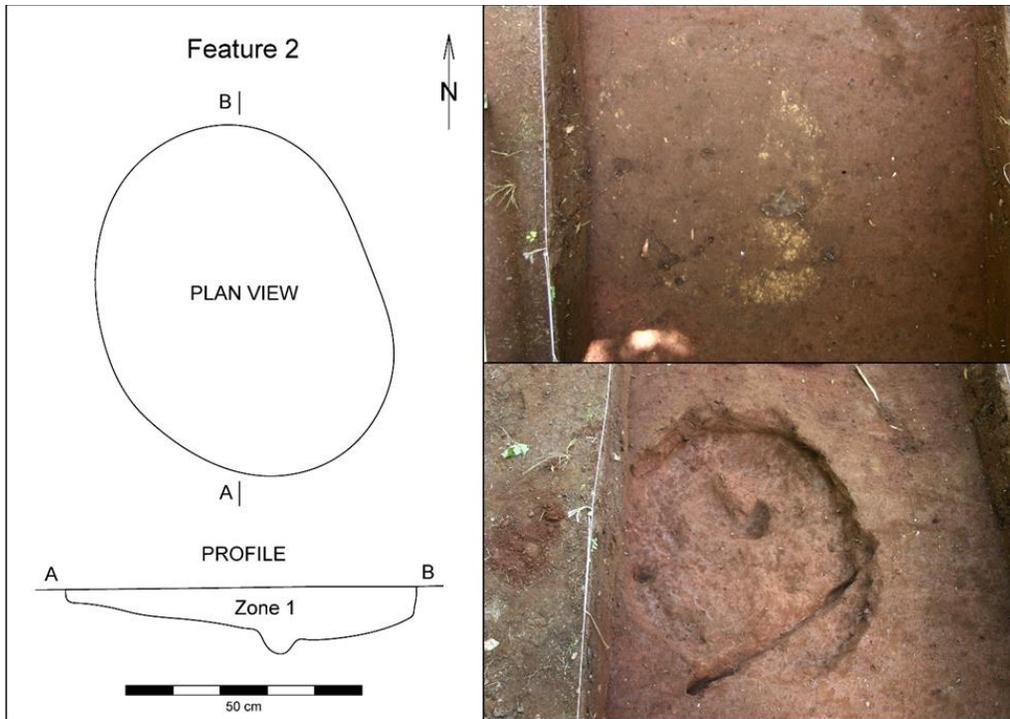
Figure 17. Plan and profile drawings of Feature 2 (left); Feature 2 before it was excavated (note the yellow mottling from the mortar) (top right); and feature fully excavated (bottom right). Courtesy of UNC RLA.

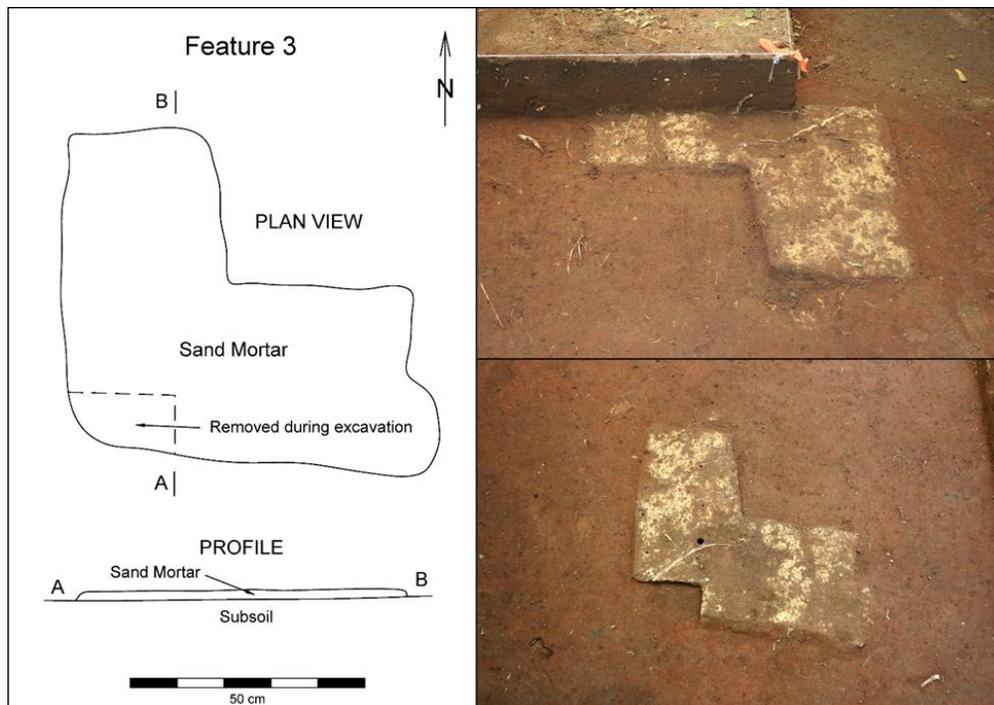
Figure 18. Plan and profile drawings of Feature 3 (left); pictures of Feature 3 before and after the sand deposit in the southeastern corner of unit 96R98 was excavated. Courtesy of UNC RLA.

Feature 3. Feature 3 was an L-shaped lens of sand mortar located in the southeastern corner of unit 96R98 and the southwestern end of unit 96R99 (Figure 18). This unit was interpreted as one of the corner foundation piers for the structure on this site. The disturbance was characterized by a change from the surrounding dark reddish brown (2.5YR 3/4) silty loam to a yellowish brown (10YR 6/4) sandy silt loam mottled with sand and mortar. In the

southeastern corner of unit 96R98, there was a layer of sand mortar that was about 1 cm thick. Feature 3 measured 0.77 m in length (E-W) and 0.68 m in width (N-S). The thickness of the feature was 24 cm. No artifacts attributed to this feature in particular. It was noted that there was a fair amount of sand and mortar surrounding this foundation pier.

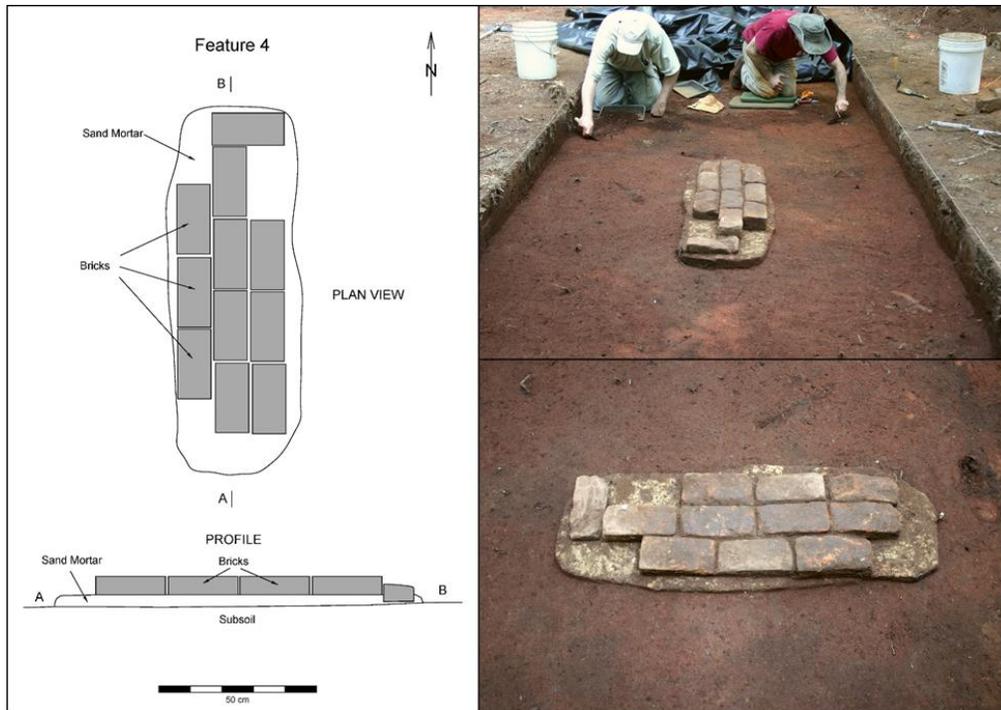
Figure 19. Plan and profile drawings of Feature 4 (left); Feature 4 (a mid-wall foundation) as it was being excavated and after it was excavated (right). Courtesy of UNC RLA.

Feature 4. Feature 4 was an *in situ* brick mid-wall foundation pier which went through the eastern edge of unit 99R98, the southeast corner of unit 100R98, the western edge of unit 99R99, and the southwest corner of unit 100R99 (Figure 19). This feature was not characterized by a soil change, but, rather by 3 rows of *in situ* bricks with 11 bricks total. There was also a layer of sand mortar that surrounded the bricks. The feature measured 1.19 m in length (N-S) and 0.42 m in width (E-W), and the thickness of the feature was 10-11 cm. The feature itself was composed solely of the row of 11 bricks and the surrounding sand mortar.

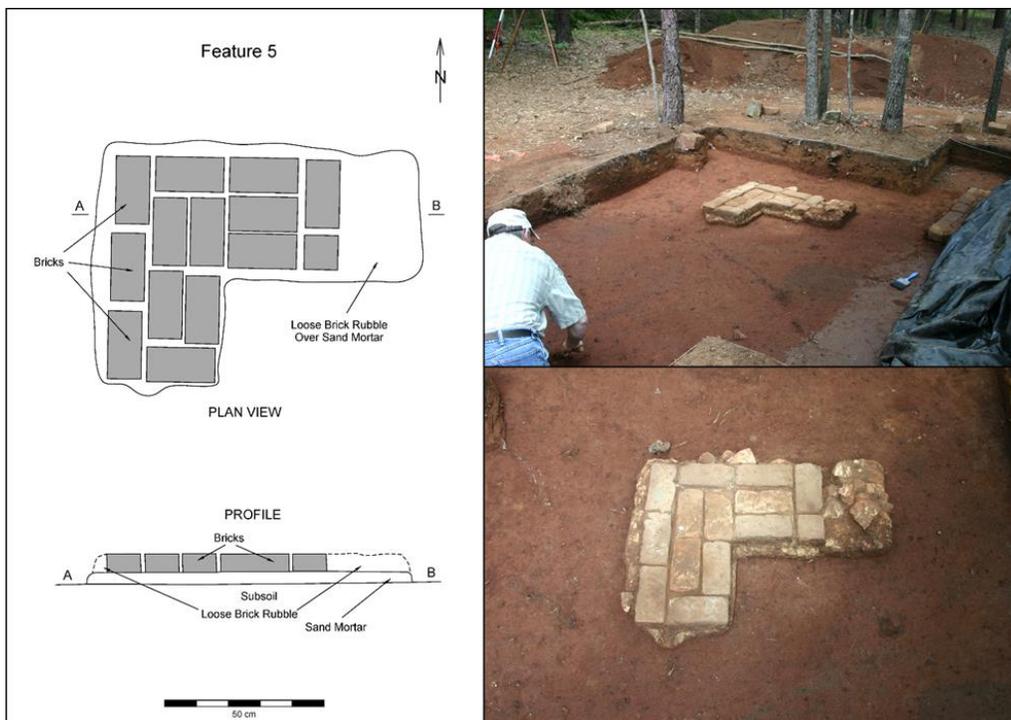
Figure 20. Plan and profile drawings of Feature 5 (left); Feature 5 (corner foundation) as it was being excavated and after excavation (right). Courtesy of UNC RLA.

Feature 5. Feature 5 was another *in situ* brick corner foundation pier (Figure 20). This feature was located in the northeast corner of unit 102R98, the northwest corner of unit 102R99, the southeast corner of unit 103R98, and the southwest corner of unit 103R99. The feature measured 0.98 m in length (E-W), and 0.73 m in width (N-S). The depth at which Feature 5 was encountered was about 18-20 cm. This feature was characterized by a corner-shaped course of 14 bricks, along with brick rubble along the outer edges. No other artifacts were found with this feature.

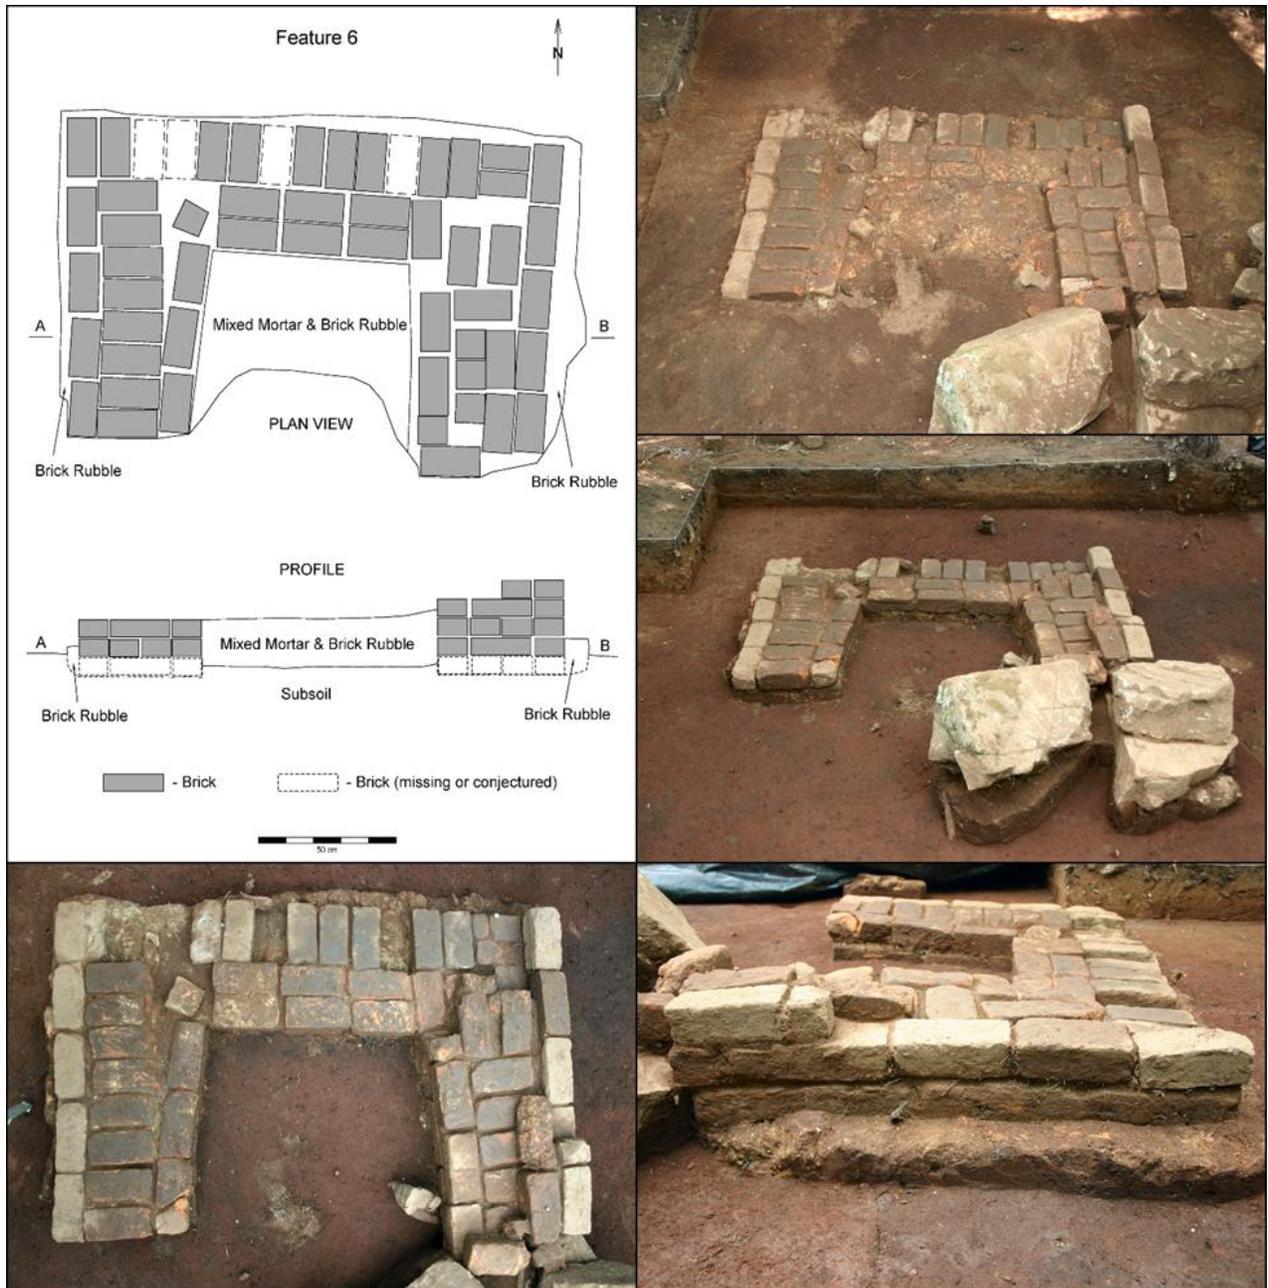
Figure 21. Plan and profile drawings of Feature 6 (top left); Feature 6 during the process of excavation (note Feature 7, the large displaced stones, on the southern end) (top right); Feature 6 from the side (bottom right); top view of Feature 6, fully excavated (bottom left). Courtesy of UNC RLA.

Feature 6. Feature 6 was an *in situ* fireplace hearth and chimney foundation (Figure 21). The feature was located along the east wall of unit 103R100, the north wall of unit 103R101, along the west wall of unit 103R102, and on the south edge of unit 104R101. Feature 6 measured 1.71 m in length (E-W) and 1.12 m in width (N-S). The feature was encountered at a depth of 15-

19 cm below the surface. This feature only contained the chimney foundation, which included 52 *in situ* bricks as well as a course of mortar and rubble.

The two hearths on this site, Feature 6 and Feature 8, are also of particular interest when studying this structure. There is a distinct difference in construction date suggested by these two hearths. Firstly, Feature 8 is constructed with different materials than Feature 6, using brick, mortar, and stone as opposed to just brick and mortar. The construction of Feature 6 appears more consistent with the brick foundation piers. Secondly, the two hearths are not aligned with each other, and only Feature 6 is aligned with the piers, suggesting this hearth was built the same time as the piers. Feature 8, then, presumably predates the construction of the foundation piers and Feature 6, as the differences in alignment and construction suggest. However, Feature 8 was likely incorporated into the structure, as it would have been completely dismantled if it was not.

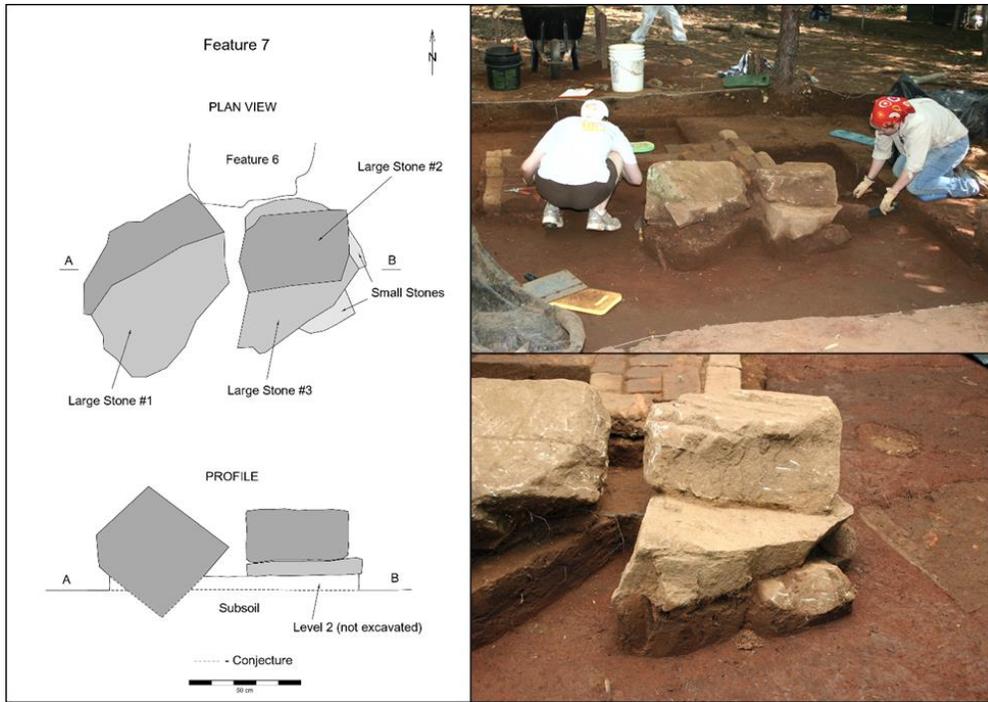
Figure 22. Plan and profile drawings of Feature 7 (left); Feature 7 as it was being excavated and post excavation (right). Courtesy of UNC RLA.

Feature 7. Feature 7 was described as a “large rock cluster” in the centers of units 102R101 and 102R102 (Figure 22). These, on the maps in Figures 17 and 18, were referred to as “displaced stone blocks,” and were visible on the surface of these units. Together, they measured 1.23 m long (E-W) and 0.72 m wide (N-S). This feature was characterized by the large stone blocks that were just south of the collapsed chimney foundation, and no other artifacts of note were part of Feature 7. This feature left a large amount of units 102R101 and 102R102 unexcavated, due to its size.

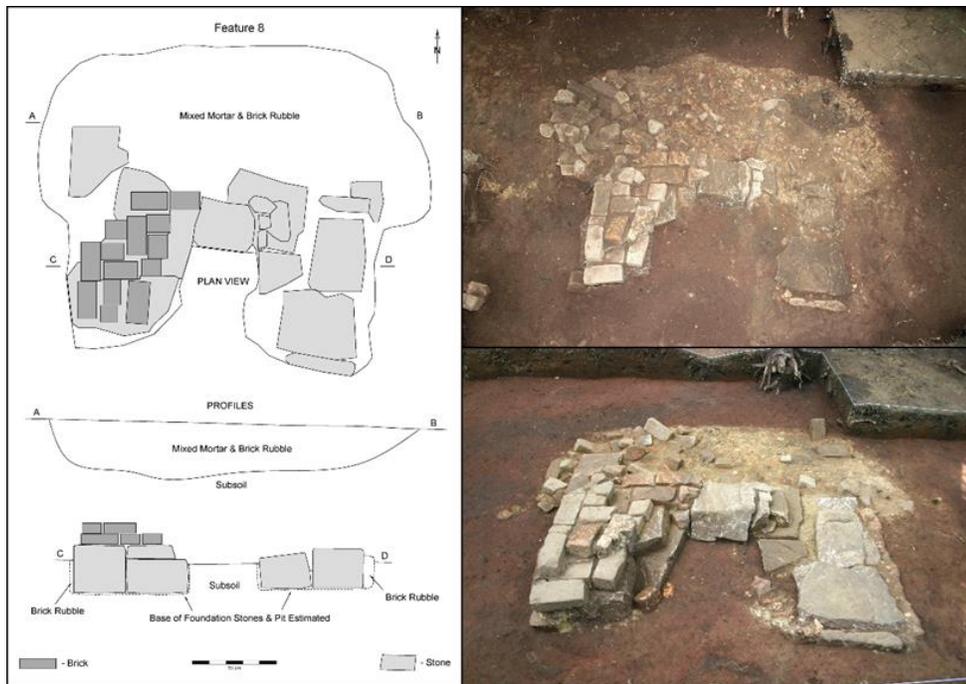
Figure 23. Plan and profile drawings of Feature 8 (left); Feature 8 before the brick rubble was excavated (right). Courtesy of UNC RLA.

Feature 8. Feature 8 was described as a collapsed fireplace hearth and chimney foundation which was characterized both by a course of brick and stone as well as a layer of brick and mortar rubble (Figure 23 and 24). Feature 8 ran through the northern half of units 102R104 and 102R105, through the entirety of units 103R104 and 103R105, the west edge of unit 103R106, and the southern edge of units 104R104 and 104R105. The further south, the more brick and stone was present in the feature. This course of bricks and stone as well as the mortar ranged from being 9-24 cm below the surface, and measured 1.69 m long (E-W) and 1.33 m wide (N-S). This feature was characterized both by the course of brick and stone that was present in the south as well as a switch to a light olive brown (10YR 5/6) to light yellowish brown (10YR 6/4) soil that was filled with mortar. It is also of note that this feature not in alignment with the foundation piers in the house, and was constructed differently from the hearth at Feature 6.

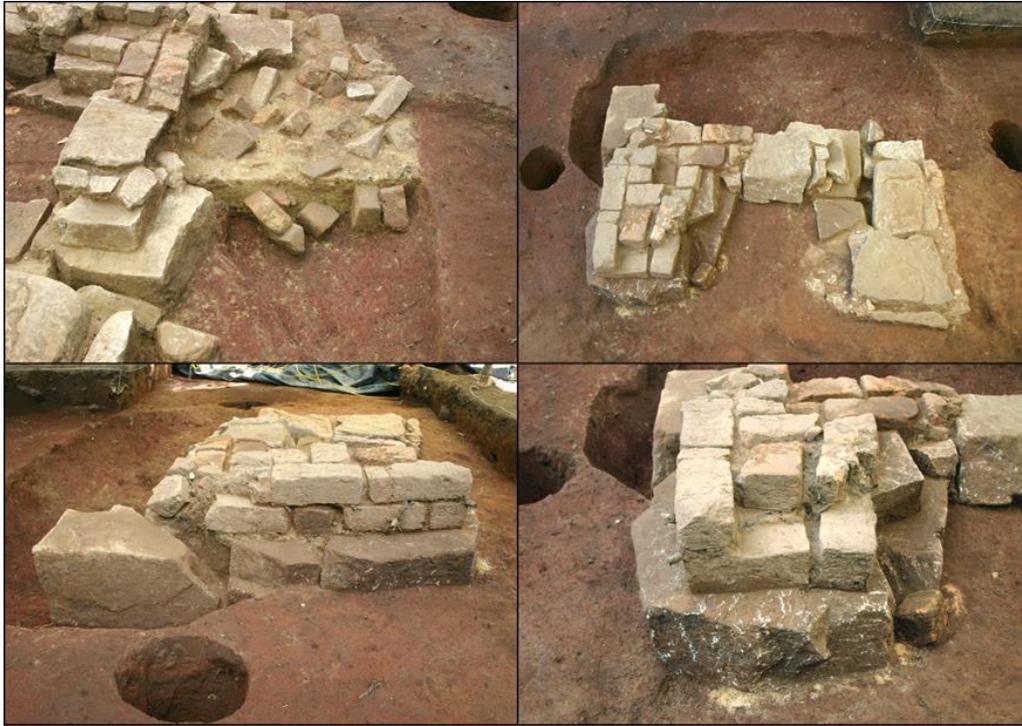
Figure 24. Feature 8 after the brick and mortar rubble was excavated. Courtesy of UNC RLA.

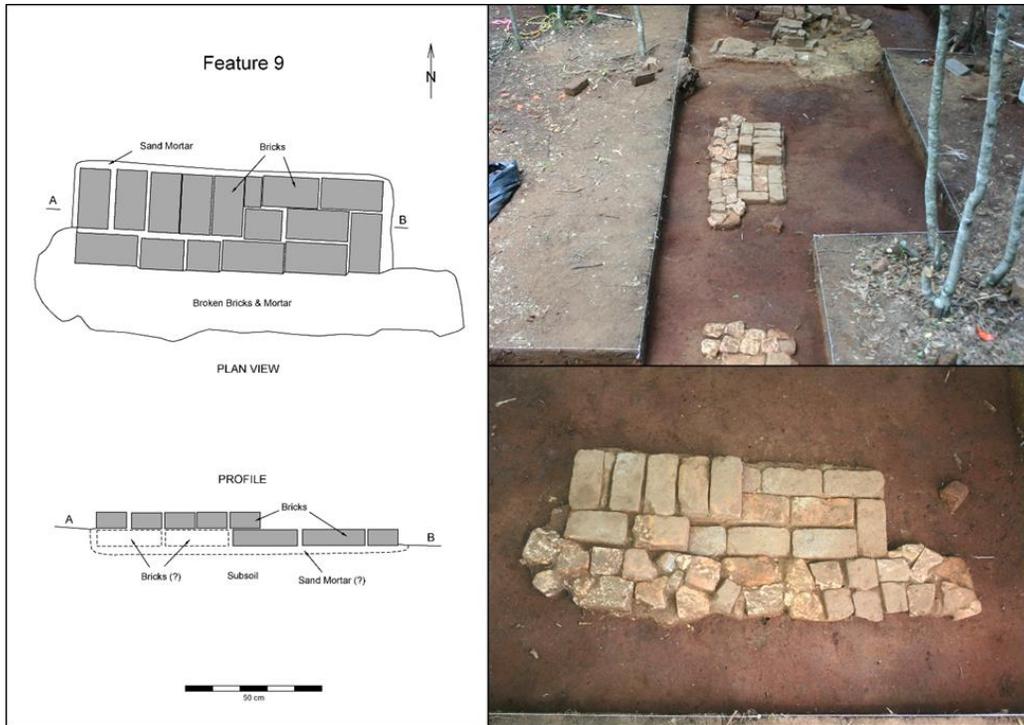
Figure 25. Plan and profile drawing of Feature 9 (left); Feature 9 post excavation, note the brick rubble below the course of bricks (right). Courtesy of UNC RLA.

Feature 9. Feature 9 was an *in situ* brick foundation pier (Figure 25). The feature was in the northeastern corner of unit 102R107 and the northwestern corner of unit 102R108. The depth at which the feature was discovered was about 13 cm below surface, and it measured 1.57 m long (E-W) and 0.59 m wide (N-S). This feature had no associated artifacts, but was characterized by the brick foundation pier consisting of 15 bricks and the associated trench of brick rubble, which was immediately south of the foundation pier.

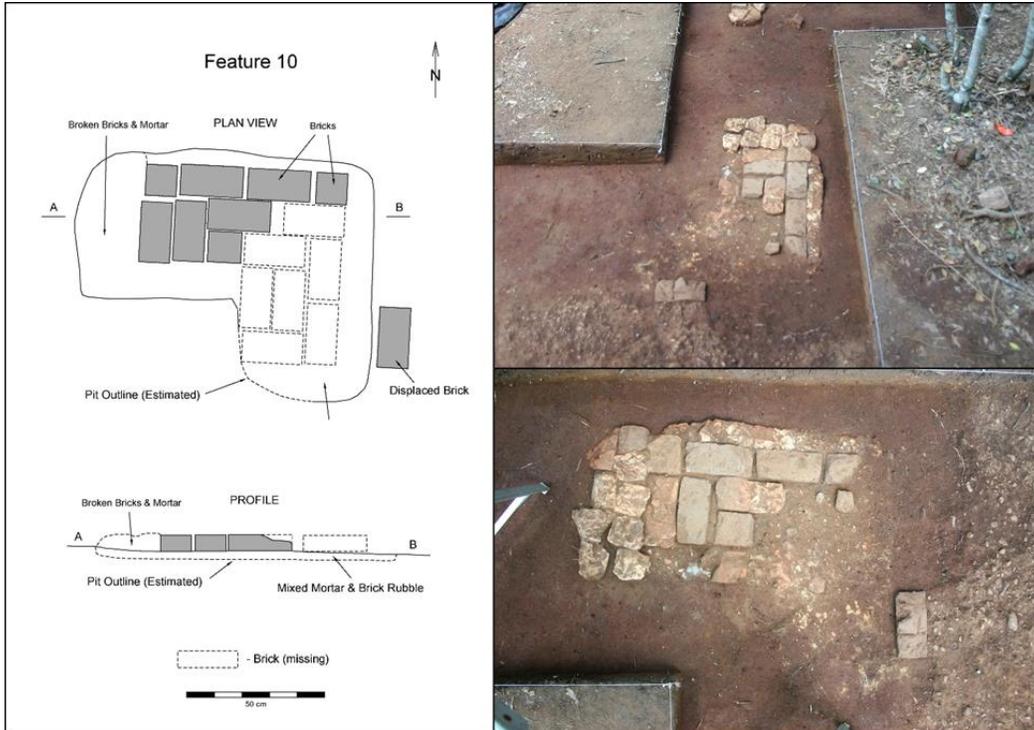
Figure 26: Plan and profile drawings of Feature 10 (left); Feature 10, fully excavated (right). Note the surrounding brick and mortar rubble and the single displaced brick. Courtesy of UNC RLA.

Feature 10. Feature 10 was an *in situ* brick foundation pier surrounded by a layer of brick and mortar rubble (Figure 26). Feature 10 was located along the eastern edge of unit 102R109 and within unit 102R110, and was bordered to the east by Feature 11. The feature measured 1.28
