REDISCOVERING TIVOLI: AN ARCHAEOLOGICAL INVESTIGATION
INTO WILLIAM R. DAVIE'S PLANTATION HOME

Honors Thesis
Curriculum in Archaeology
University of North Carolina at Chapel Hill

2020

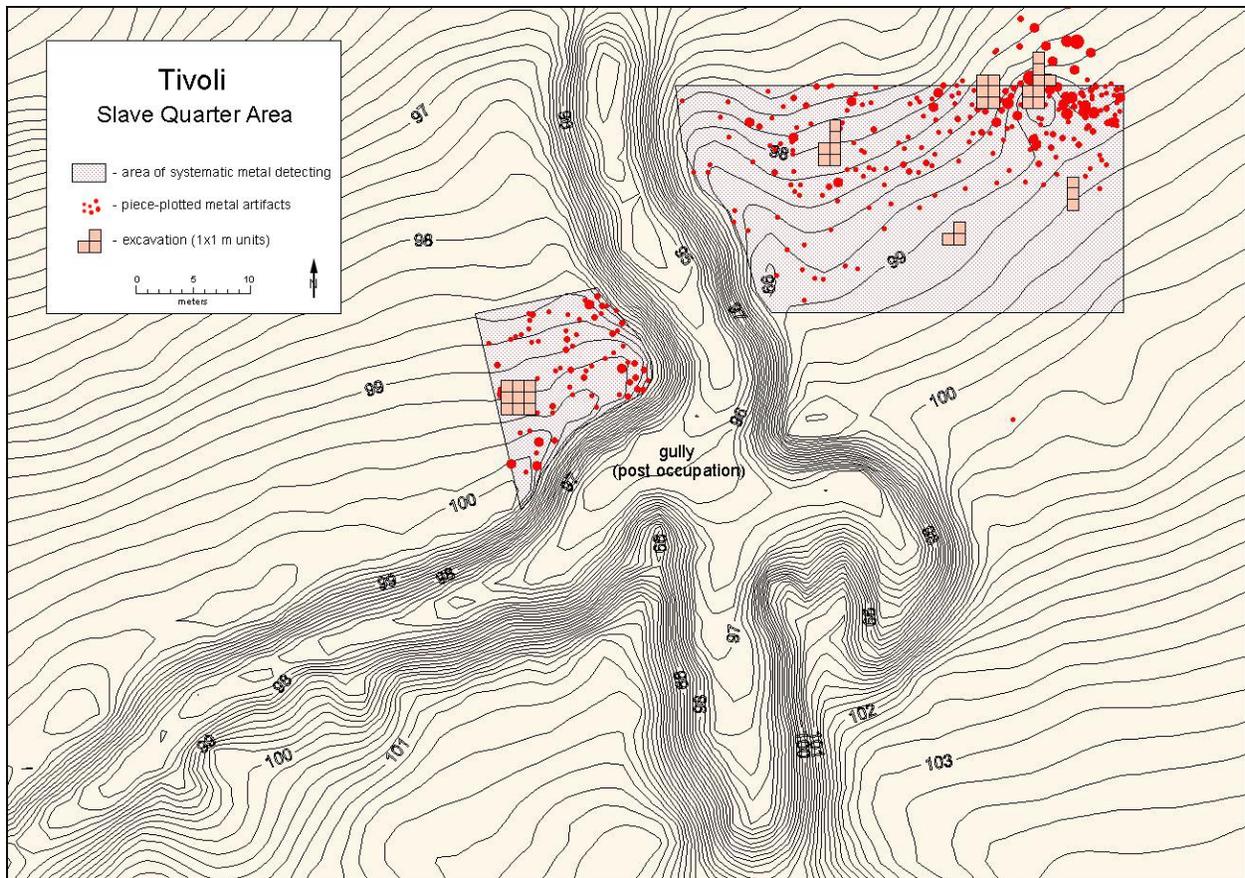
Figure 28. Contour map of the investigated area of site 38CS301, showing locations of artifacts identified and recovered during systematic metal detecting (red dots) and the excavated units (orange squares). Courtesy of UNC RLA.

This site is known as the "slave quarter" and was initially discovered by Deborah Joy in 2000, but was not identified then as having any potential nineteenth-century artifacts. However, in a re-survey of the Tivoli site, the "slave quarter" was rediscovered as an area of interest due to large concentrations of artifacts discovered in shovel test pits as well as extensive metal detector survey. It was considered a possibility for Tivoli's slave quarter because according to his will, William R. Davie owned many slaves, but it was unknown where these people lived. This site provides a possible location for the homes of those who were enslaved. Thirty-five units were excavated in this area (Figure 28).

A total of 2,564 artifacts were found, in both the excavations and the metal-detector survey. The concentration of artifacts was heavier in the northeastern-most area of this investigation (Figure 28). The types of artifacts found were refined earthenware, porcelain, iron nails, bottle glass, oyster shell, Catawba-made earthenware, clay pipe fragments, window glass, brass buttons, iron sheets, animal bones/teeth, slate, and a jaw harp.

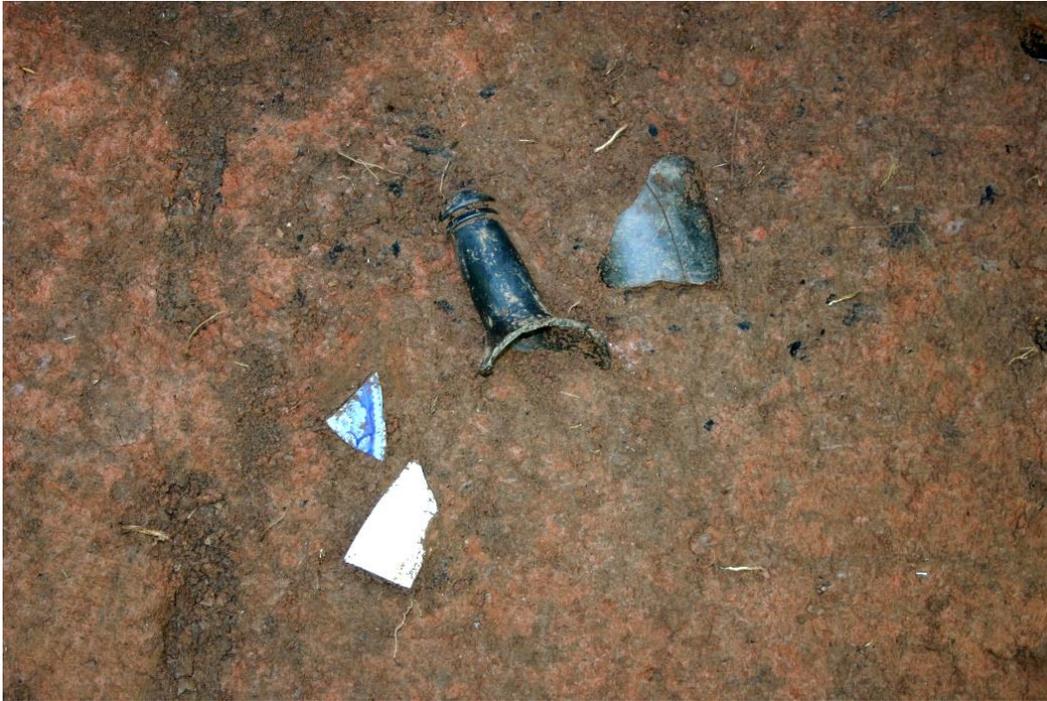
Figure 29. Feature 1 of 38CS301 as it appeared near the base of excavation. Note the refined earthenware sherds and the green glass bottle neck present. Courtesy of UNC RLA.

Feature 1. Feature 1 was an artifact cluster located along the west edge of unit 203L82, the northeast corner of unit 203L83, the western wall of unit 204L82, and the southeastern corner of unit 204L83 (Figure 29). There are no recorded length and width measurements for this feature, but at its deepest point, it was 32 cm below the surface. Thirty-nine artifacts were found in Feature 1, including container and bottle glass, animal bones, pig teeth, refined earthenware,

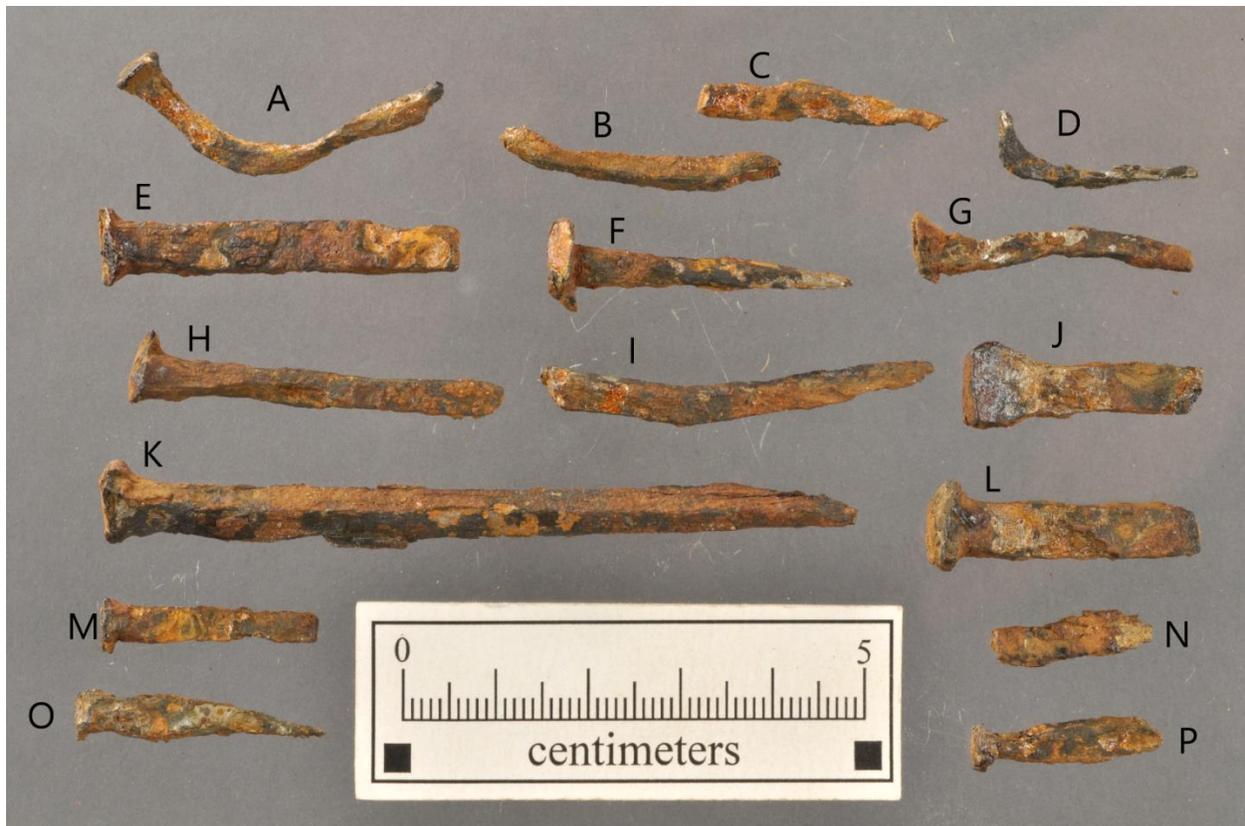
Figure 32. A sample of nails recovered from 38CS299. A: bent machine cut with a cut head; B: machine cut; C: machine cut; D: hand-wrought; E: machine cut with a cut head; F: hand-wrought; G: machine cut with a cut head; H: machine cut with a cut head; I: bent, machine cut; J: machine cut with a cut head; K: machine cut with a cut head; L: machine cut with a cut head; M: machine cut with a cut head; N: machine cut; O: hand-wrought; P: machine cut with a cut head. Courtesy of UNC RLA.

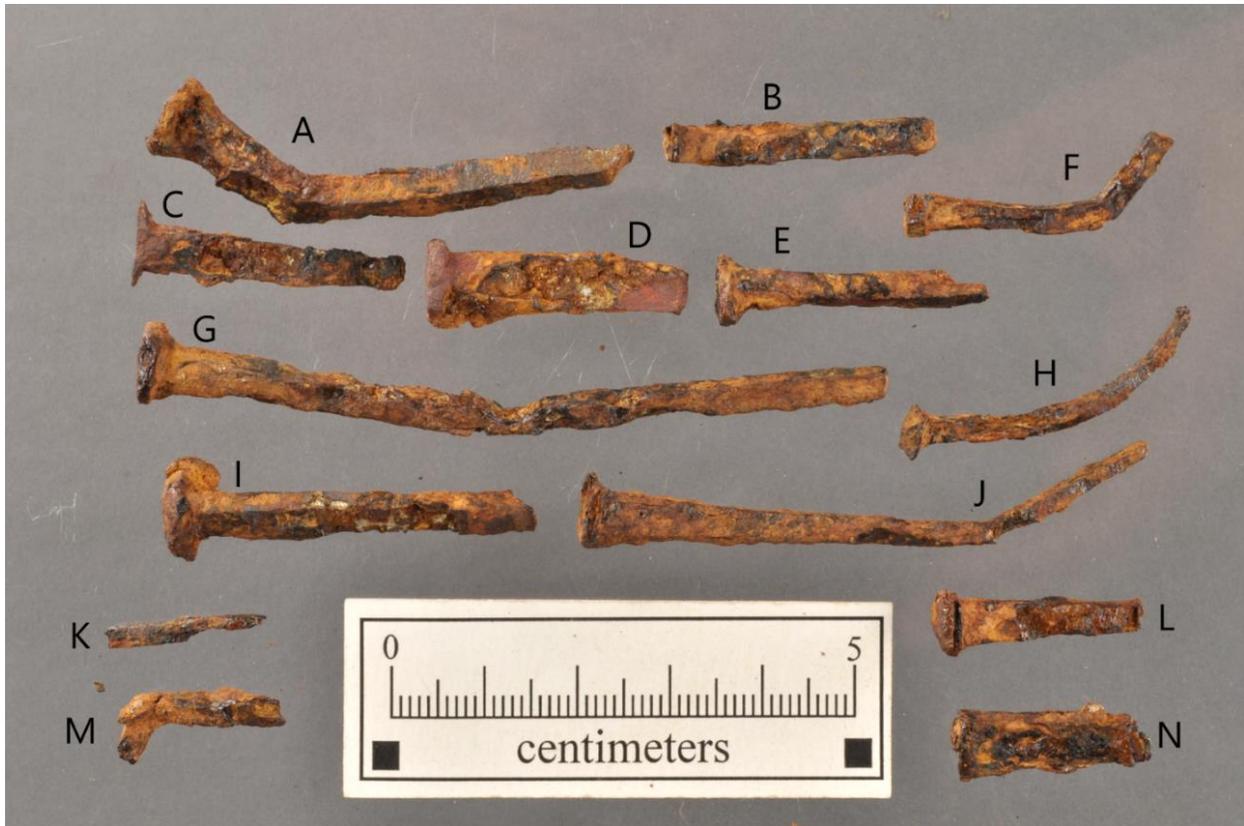
Figure 33. A sample of the nails recovered from 38CS301. A: bent machine cut with a cut head; B: machine cut; C: machine cut with a cut head; D: machine cut with a cut head; E: machine cut with a cut head; F: machine cut with a cut head; G: machine cut with a cut head; H: clinched hand-wrought; I: machine cut with a wrought head; J: bent, machine cut with a cut head; K: cut; L: machine cut with a wrought head; M: machine cut; N: machine cut. Photo courtesy of UNC RLA.

There were 608 total nails in this assemblage (Figure 33). Out of these, 30 (4.9%) were of an indeterminate type, 72 were wrought nails (11.8%), and 504 were cut nails (82.8%). Among

The physical descriptions of the nails were also notable. Ten nails were described as “bent” (1.6%) and 21 nails were described as “clinched” (3.4%), leaving 578 “unaltered” (94.9%). Nineteen were described as “burned” (3.1%).
