HUACA DE LOS CHINOS: THE ARCHAEOLOGY OF A FORMATIVE PERIOD  
CEREMONIAL MOUND IN THE MOCHE VALLEY, PERU

A dissertation submitted to the faculty of the University of North Carolina at  
Chapel Hill in partial fulfillment of the requirements for the degree of Doctor of Philosophy  
in the Department of Anthropology

Chapel Hill  
June 2009

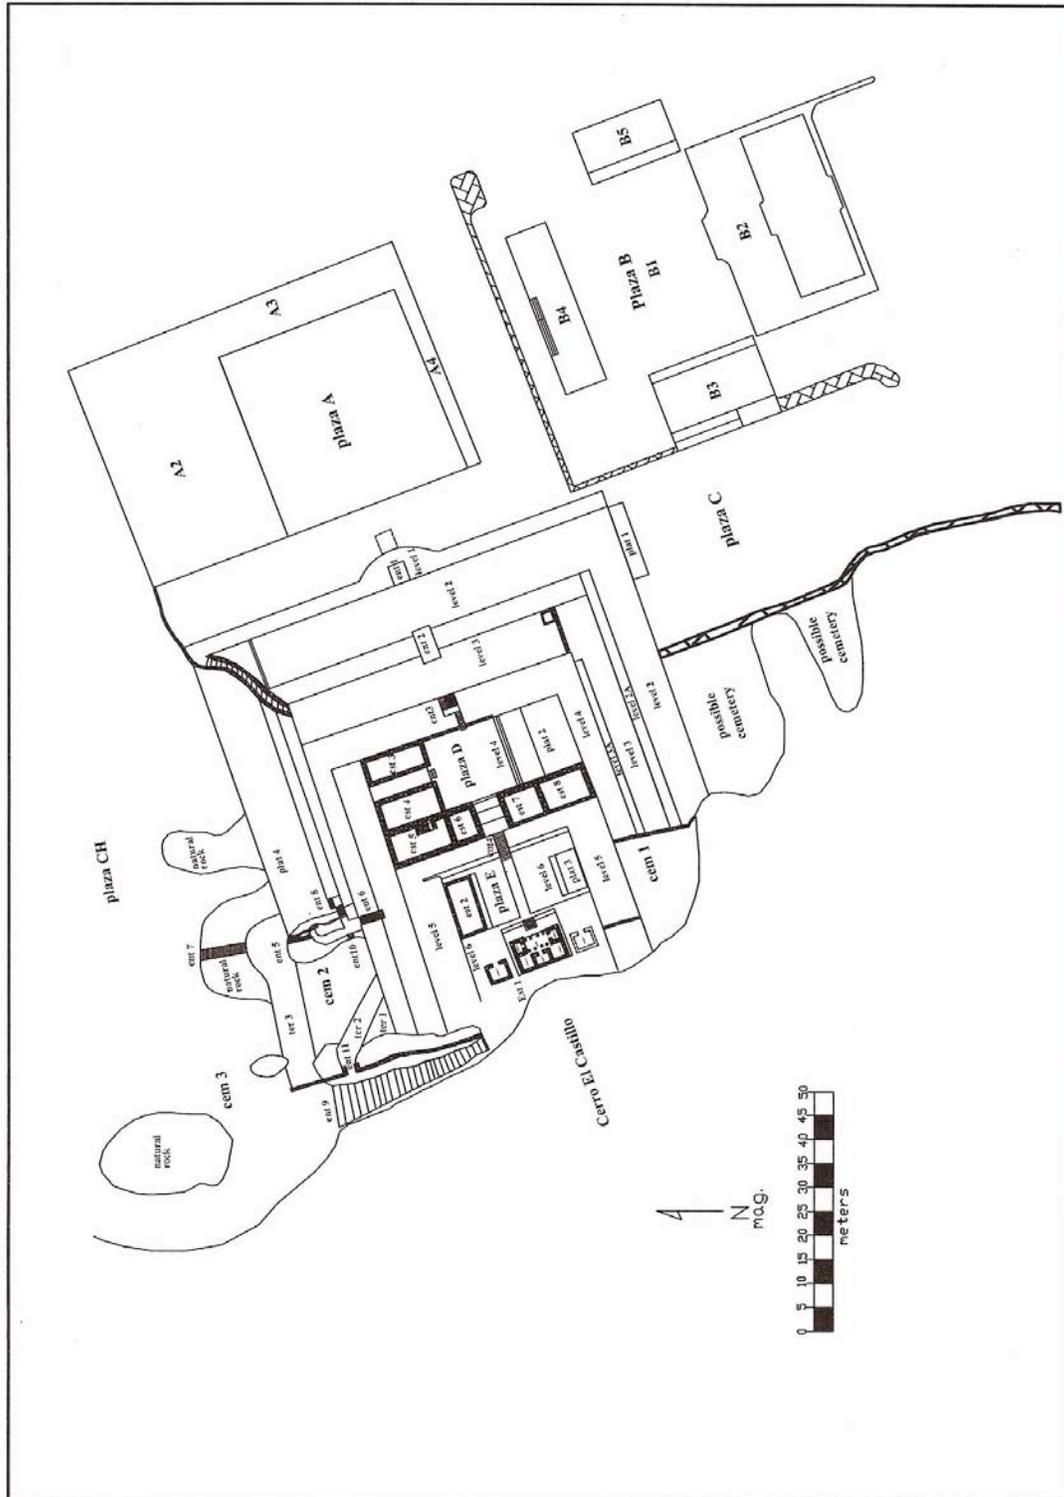
Figure 1.4. Map of Huaca de los Chinos.

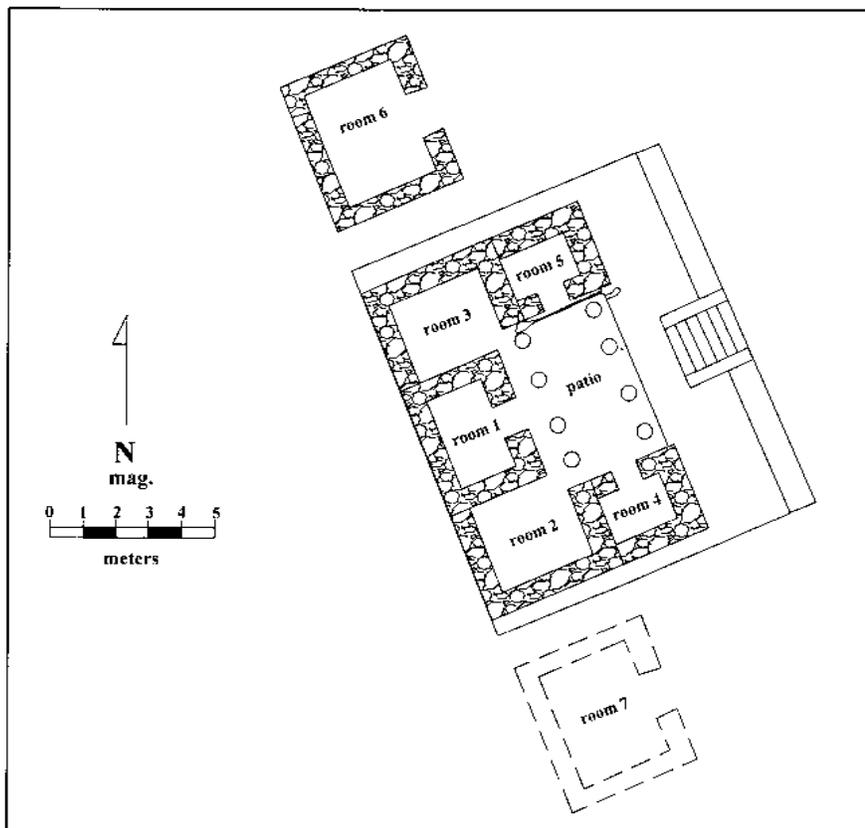
Figure 1.5. Drawing of the structure on the summit of Huaca de los Chinos (*Est 1*).

axis of *Est 1* passed up the front staircase, down the central aisle between the eight columns, and through the center of Room 1 (Figure 2.55). The architecture patterns on both sides of the axis were mirror images; making the structure bilaterally symmetrical. A sixth and seventh room were located 1 m from the northwestern and southeastern sides of *Est 1* and were considered part of *Est 1* (Figure 1.5). Substantial evidence suggests that the entire huaca—including *Est 1*—had been covered by a fine plaster during its active life, and all exterior and interior surfaces of *Est 1* had been painted using red, white, and black paint. It is interesting that while the architecture of *Est 1* was bilaterally symmetrical, the rest of Huaca de los Chinos was asymmetrical.

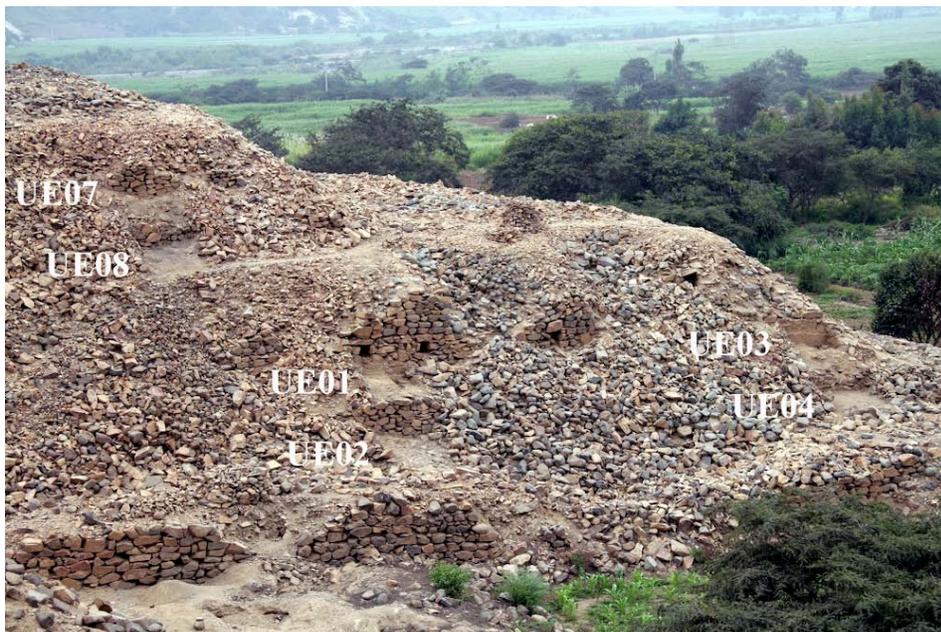
Figure 2.1A. Photograph of the southeastern side of Huaca de los Chinos showing the locations of UE01, UE02, UE03, UE04, UE07, UE08

Excavation Units UE01, UE02, UE03, UE04, UE07 and UE08 were designed to expose and clarify the original architecture at various locations on the southeastern side of the huaca (Figure 2.1A).

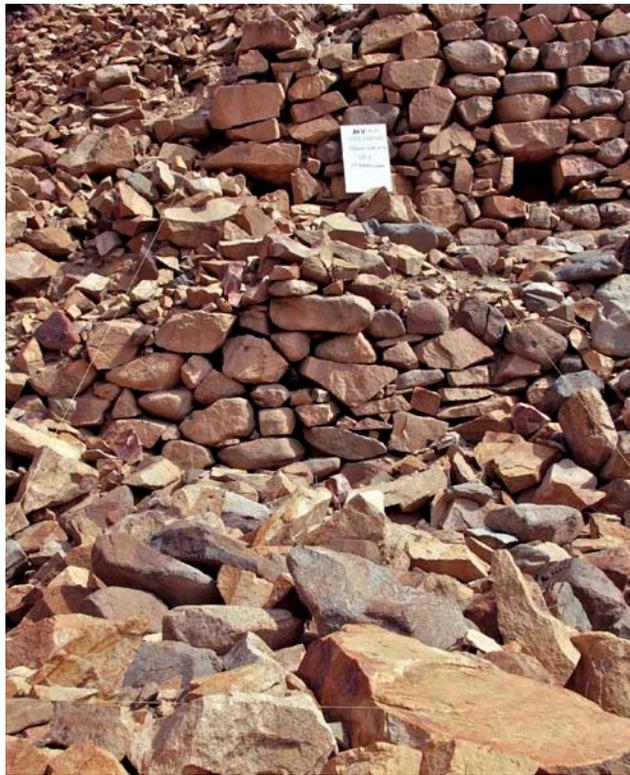
Figure 2.2. Photograph of UE01 before excavation showing the wall 3 (Feature 1) and the niche (Feature 1.01) in the background and Wall 2A (Feature 2) in the foreground.

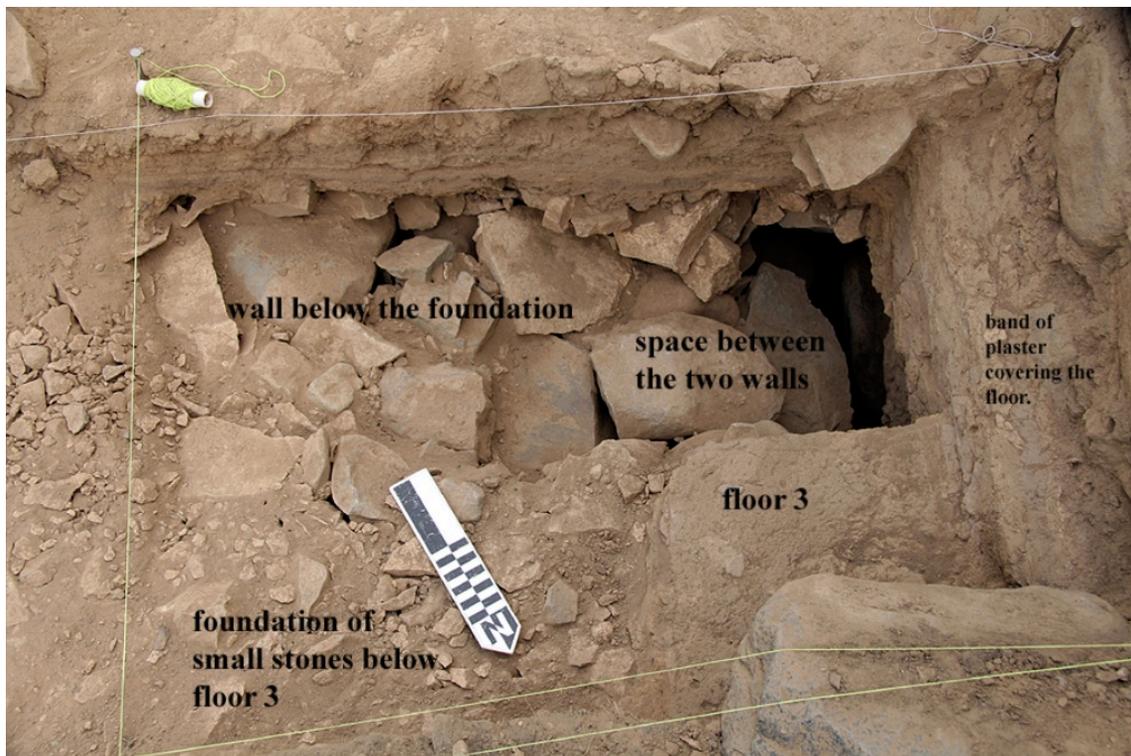
Figure 2.3. Photograph of UE01 after excavation. The figure shows part of Floor 3, the foundation of small white pebbles under Floor 3, the large rocks of Wall 2A (Feature 2), the 10 cm wide band of plaster that covered Wall 3 (Feature 1), and the 20 cm space between Wall 2A and Wall 3.

A 10 cm thick band of plaster extended across the excavation unit at the juncture of the front wall of huaca Level 3 (Feature 1) and the wall forming huaca Level 2A (Feature 2). It rose vertically up Feature 1 to about 10 cm above Floor 1 (Figure 2.3). This was the first indication that Huaca de los Chinos might have been covered with plaster. There was a 20 cm wide gap between the back part of Feature 2 and the front wall of Feature 1. The width of this gap was consistent across the entire excavation unit. At this time, the purpose of the gap is unknown.

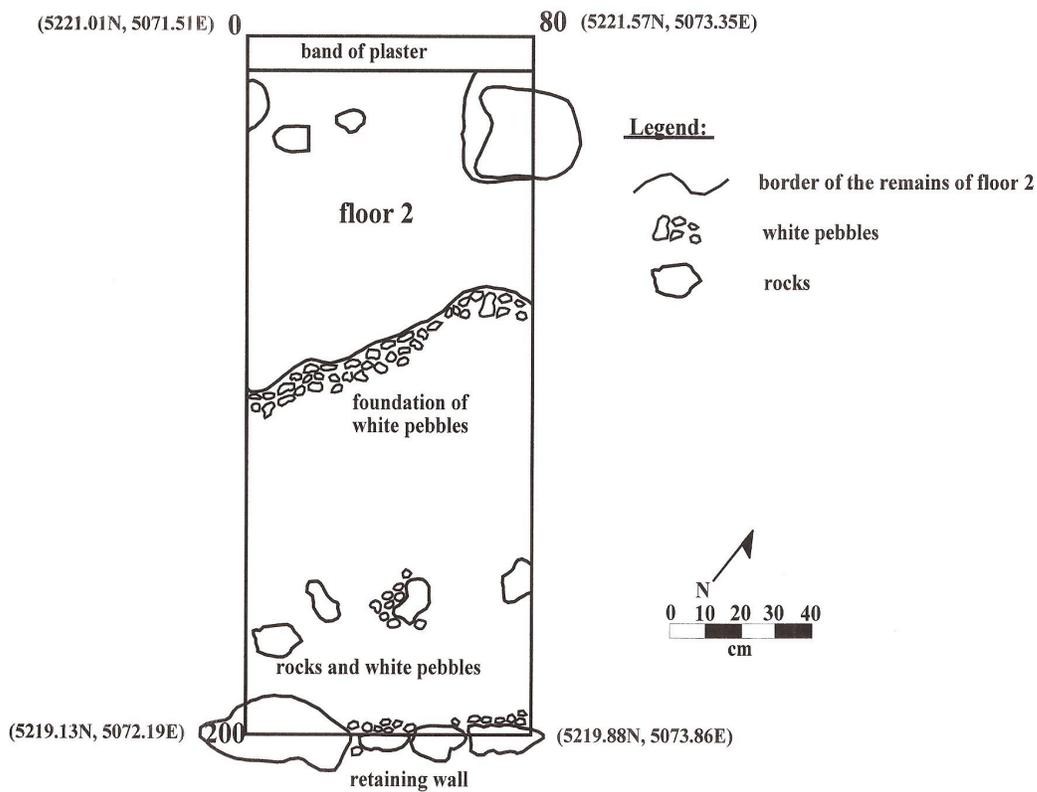
Figure 2.4. Excavation Unit 01 (UE01), Level 3 located on the southeastern side of Huaca de los Chinos. The drawing shows the remains of Floor 2, the small pebbles that formed the foundation beneath the floor, the retaining wall, and the band of plaster that coated the huaca during its active life.

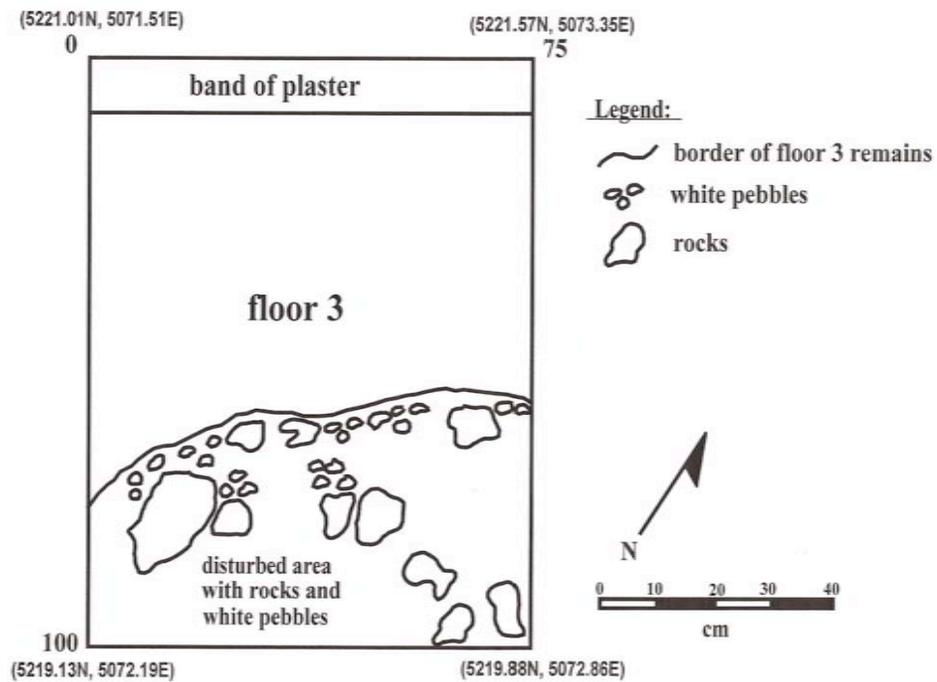
Figure 2.5. UE01, Level 4 on the southeastern side of Huaca de los Chinos showing Floor 3, the band of plaster that covered the huaca, and the foundation of white pebbles.

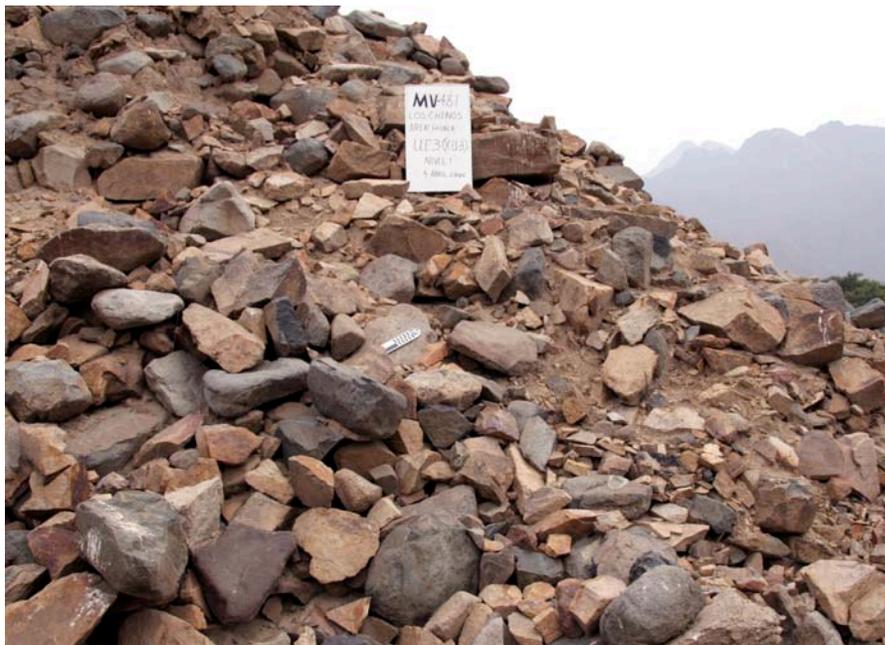
Figure 2.6. Photograph showing UE03 and UE04 before excavation.

UE03 measured 2 x 2 m, and it was located 14 m to the northeast of UE01 (Figure 2.1). The excavation was realized in 5 levels. Excavation Level 1 focused on the removal of architectural rubble (Figure 2.6). The remaining levels measured 80 cm x 1 m, and they confirmed the evidence found in UE01 and UE02, which were: the existence of three superimposed plaster floors (floors 1 - 3; Munsell 10YR5/4); a foundation of small white stones beneath Floor 3; the large stones that formed Feature 2 underneath the floor foundation; a 10 cm thick layer of plaster across the entire width of the unit that extended 40

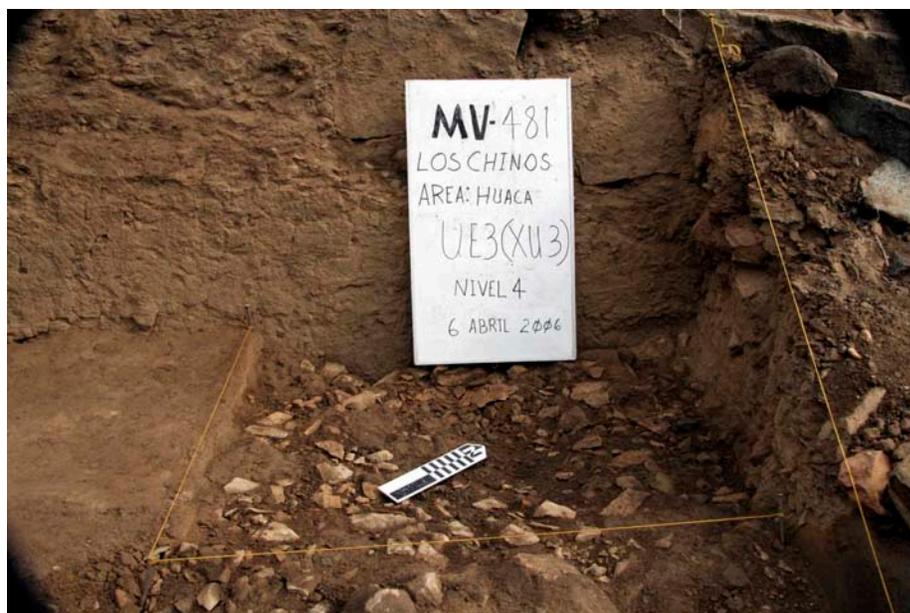
Figure 2.7. Photograph of UE03, Level 4 showing the foundation of small white pebbles beneath Floor 3.

cm - 50 cm vertically up Feature 1; and a 20 cm wide gap between the back part of Feature 2 and the front wall of Feature 1 (Figure 2.7). Although there is no clear evidence for the function of the gap, it is possible that it was a construction feature that permitted some movement of Feature 1 during an earthquake without destroying Feature 2. This would be consistent with the regular occurrence of earthquakes in this area and with the precise and complex nature of the construction of Huaca de los Chinos. No tenon-head sculpture was found in this unit. The construction of Feature 1 in this unit was identical with that portion exposed in UE01. The 10 cm-thick layer of plaster that still covered part of Feature 1 was considered strong evidence that the external surfaces of Huaca de los Chinos had been entirely covered with a plaster layer in the same manner as the monumental architecture at Sechín Bajo.

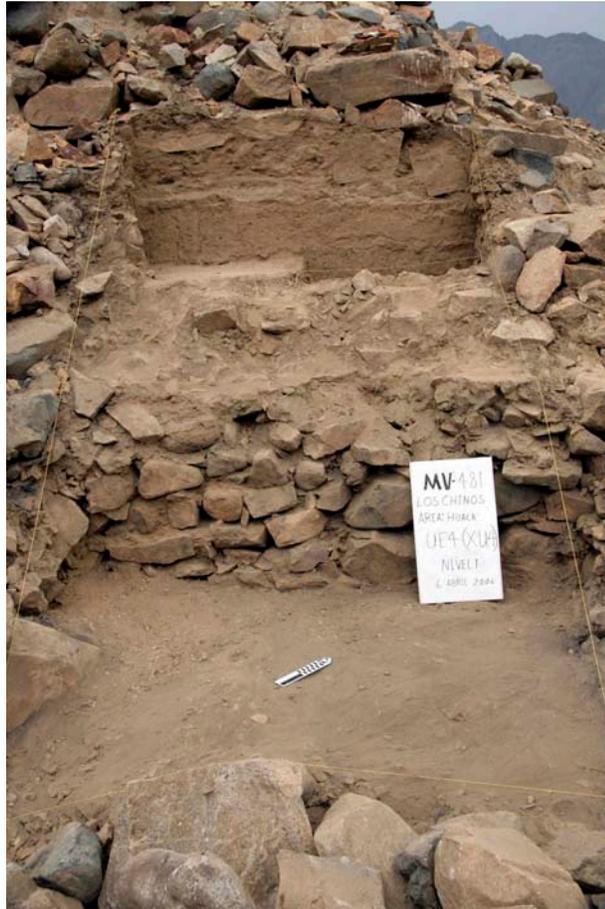
Figure 2.8. UE03 and UE04 after excavation. Wall Feature 2 is in the foreground and wall Feature 1 is in the background. The band of plaster that extends up Feature 1 is visible.

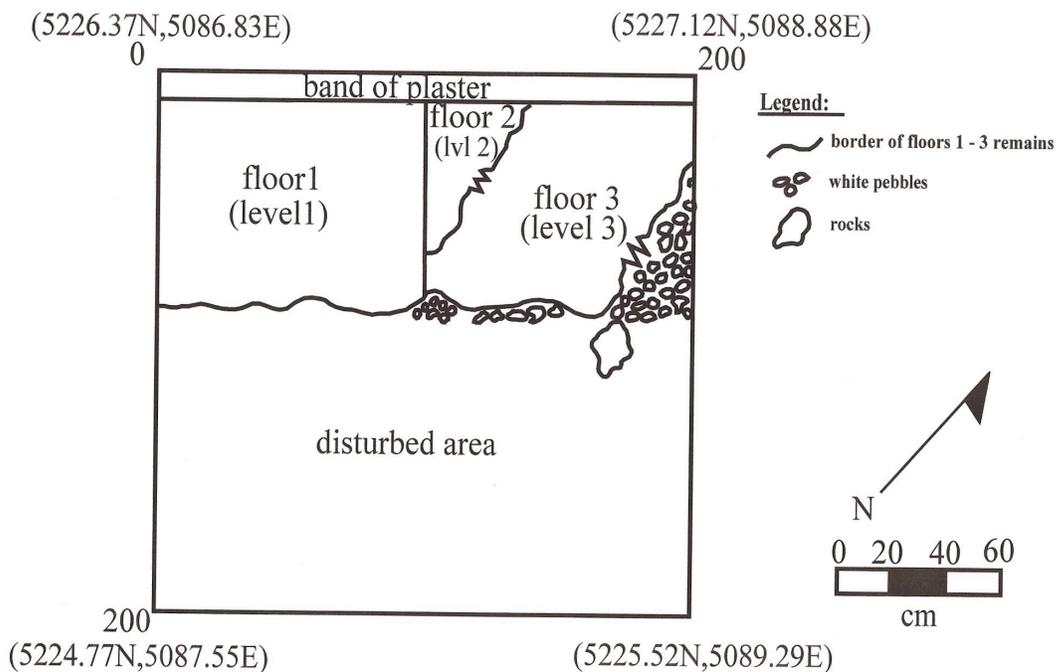
Figure 2.9. UE03, Levels 1 - 3 on the southeastern side of Huaca de los Chinos showing the band of plaster that covered the huaca, floors 1 - 3, and the foundations of white pebbles.

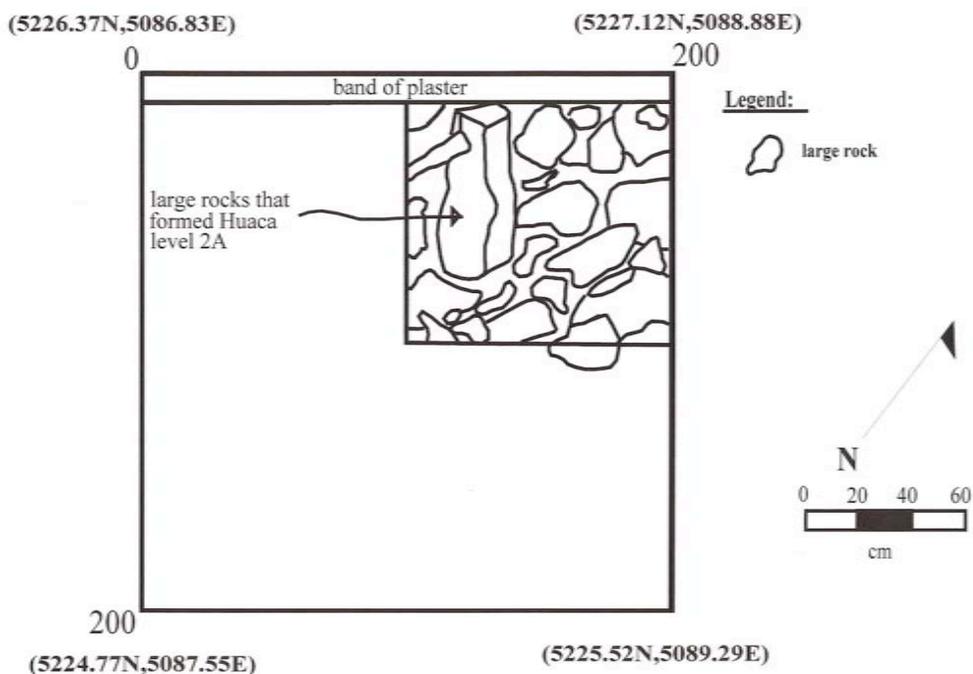
Figure 2.10. UE03, Level 5, southeastern side of Huaca de los Chinos, large rocks below Floor 3 and its foundation of small white pebbles that formed Wall 2A (Figures 1.4, 2.1).

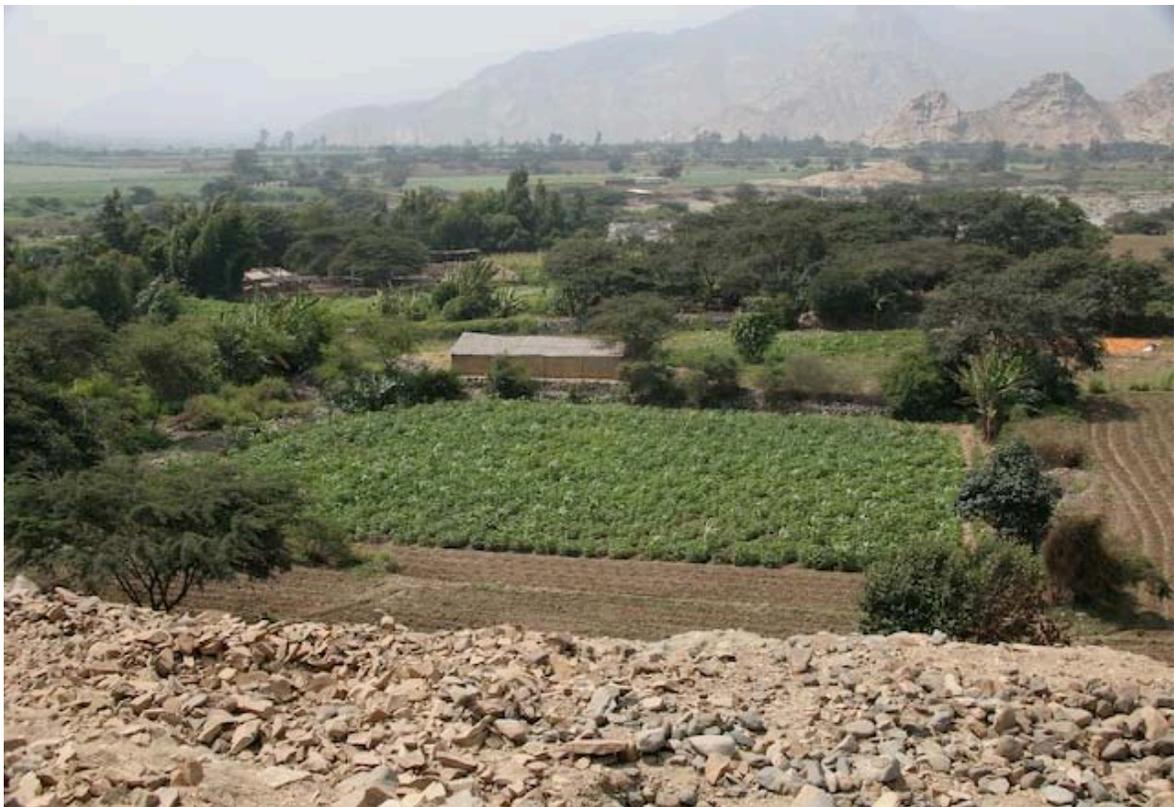
Figure 2.11. *Plaza A* is the area under cultivation.

Directly in front of Huaca de los Chinos were the remains of a 40 x 40 m plaza (Figure 2.11). It was important to discover if it was a sunken plaza, since this was an important architectural feature associated with the Initial period on the coast of Perú. Therefore, the objectives of UE05 and UE06 were: (1) to determine if the 14 m area between *Plaza A* and the huaca was covered with a plaster floor or natural earth and (2) to determine if *Plaza A* was a sunken plaza.

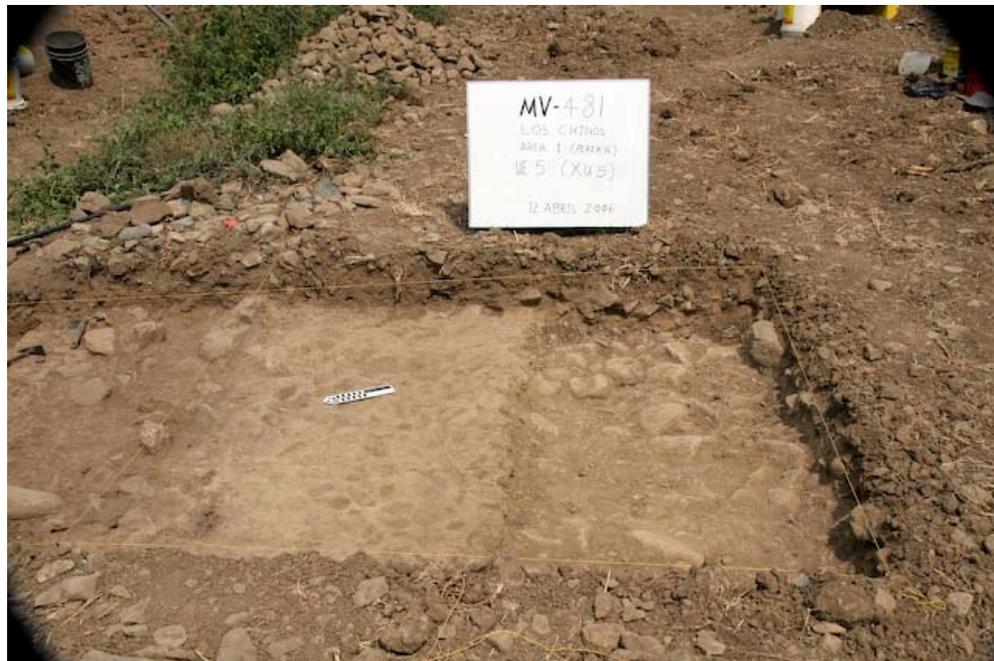
Figure 2.13. UE05 after excavation showing the plastered area and the foundation of stones beneath it.

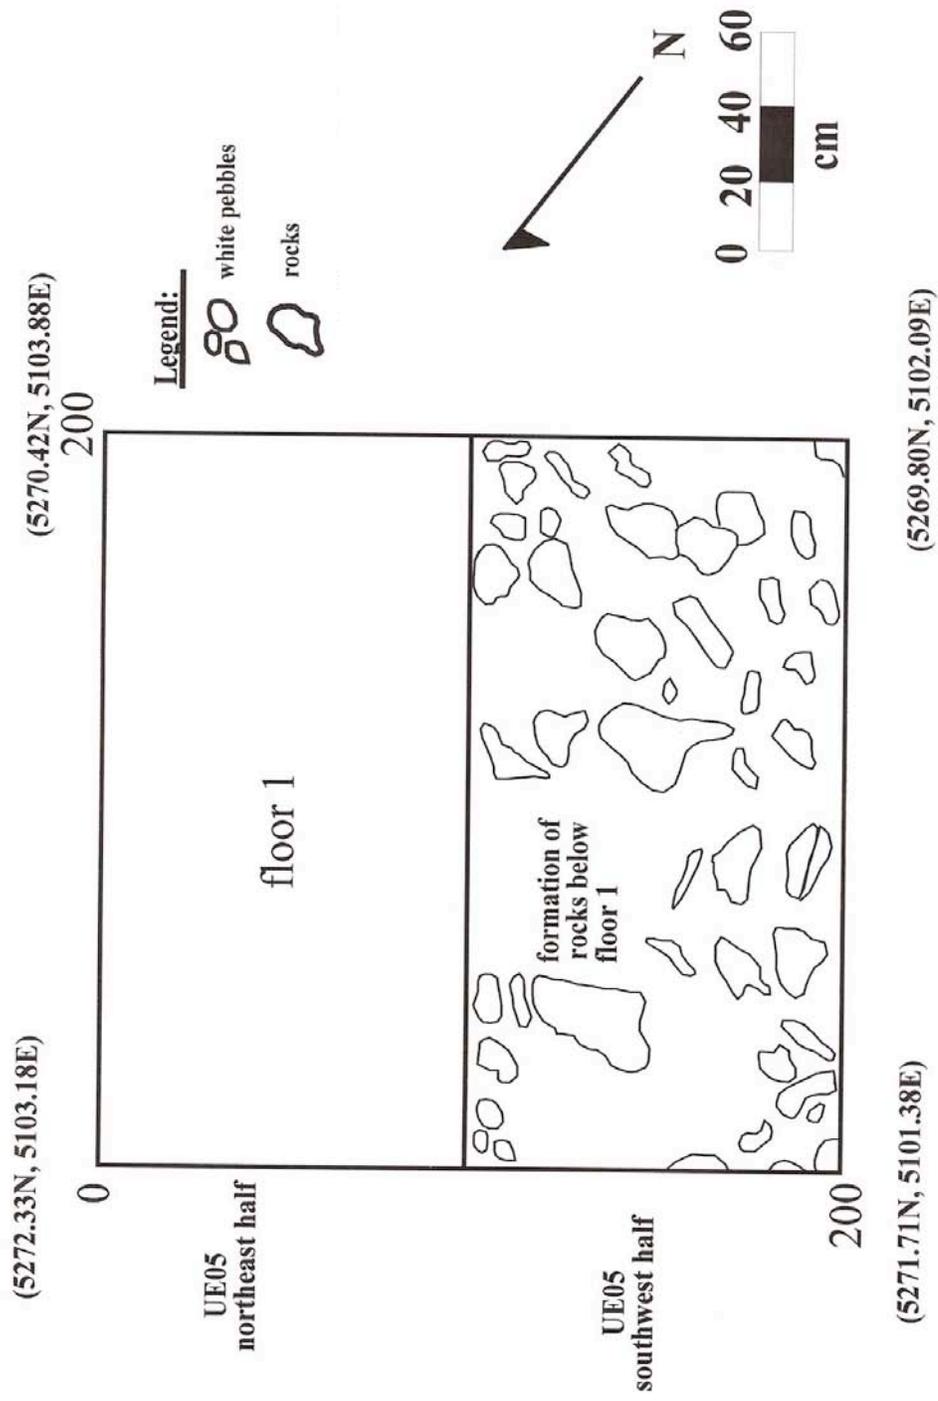
Figure 2.14. UE05, levels 1 and 2, floor 1 and the foundation beneath it.

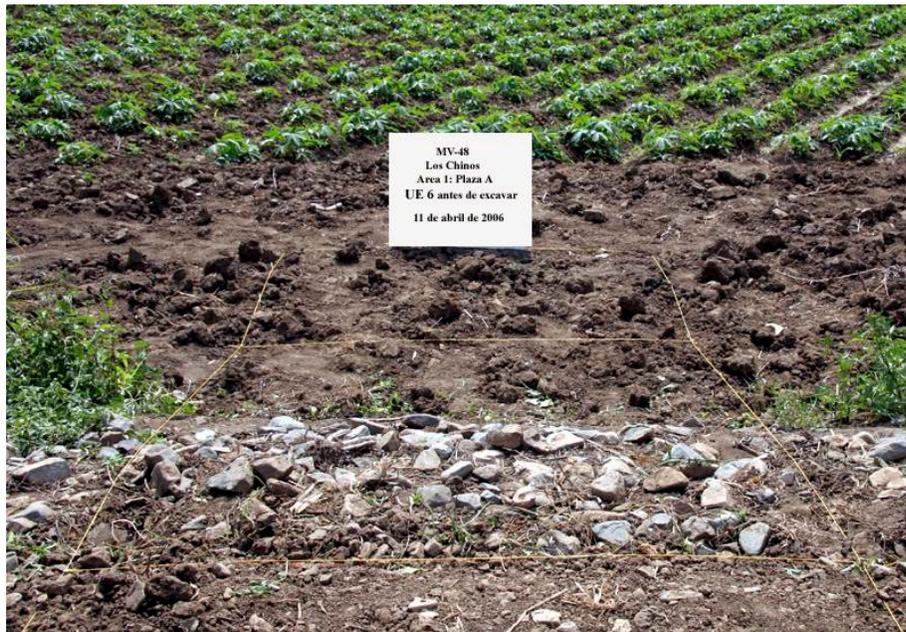
Figure 2.15. UE06 before excavation

UE06 measured 2 x 4 m, but its was excavated in two 2 x 2 m halves: northeastern and southwestern (Figures 2.15, 2.16, 2.17). Excavation of the southwestern half was carried out in four levels, and the northeastern half excavation was realized in six levels. These excavations exposed a retaining wall (Feature 4) and two steps (Feature 5) that led down to a plaster floor that was supported by a foundation layer of small white stones (Figures 2.16, 2.17).

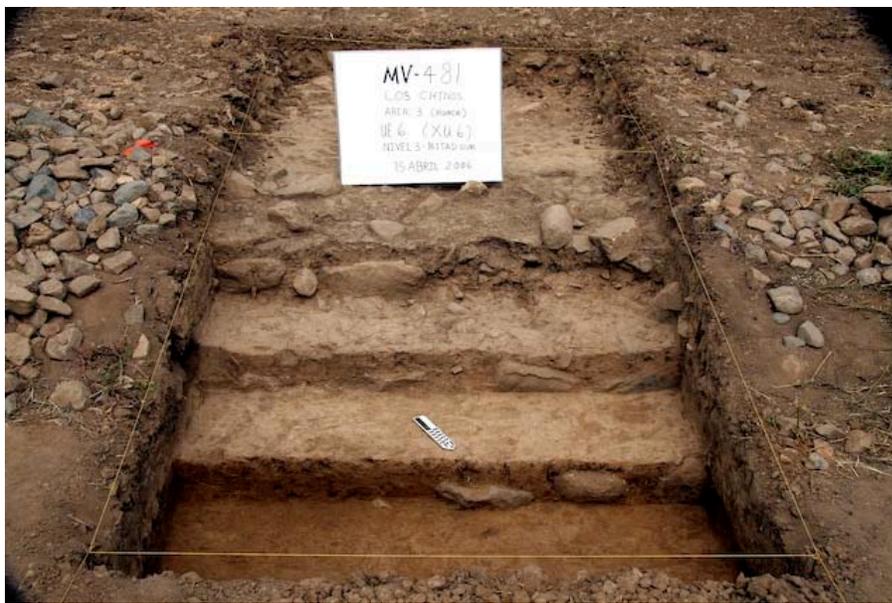
Figure 2.16. The retaining wall and two steps at the border of *Plaza A* in UE06.

Approximately 20 cm below the northeastern side of Feature 4, the first of two steps that led to the floor of *Plaza A* was uncovered. Each step measured 50 cm horizontally and 20 cm vertically, and both consisted of a core of small to medium-size stones that were covered with a fine plaster (Figures 2.16, 2.17). These steps clearly provided access between the level of UE05 to the floor of *Plaza A*, but it was not known if they extended across the full width of the southwestern side of the plaza or if they were part of a central staircase.

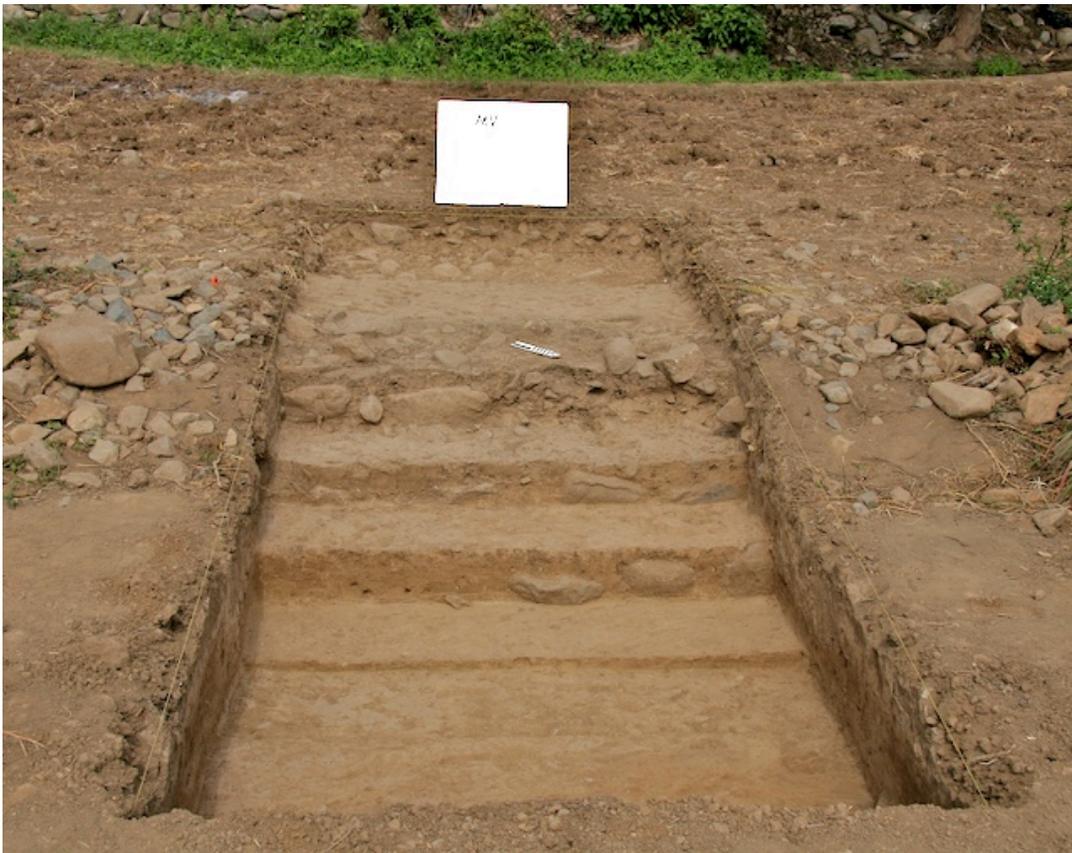
Figure 2.17. UE06 after excavation. The retaining wall, two steps and the floor are visible in the photograph.

The floor (Floor 1) of the plaza was located 70 cm below the modern surface. It consisted of a very fine plaster, was 6 cm thick, and was supported by a 14 cm-thick foundation layer composed of the same type of small white pebbles that composed the floor foundations in the other excavation units (Figure 2.17, 2.18, 2.19).

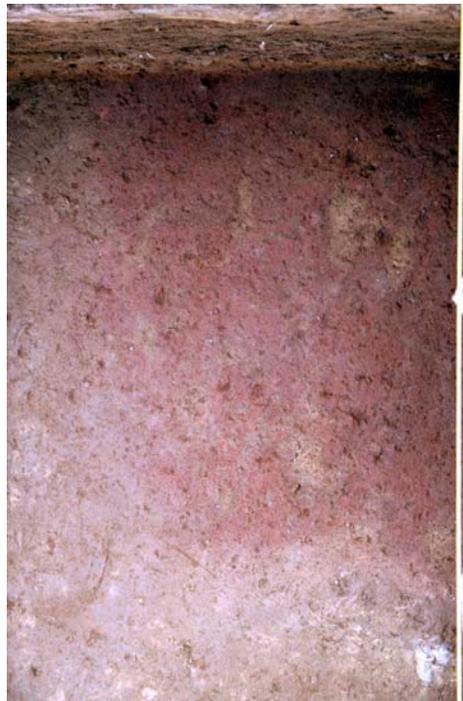
Figure 2.20. The circular area of reddish soil found in the floor of *Plaza A* (UE06).

(Figures 2.20, 2.20A). All of this soil was recovered, placed in a plastic bag, labeled and transported at the end of the day to the field headquarters in Huanchaco. This sample will be stored for future chemical analysis.

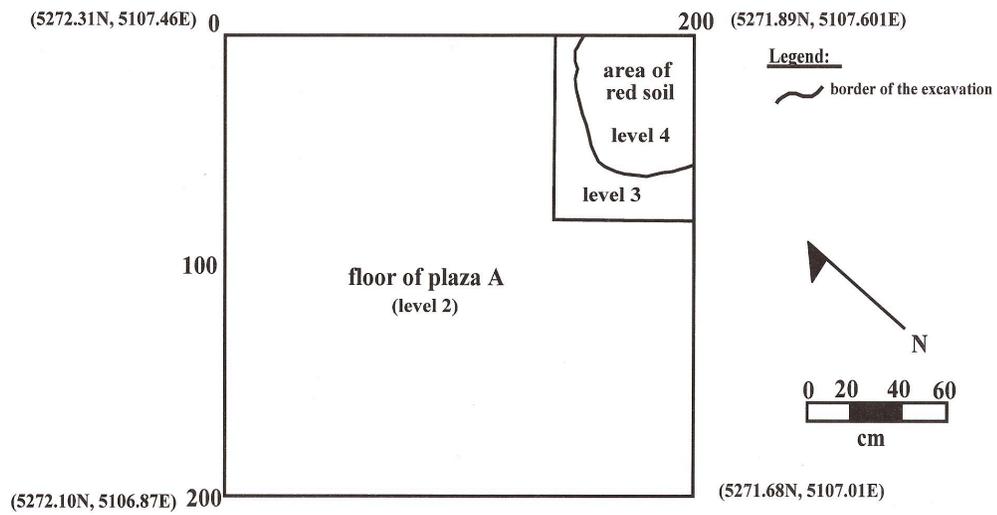
Figure 2.20A. UE06, Levels 2, 3, 4 excavation drawing showing the floor of Plaza A and the area of red soil.

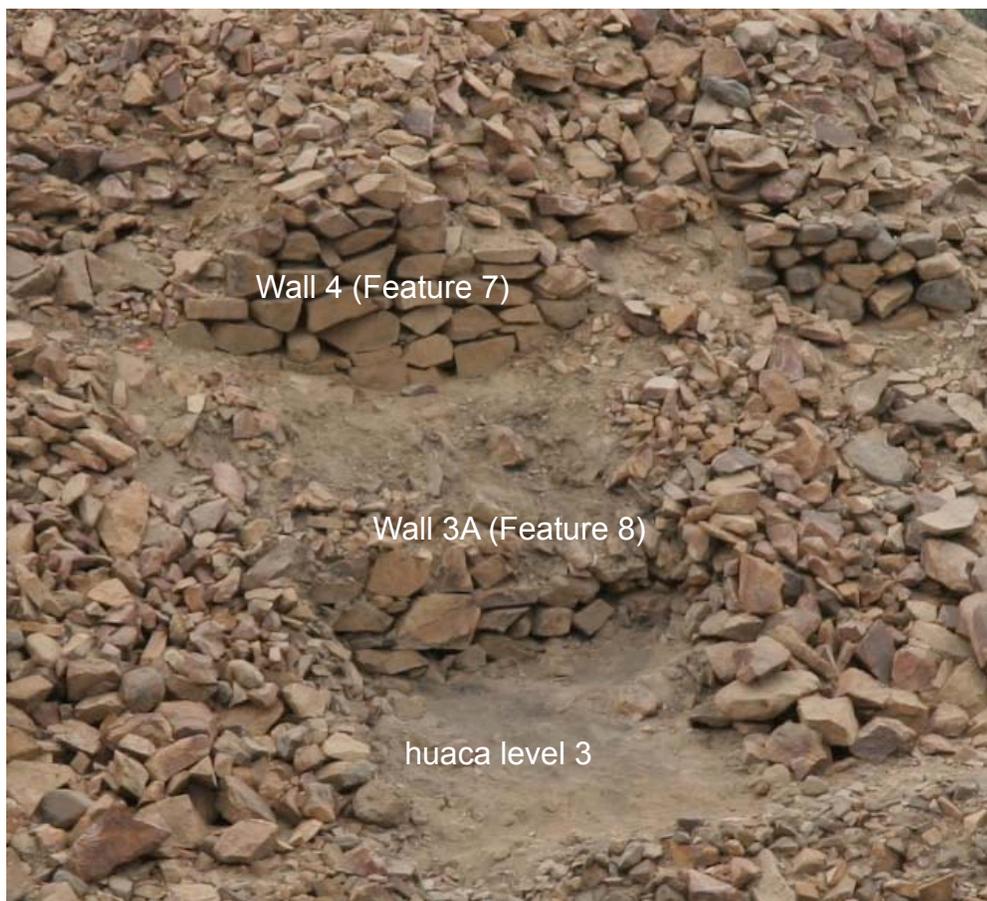
Figure 2.21. UE07 and UE08 after excavation. Feature 7 is visible in the background (UE07), and Feature 8 is visible is in the foreground (UE08).

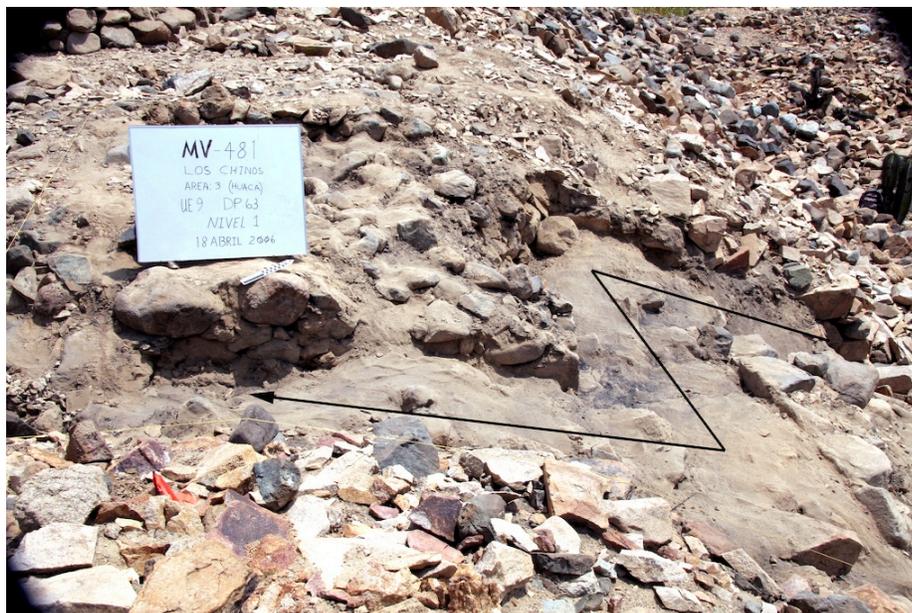
Figure 2.23. UE09 after excavation. The zigzag pattern of the staircase is visible in the center of the photograph.

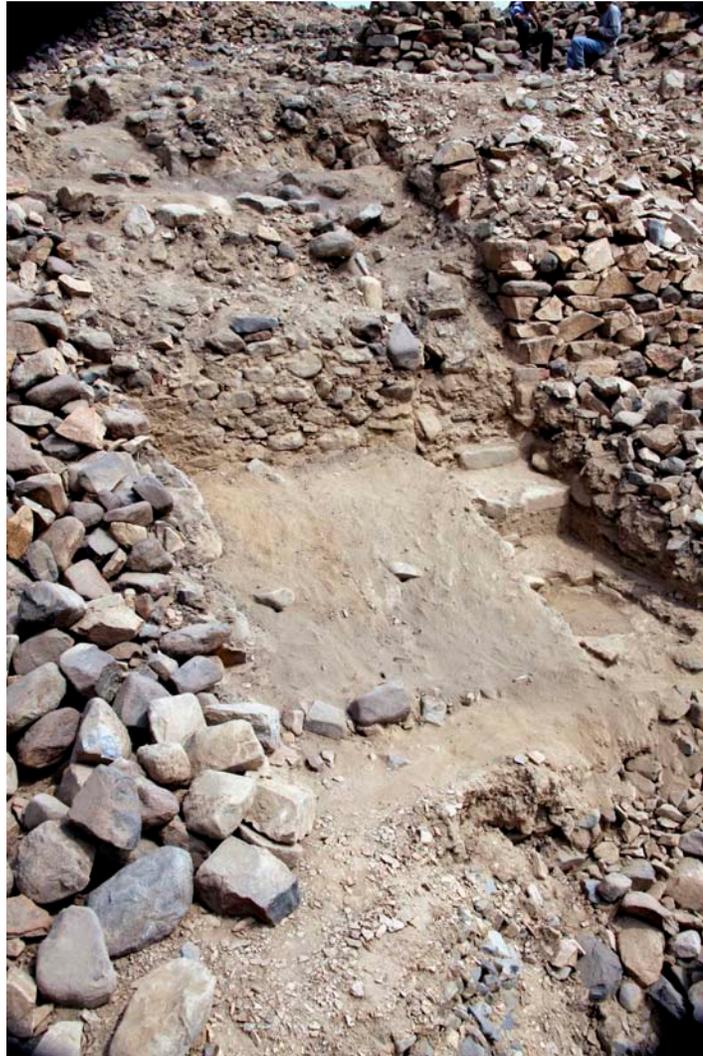
Figure 2.24. A frontal view of the staircase that led from huaca Level 3 to huaca Level 4, as well as the wall (Feature 9) that was associated with it.

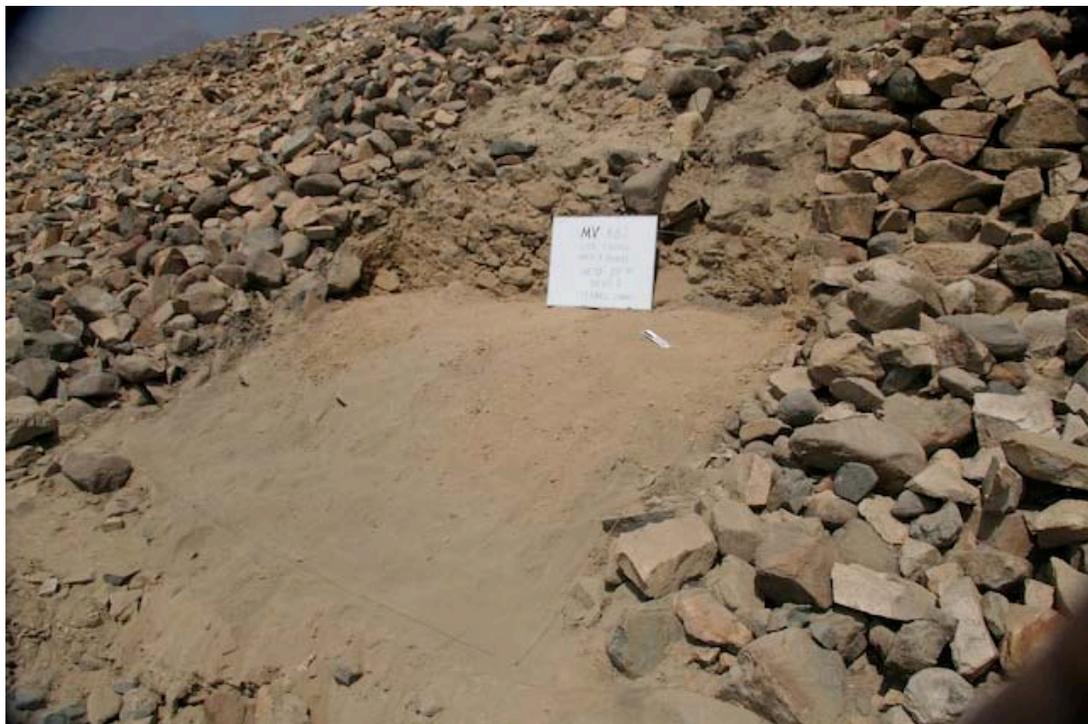
Figure 2.26. UE10 after the architectural rubble was cleared.

The next four excavation levels were carried out in the northwestern half of the unit, which was in front of the lower staircase (Figures 2.26, 2.27). These units measured 1.3 x 2.6 m. The excavation of these four levels revealed a small shallow-angled ramp that led from the floor of huaca Level 3 to a plaster-covered stone step 60 cm in front of the lower staircase. This created a 1 x 60 cm flat area that led to the initial step of the staircase. Since this flat area was wider than the lower staircase, it may have extended across the total width of Feature 9. This would have given access to the stairway, and would have provided ample space for the officials who were controlling access to the stairway.

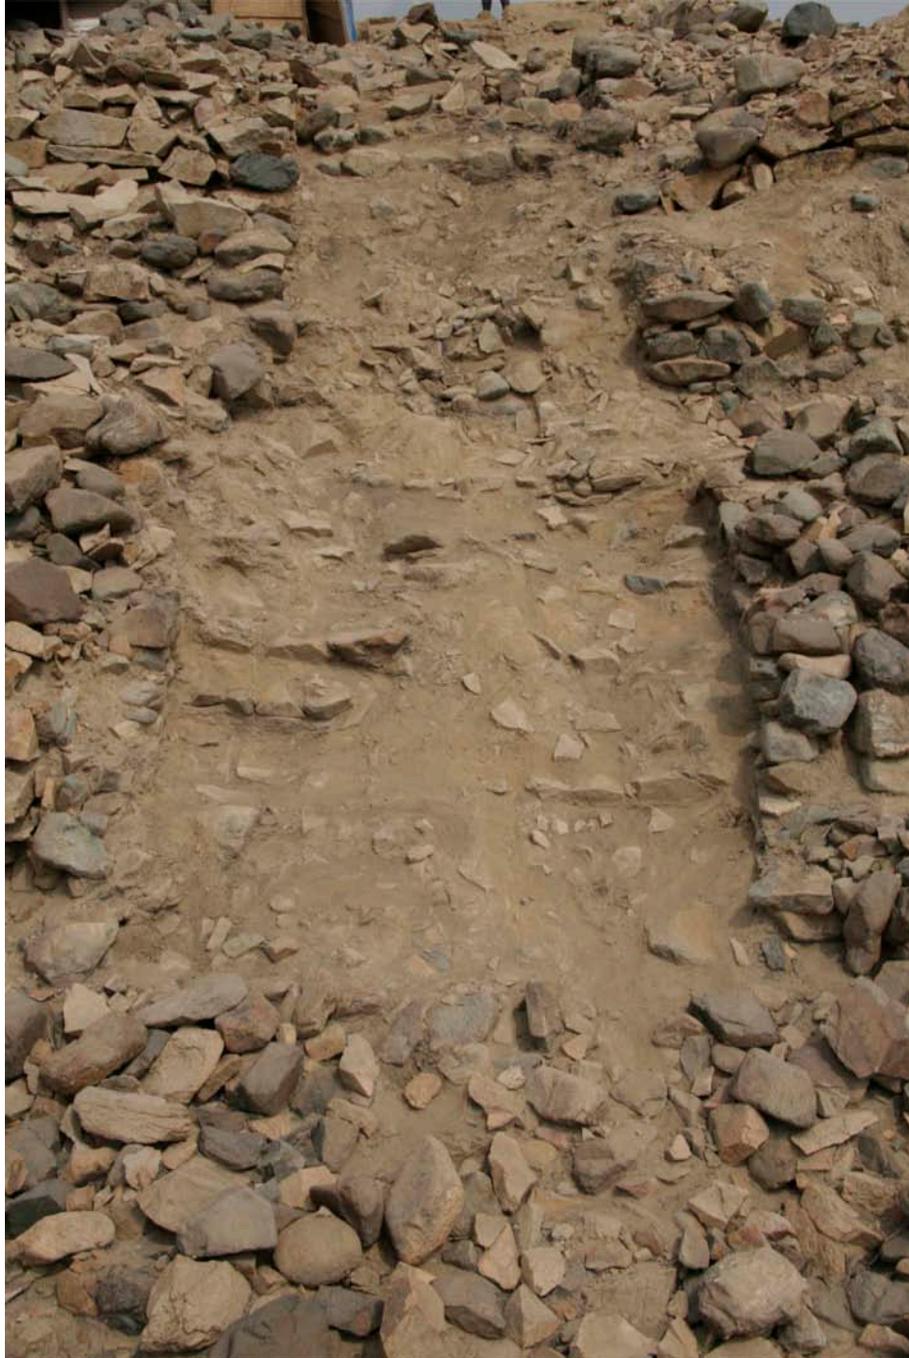
Figure 2.30. UE11 and UE12 after removing the architectural rubble. The walls that formed the side borders of the staircase and portions of the steps are visible in the photograph.

These excavation units were designed to uncover Entrance 4 (*Ent 4*), which was the primary access route between Levels 4 and 6 of Huaca de los Chinos (Figure 1.6). UE11 and UE12 measured 2 x 2 m and 2 x 3 m, respectively, and they were excavated in a single level, which consisted of the removal of the considerable architectural rubble that covered the entrance (Figure 2.29). After removing the rubble from UE11 and UE12, the architectural form of the entrance was clearly discernible. It was a staircase (Feature 11) consisting of stone steps with stone retaining walls on each side, and it appeared to be designed to provide direct access between Plazas D and E. There was sufficient width to permit 3 or 4 persons to ascend it while walking abreast (Figures 2.29, 2.30, 2.31).

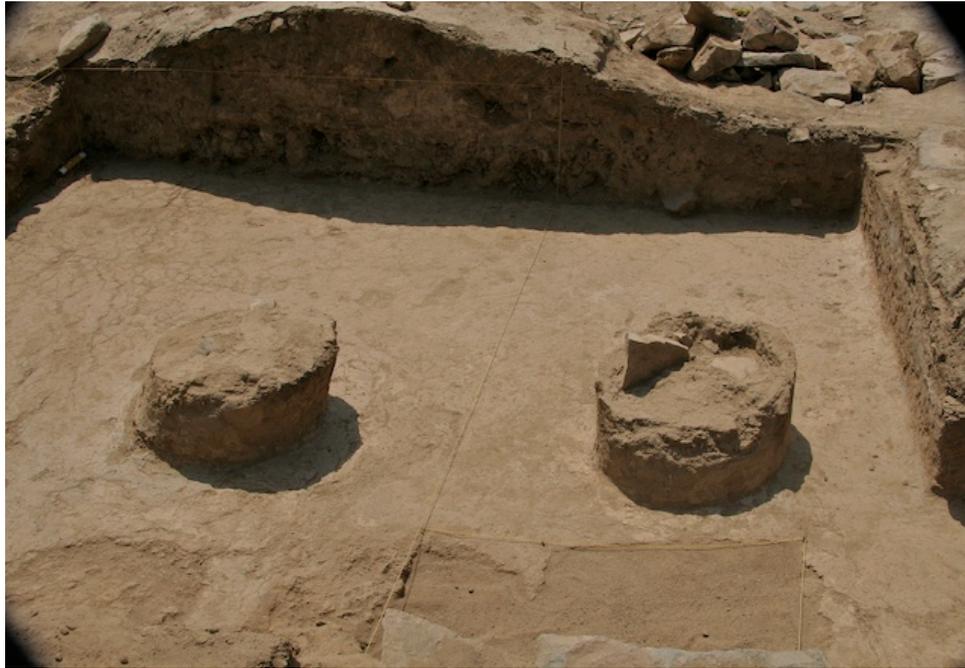
Figure 2.33. UE13 after excavation. The photograph shows the remains of Column 1 (Feature 13; UE13), Column 2 (Feature 14; UE14), and the possible offertory area, which is located in both excavation units.

On the southwestern side of UE13 an oblong area of disturbed earth was observed in the floor of the patio beside the northeastern wall of Room 1 (Feature 15; Figures 2.33, 2.124). Because it was partially in UE13 and UE14, it was not excavated as a part of either unit, but was excavated later as a separate unit (UE26). At the time UE13 was excavated, we speculated that it was either a votive offering or a place for burning offertory. It will be further described in the UE26 section.
