HUACA DE LOS CHINOS: THE ARCHAEOLOGY OF A FORMATIVE PERIOD  
CEREMONIAL MOUND IN THE MOCHE VALLEY, PERU

A dissertation submitted to the faculty of the University of North Carolina at  
Chapel Hill in partial fulfillment of the requirements for the degree of Doctor of Philosophy  
in the Department of Anthropology

Chapel Hill  
June 2009

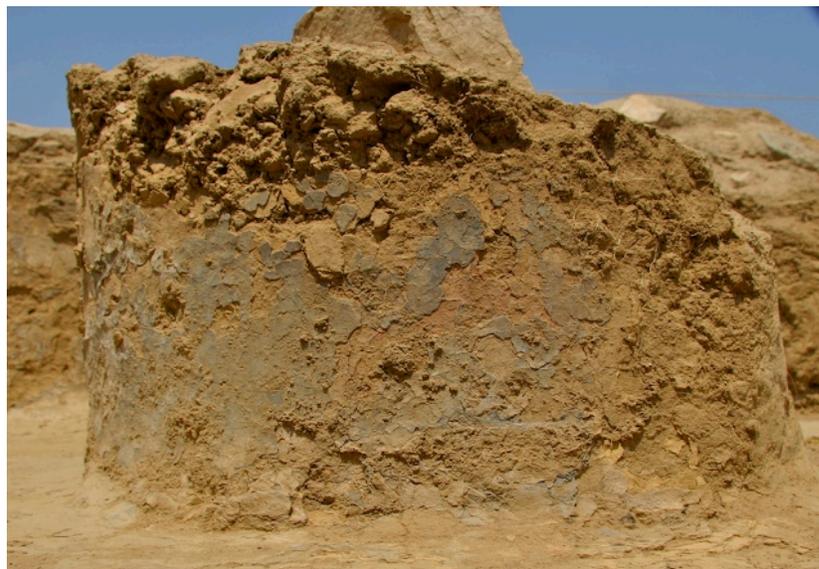
Figure 2.34. UE13, Column 1 (Feature 13) after excavation. The remains of black paint are visible around the column.

Feature 13 was the remnant of the base of a column. It was 46 cm in diameter and 26 cm tall, and it contained the remains of black and white paint (Figures 2.33, 2.34, 2.35). It was the first of eight columns that were discovered during the excavations of this structure. The column appeared to be constructed of a clay-mud mixture and small rocks with a coating of fine plaster around the circumference. The paint was applied to the exterior surface of the column.

The southeastern side of UE13 exposed a portion of the northwestern wall of Room 4 (Feature 12; Figures 2.33, 2.34). Its core was constructed of layers of medium-size stones, and the wall was covered with a thick layer of plaster. The outermost surface was coated with a fine plaster of the same quality as the floor. Remnants of black paint were observed on the wall and adjacent floor.

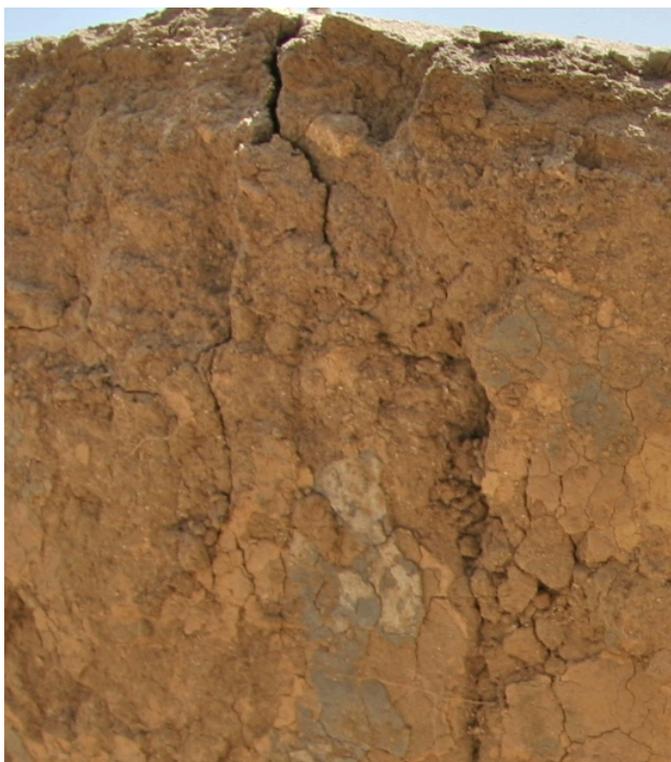
Figure 2.35. UE13, Column 1 (Feature 13) with the remains of white on black paint.

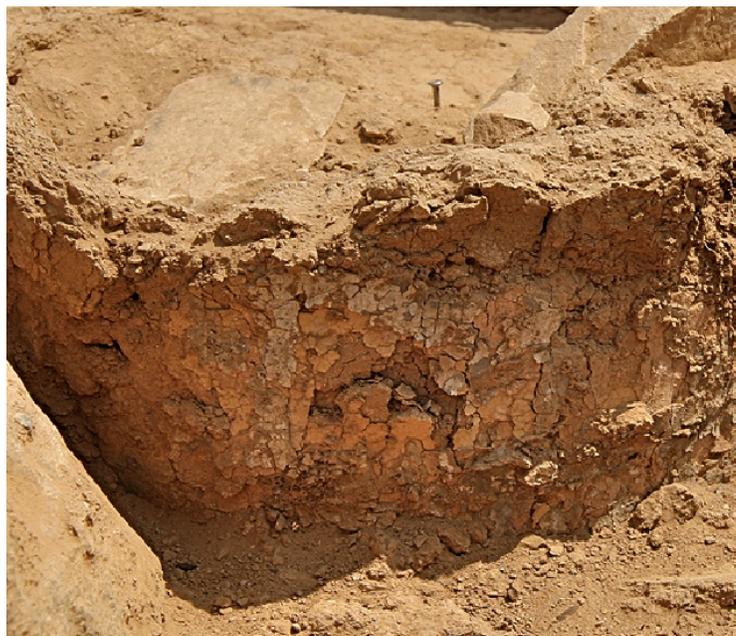
Figure 2.36. UE13, Column 1 (Feature 13) with remains of white on black paint.

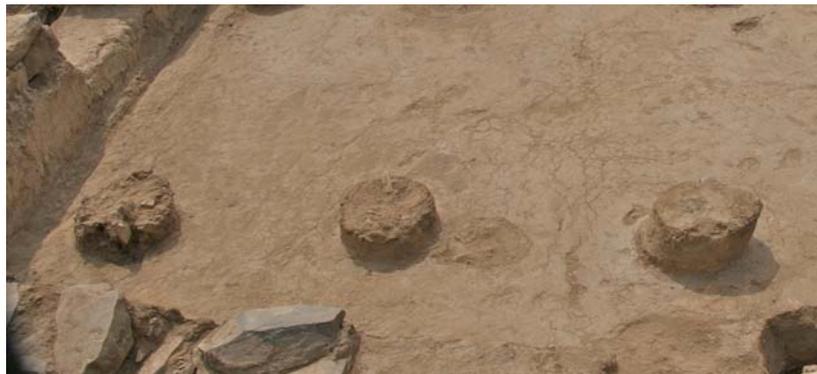
Figure 2.37. UE14 after excavation. Columns 2, 3, and 4 (Features 14, 19, 20) and an additional area of the patio floor were exposed.

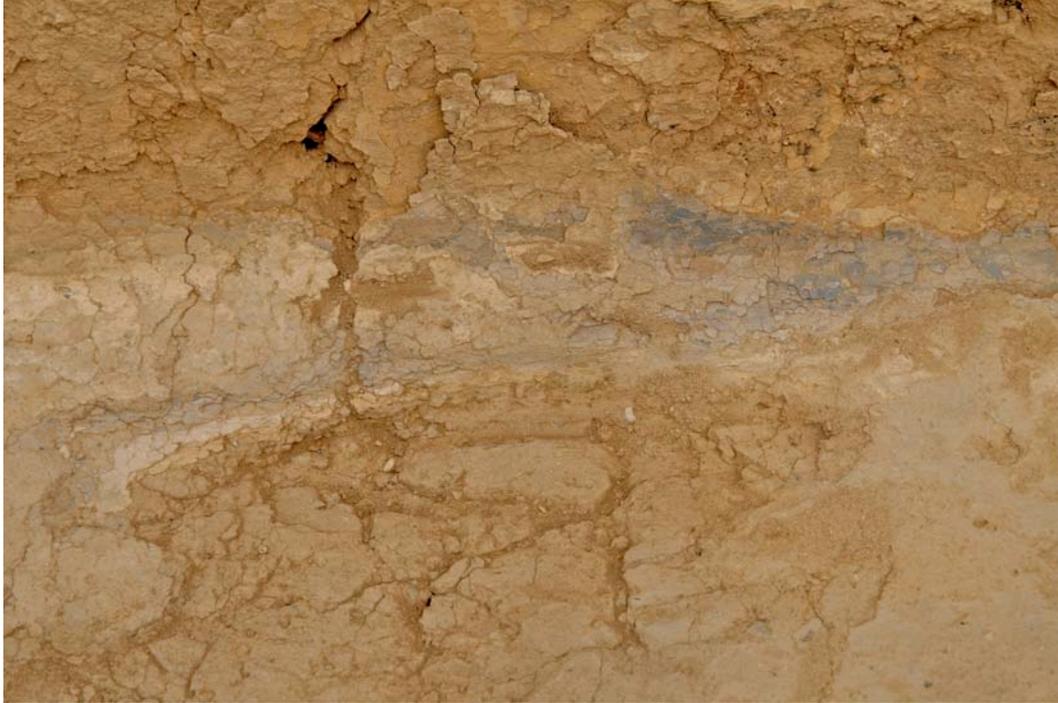
Figure 2.38. White on black paint at the juncture of the patio floor and the base of the northeastern wall of Room 1. The paint extends onto the patio floor.

The floor that was discovered in UE13 also extended across the entire area of the UE14 (Figure 2.37). Remnants of black and white paint were found on the floor along the wall adjacent to Room 1 (Feature 15, UE16; Figure 2.38) and on walls and the floor in the entrance to Room 3 (Feature 17).

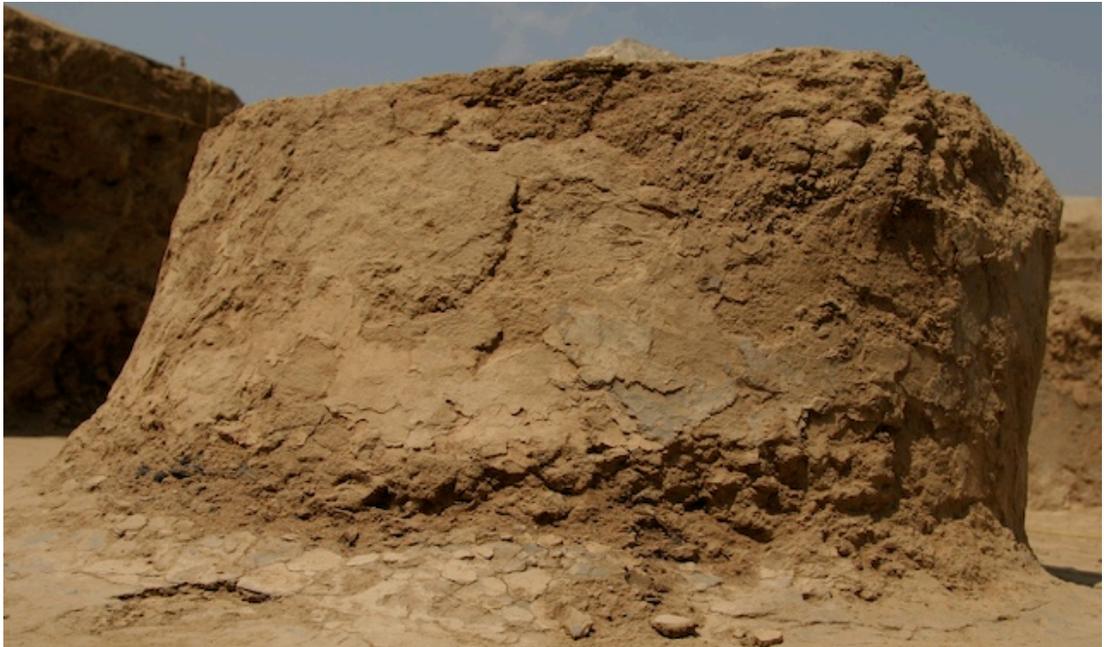
Figure 2.39. Column 2 (Feature 14) in UE14. Black paint is visible in the lower center and at the base of the column.

Three more columns were discovered (Features 14, 19, and 20; Figures 2.37–2.41). They were 46 cm in diameter, protruded from the floor at various heights, and were various distances apart. Features 14 and 19 were 1 m apart. Remnants of black and white paint were found on each column. Once UE13 and UE14 were completely excavated, it began to appear that *Est 1* consisted of several rooms positioned around a patio that contained painted columns.

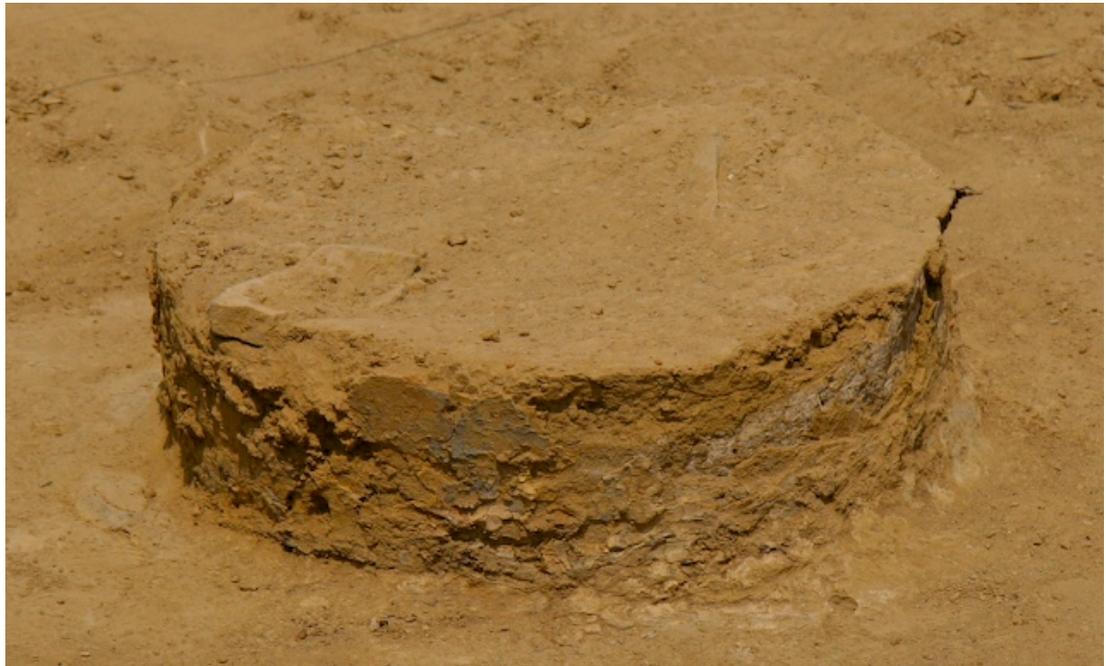
Figure 2.40. Column 3 (Feature 19) in UE14. Black paint is visible near the top edge of the column.

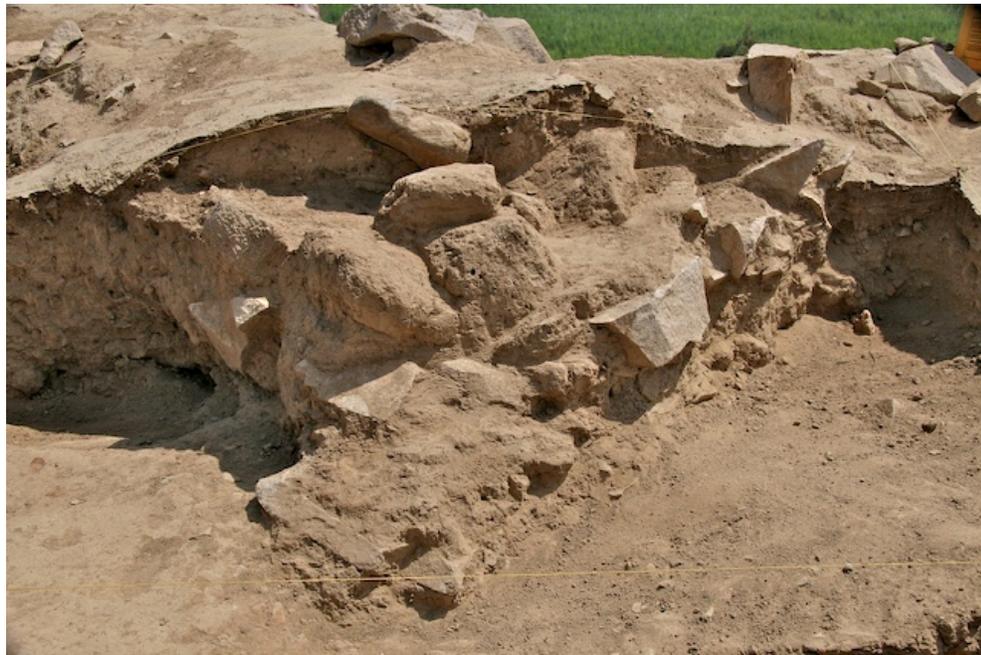
Figure 2.42. The area of fill in UE14 that contained three conical adobes.

bricks (Figures 2.42, 2.43). Ultimately, three conical adobes were recovered from this fill, and two conical adobes were recovered from the fill in the entrance to Room 3 (Figure 2.75). One of the adobes was whole while the rest had varying degrees of damage. The whole adobe had a top diameter of 10 cm, a base diameter of 13 cm, and a length of 20 cm. Its color was 10YR 5/4 yellowish brown (Munsell), which was consistent across *Est 1* for adobes, floors, columns, and wall plaster.

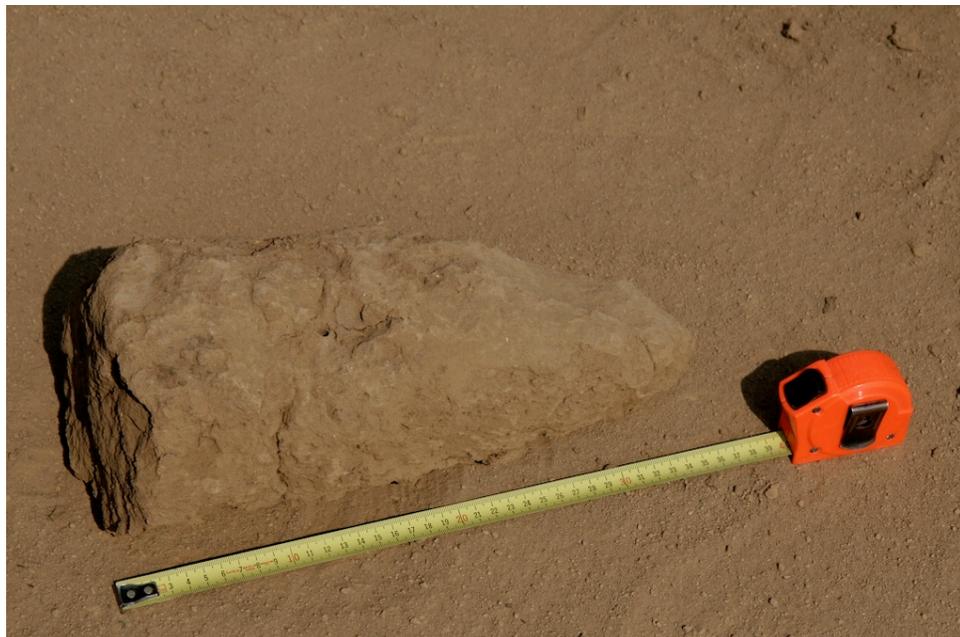
Figure 2.43. The largest of the conical adobes that were found in UE14.

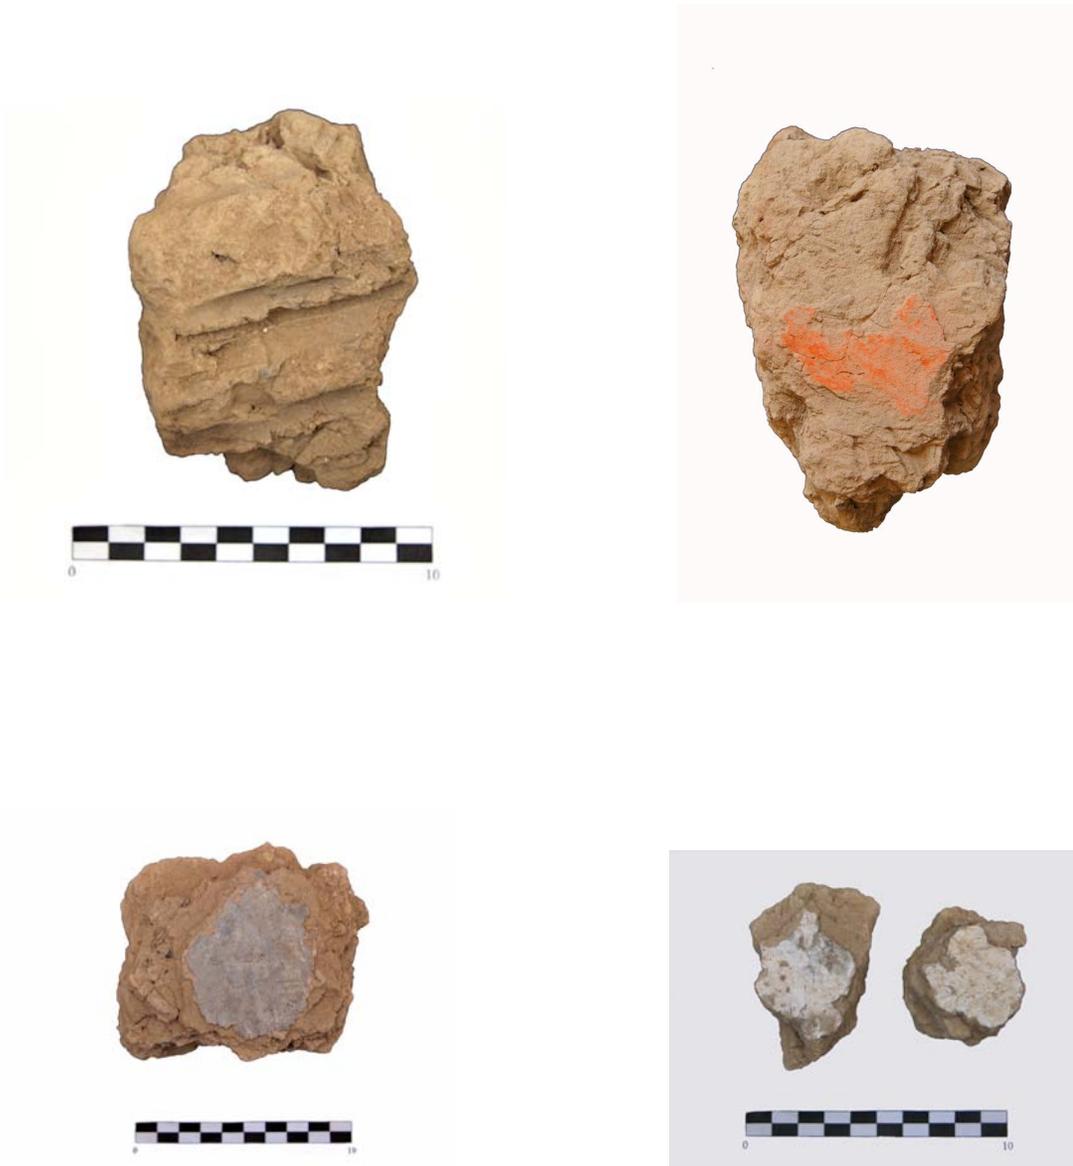
Figure 2.44. Roof fragments showing cane impressions on one side and the remains of red, black, and white paint on the interior side. The two images at the top are different sides of the same fragment.

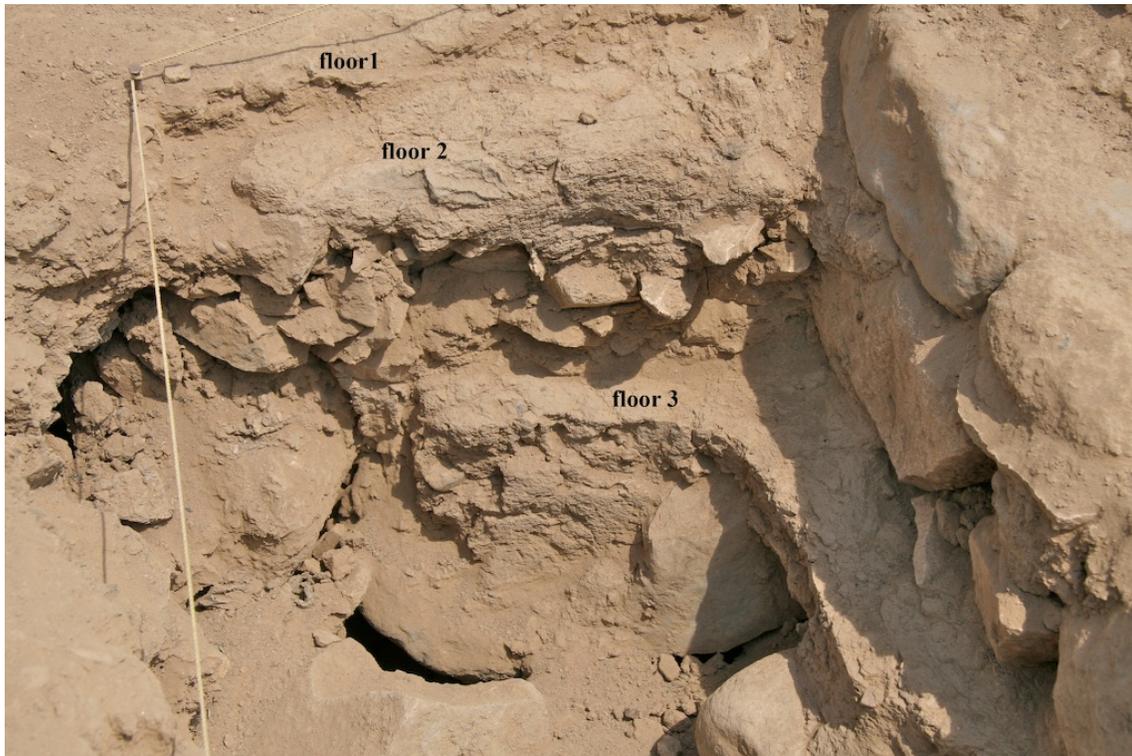
Figure 2.51. Three floors were found in UE15. Floor 1 was superimposed on Floor 2, but there was a foundation of small white stones and a layer of mud between floors 2 and 3. Also visible in the photograph are some of the larger rocks that formed the foundation of *Est 1*.

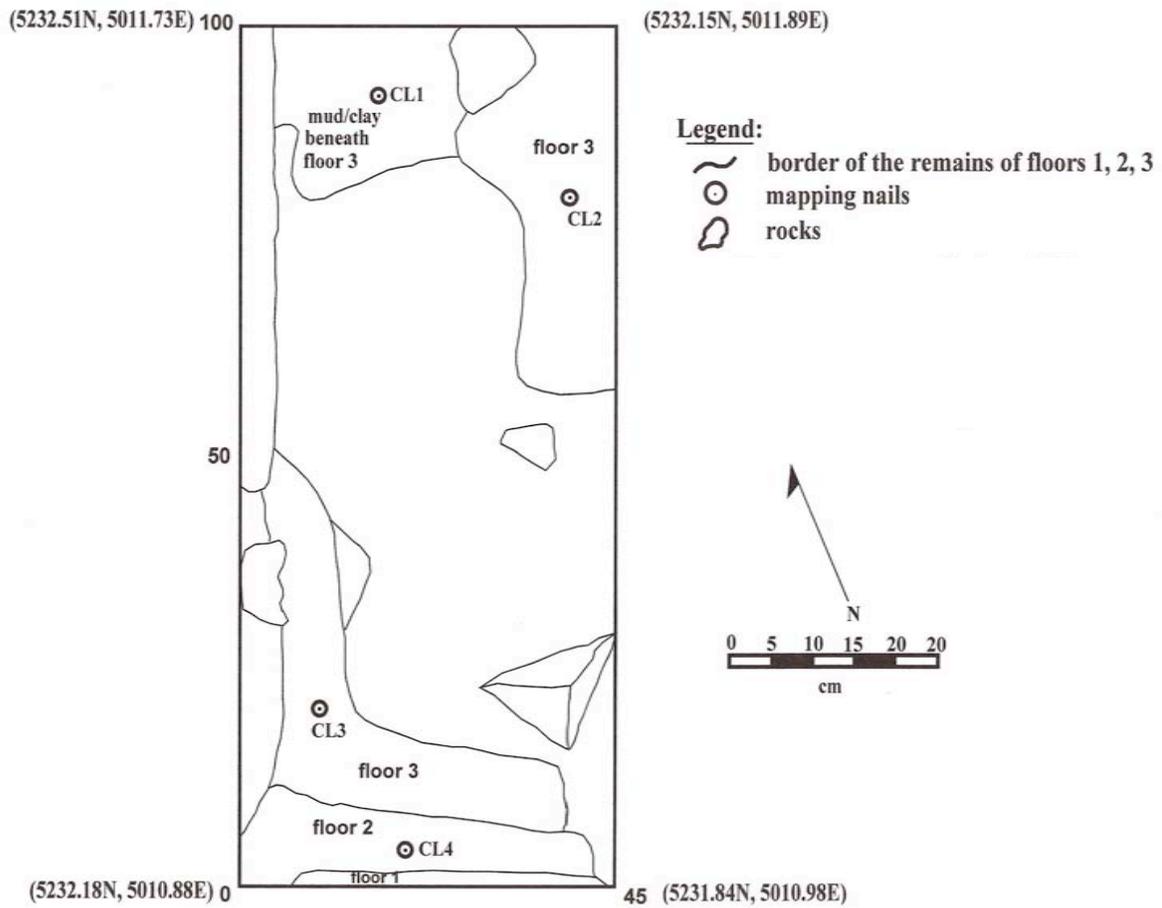
Figure 2.52. UE15, Level 2, excavation drawing showing floors 1, 2, and 3.

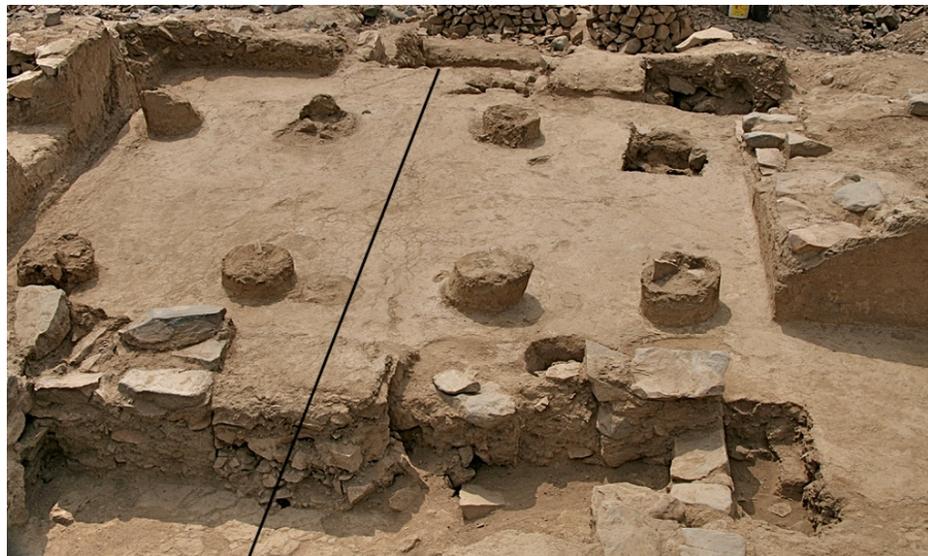
Figure 2.55. The relationship of the central axis of *Est 1* to the entrance of Room 1. The photograph was taken facing to the northeast.

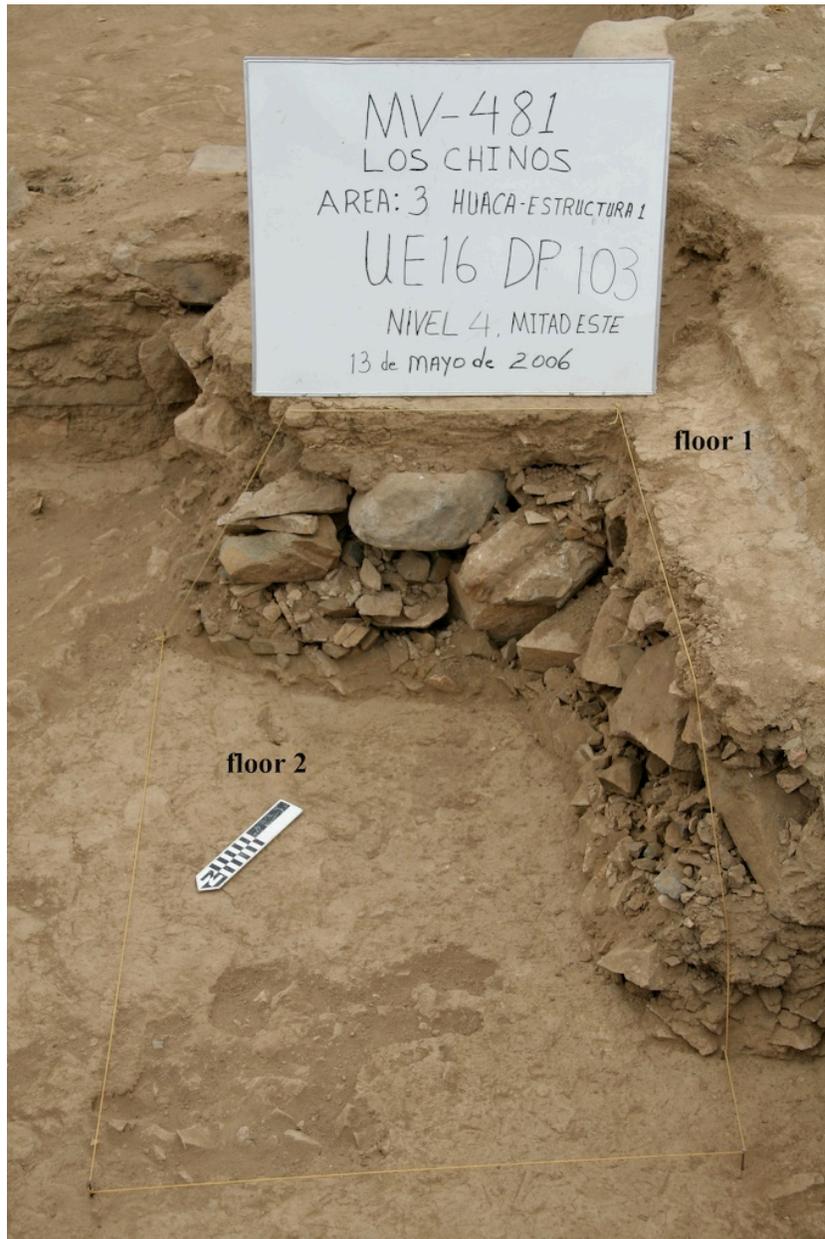
Figure 2.56. Floors 1 and 2 in Room 1 (UE16).

Evidence of construction Episode 3 associated with *Est I* comes from UE16 and UE19. At some point, the Episode 2 summit structure was destroyed by fire (UE14, UE20), and a new floor was constructed that was 60 cm higher than the Episode 1 floor in UE16 (Floor 2), in UE15 (Floor 3), and in UE22 (Floor 3). The new floor extended across the entire structure, and it is represented by Floor 1 in UE16. Evidence for this comes from UE16 and UE19. Room 1 (UE16) was filled in and covered by the new floor. There was a large remnant of the new floor (Floor 1) in Room 1 (Figures 2.56, 2.57). Another remnant of this

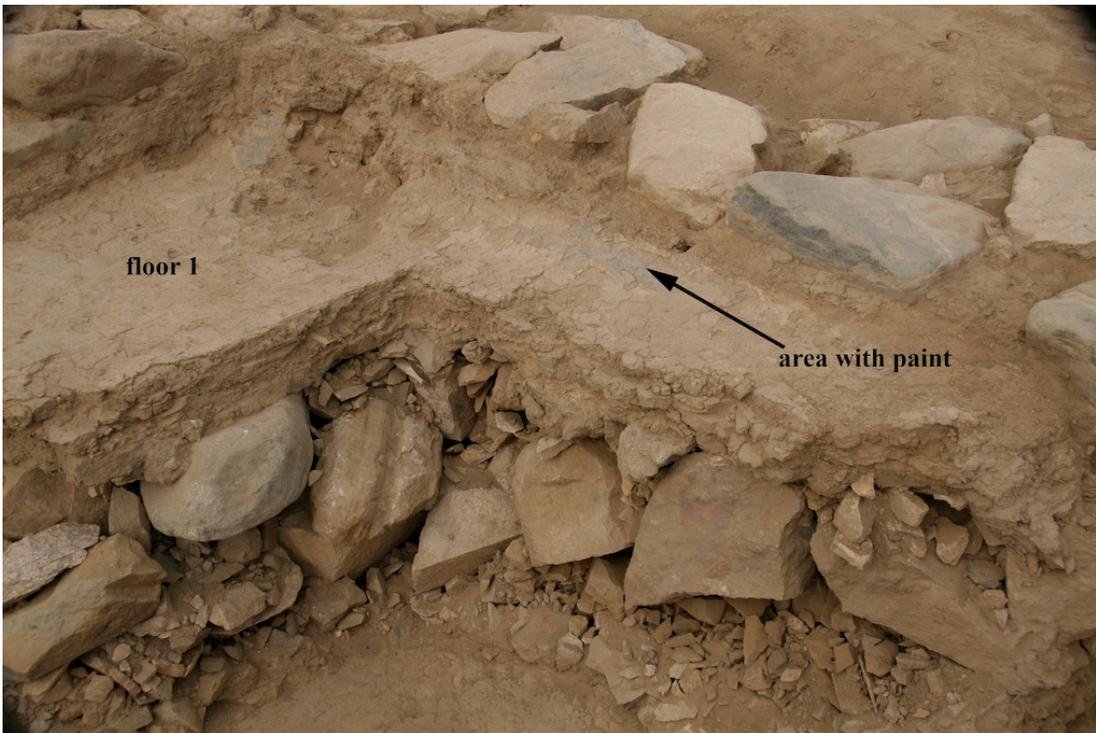
Figure 2.57. UE16, the fill between floors 1 and 2, an area on Floor 1 with paint.

floor is present in the top portion of previous entrance to Room 1, which was filled in by construction Episode 3 (Figures 2.54, 2.59, 2.60). Remains of this floor were also found in UE19. Floor 1 and the filled-in entrance of UE16 and the remnant of the floor from UE19 are all at the same elevation (Figures 2.60, 2.61). The interior walls of Room 1 had evidence of multiple construction episodes. These are represented by seams in the architecture and very different construction materials and technique. There was a seam in the wall on each side of what had been the Episode 2 entrance to Room 1 (Figures 2.54, 2.59, 2.60). Figures 2.57 and 2.59 show that the core material used to construct the Episode 3 foundation consisted of rubble that was not placed in a systematic manner, whereas the Episodes 1 and 2 walls were constructed of medium-size stones of similar size that were placed in rows with clay-mud mortar used in between the layers. It appears that the Episode 3 construction lacked the precision and technique of previous episodes, and it consisted of rubble that was capped by a plaster floor, which buried the prior burned structure. Floor 1 in UE16 had significant remnants of black and red paint in several areas (Figures 2.57, 2.58).

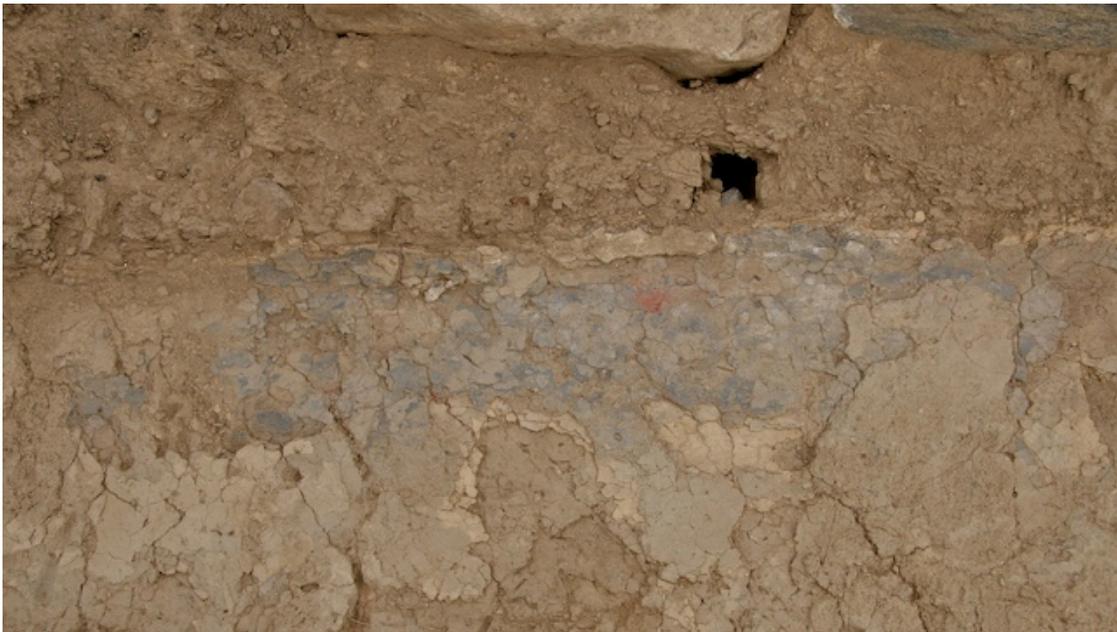
Figure 2.58. UE16, close up of the area of black and red paint from Figure 2.57.

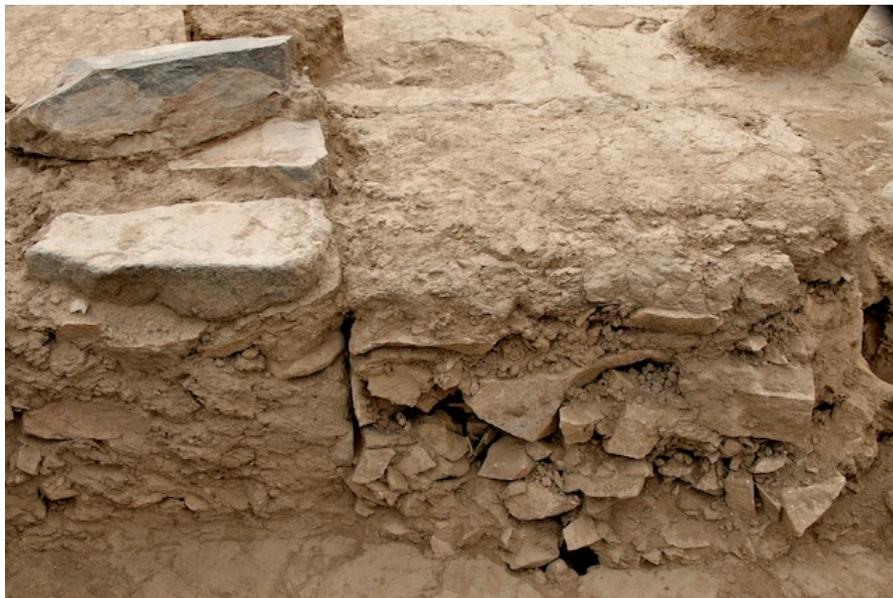
Figure 2.59. UE16, the fill of construction Episode 3 in the previous entrance to Room 1 from construction Episode 2. A seam is visible between the Episode 2 and 3 construction. The photograph was taken facing to the northeast.

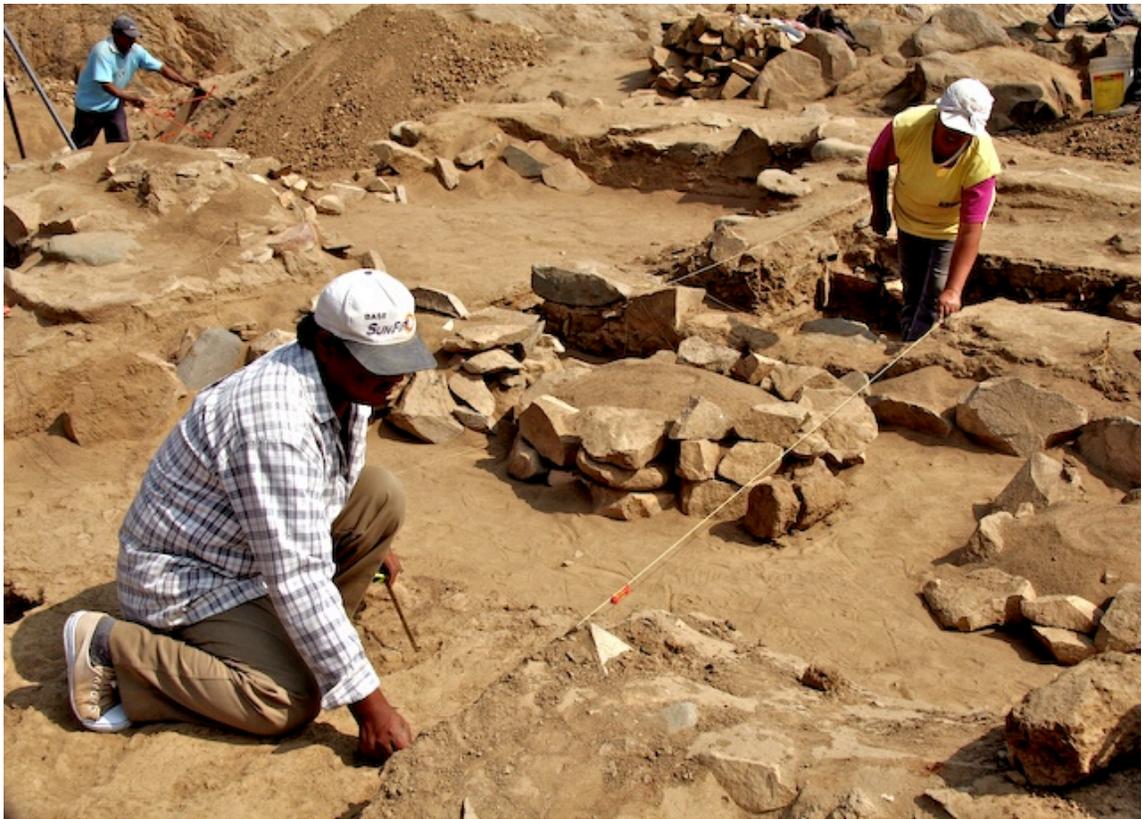
Figure 2.61. The remains of the construction Episode 3 floor found in patio (UE19) and in the entrance to Room 1 (UE16) were at the same elevation. The remains of Floor 1 in Room 1—visible behind archaeologist Flor Díaz (yellow shirt)—were also at the same elevation.

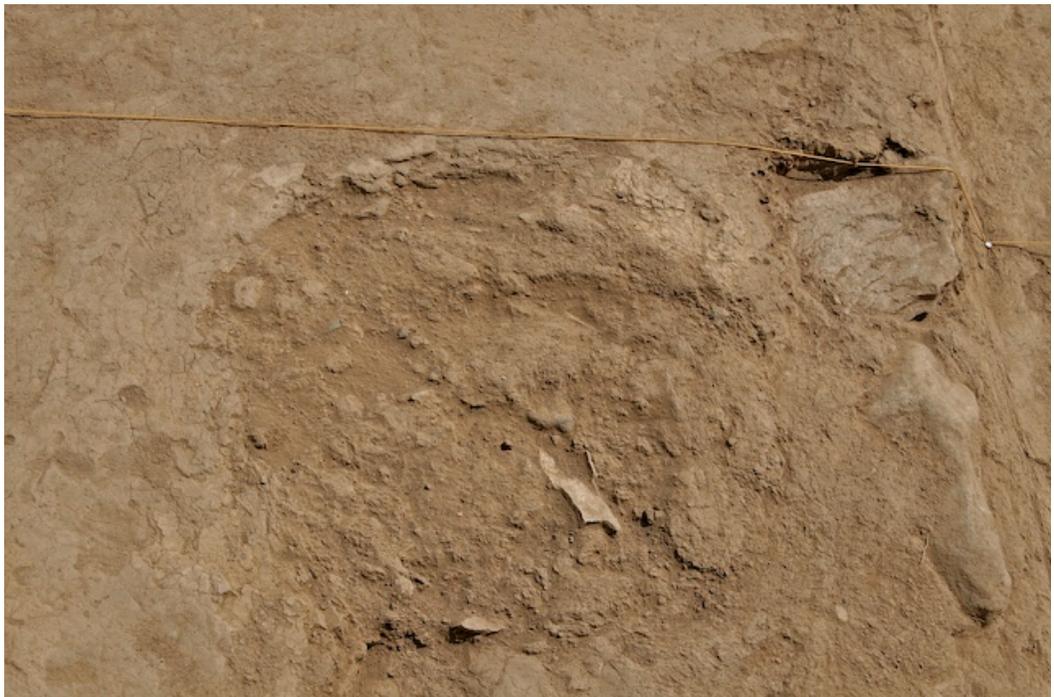
Figure 2.64. UE17, the remains of Column 5 (Feature 22). The photograph is a close-up of Column 5 from Figure 2.63.

Excavation of the southwestern half of the unit revealed the existence of a fifth column (Feature 22; Figure 2.63). It had been destroyed by looting activity down to the level of Floor 1 (Figure 2.64). It measured 45 - 47 cm in diameter, but no part of it existed above the floor.

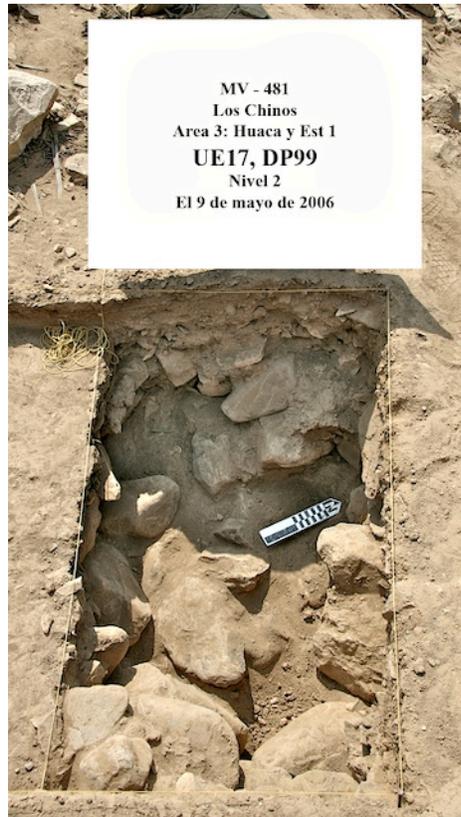
Figure 2.65. UE17, rocks that formed the foundation of *Est 1*.

The level 3 excavation was a 1.2 m x 67 cm unit in the northeastern most part of UE17. Its purpose was to examine the foundation underneath the floor and the profile. This portion of the unit had been disturbed by looter activity down to the level of the medium-to-large rocks that comprise the foundation of the total structure (Figure 2.65). Figure 2.66 shows this unit in profile, and there appears to be only one floor supported by small rocks that rest on the main foundation of the entire structure.

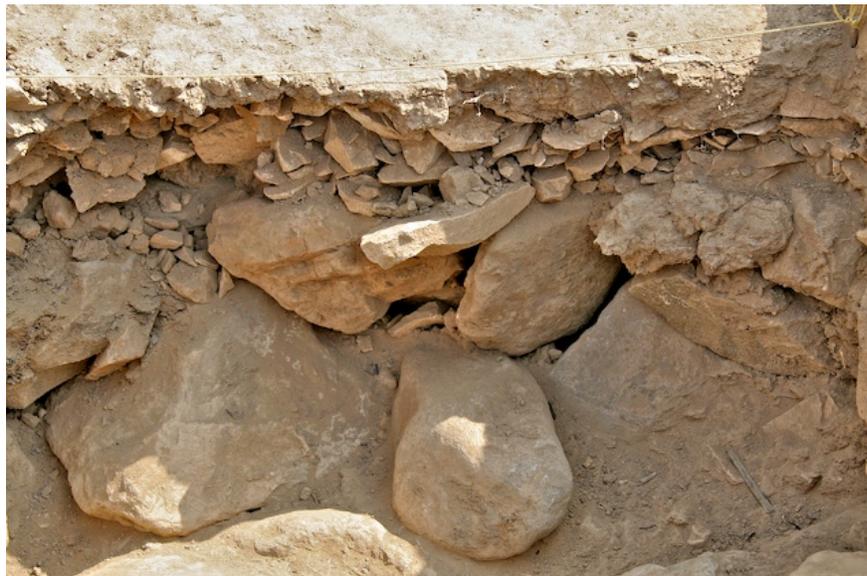
Figure 2.66. Profile of UE17, northeastern half, showing the platform floor, the foundation of small white rocks, and the medium-to-large rocks that formed the foundation of *Est 1*.

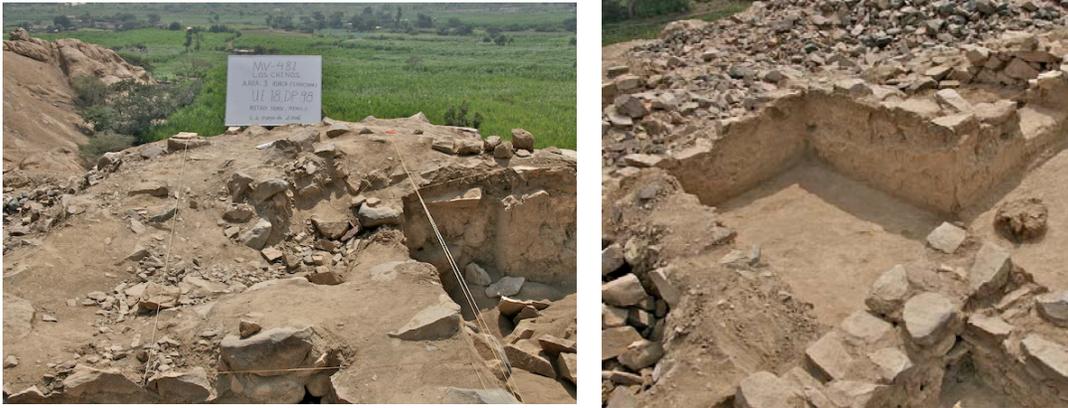
Figure 2.68. UE18 (Feature 17), Room 3 before (left) and after (right) excavation.

UE18 (Room 3, Feature 17) was located in the southwestern corner of *Est 1*, and it was contiguous with Room 1 (Feature 15) and Room 5 (Feature 28; Figure 2.68). The objective was to expose the northeastern half of Room 3. The southwestern half could not be excavated because a large hole from looting activity extended under the floor from the base of the southwestern wall to the middle of the feature. Even though we filled it with rocks, excavation in the southwestern half could have caused the floor to collapse (Figures 2.69, 2.70). UE18 measured 3 x 2 m, and it was excavated in 2 levels.

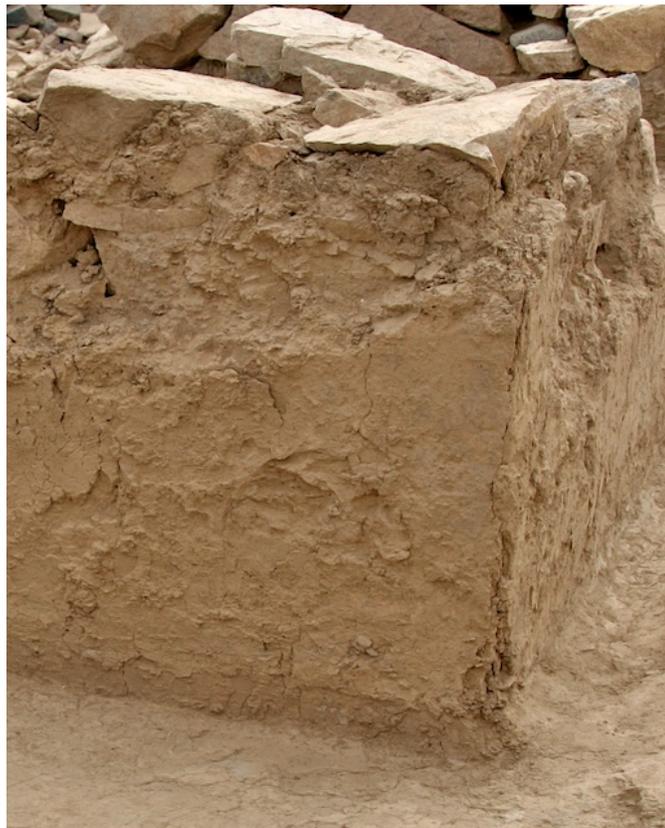
Figure 2.71. UE18, thick layer of plaster on the walls of Room 3.

The floor of Feature 17 was the same type, material, and construction as the floor of the patio, platform, and Features 15 and 16 (Rooms 2 and 1). It sloped slightly downward from the southeastern to the northwestern side of the room, producing a difference in height from one side to the other of 11 cm. The walls were constructed with a core of medium-size stones laid in rows with mud between each layer. The walls were covered with a thick layer of plaster (Figure 2.71). Numerous areas of black paint were present on the floor and interior surface of the walls.

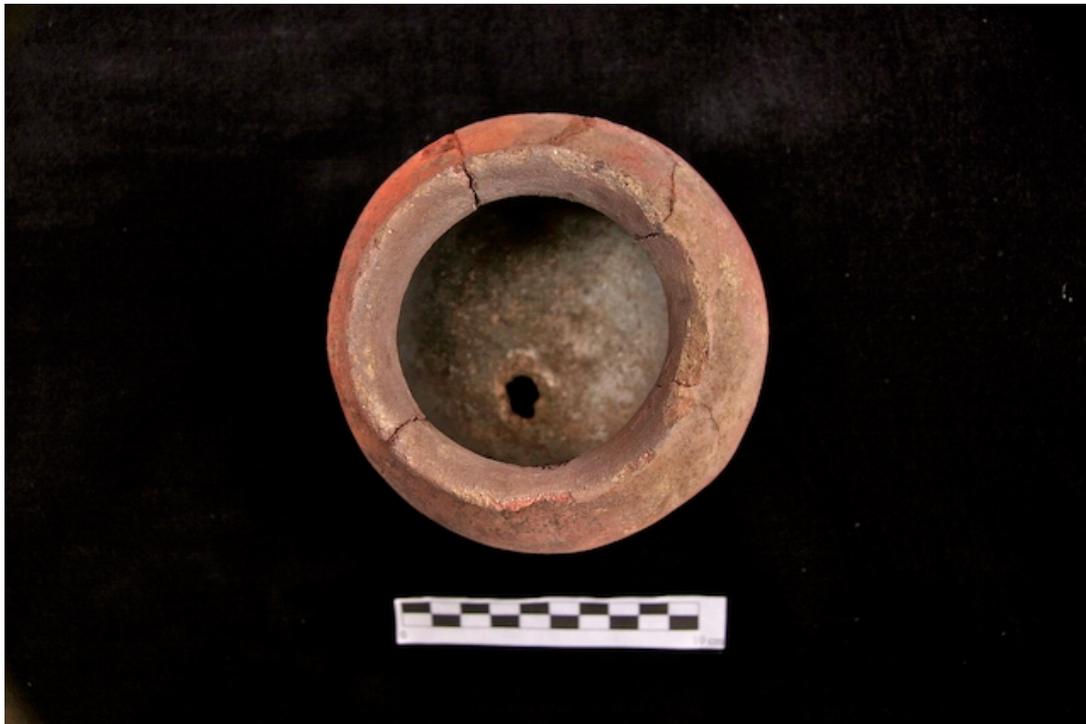
Figure 2.74. Circular hole in the bottom of the vessel recovered from UE18.

A circular hole in the bottom of the olla appeared to have been punched through from the outside (Figure 2.74). This was consistent with the practice of ritually “killing” a vessel before ceremonially burying it, but the hole also may have been made by a looter’s probe.

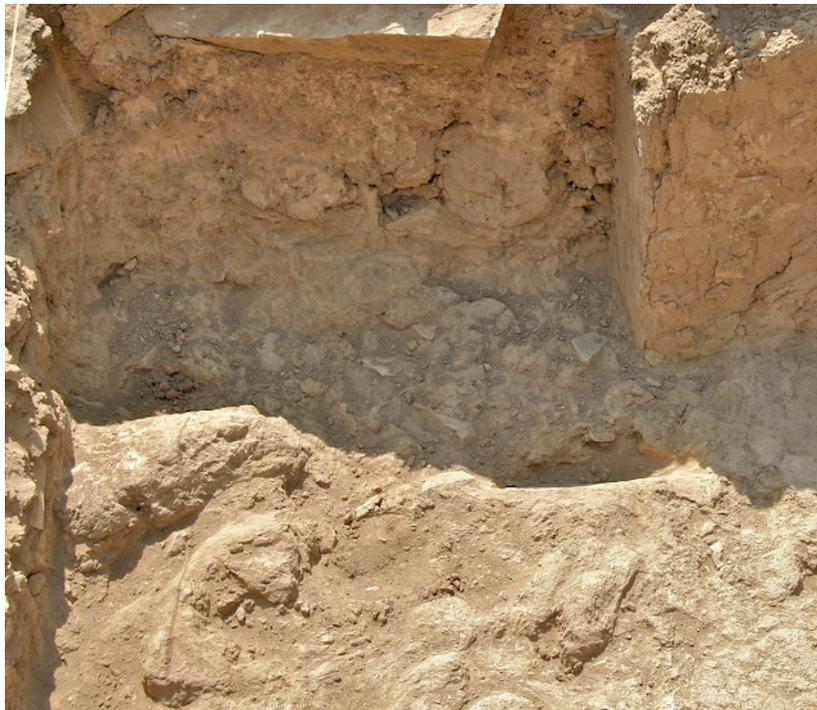
Figure 2.75. UE18, conical adobes in the fill within the doorway.

Non-ceramic artifacts were recovered including conical adobes, small beads and a large white bead, gold ornaments of various shapes, and several areas of paint. Four conical adobes were found in the fill of the doorway to Room 8 (Figure 2.75).

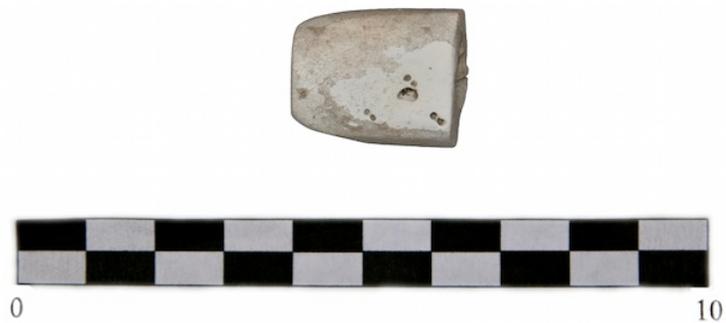
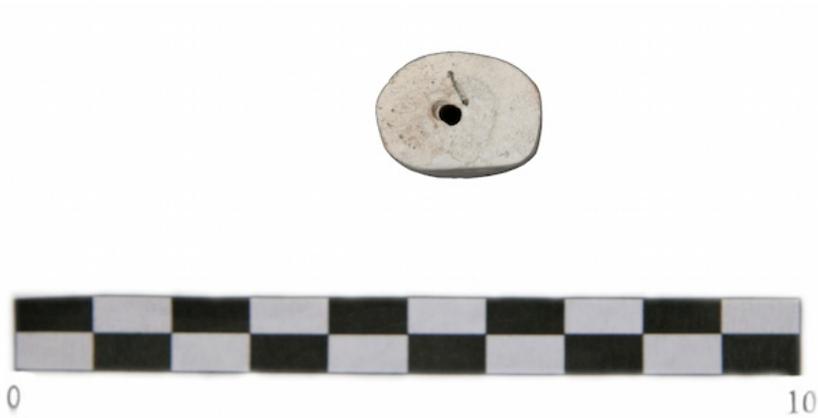
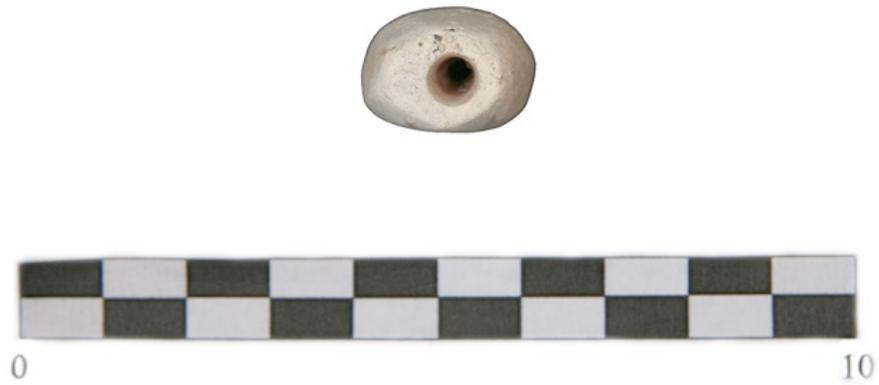
Figure 2.77. UE18, white pendant (scale in cm).

Figure 2.78. UE18, large white pendant (scale in cm).

Figure 2.79. UE18, large white pendant (scale in cm).

A cluster of 13 small beads were recovered together (Figure 2.76). Most were green, one was white, and three were brownish. Five additional circular beads were also recovered from this excavation (Figure 2.76). Two were green, two were made from conch, and one was ceramic. A large white pendant made from calcium carbonate and measuring 1.5 cm on the small end, 2 cm in diameter at the large end, and 2.5 cm in length, was found in the fill from excavation Level 2 (Figures 2.77, 2.78). A hole 5 mm in diameter ran through the center of the pendant for its entire length. The texture of the large end was rough as if it had been broken (Figure 2.67). Small areas on the large end and on one side seemed to be painted with white paint (Figure 2.77). Furthermore, the interior of the hole had an amber color similar to the coloration of a meerschaum pipe after it has been smoked over a long period (Figure 2.79).

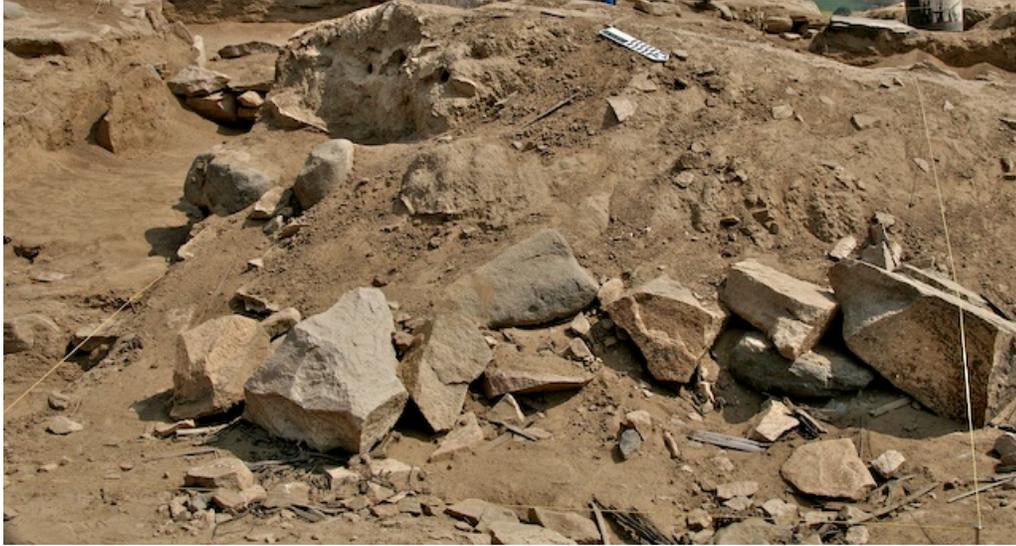
Figure 2.80. UE19 before excavation.

UE19 was situated on the northeastern edge of the patio, and was adjacent to UE13, UE14, UE17, UE20, and UE24 (Figures 2.32, 2.80, 2.81). It was established as a 2 x 2 m unit, and it was excavated in two levels. UE19's objective was to continue to expose the architecture of the patio. Significant evidence was recovered by means of this excavation, and these included two floors, conical adobes, beads, burned wood, Column 6 (Feature 23), an incised ceramic fragment found next to Column 6, and red pigment.

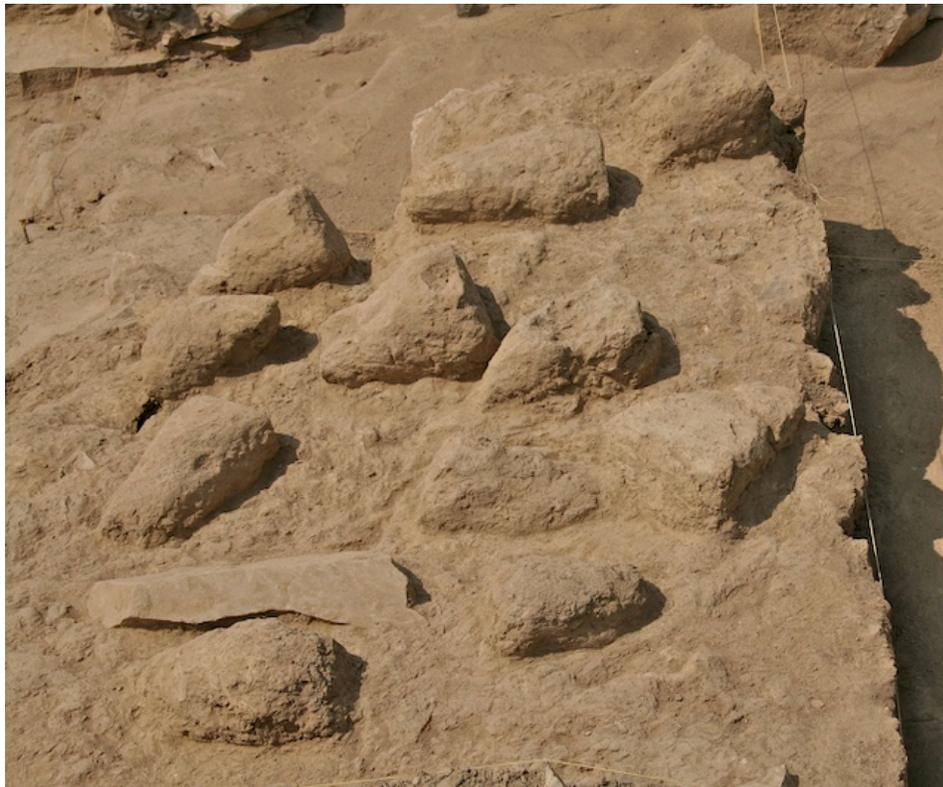
Figure 2.82. UE19, 11 conical adobes.

During the excavation of Level 1 of UE19, a group of 11 conical adobes were found together (Figure 2.82). The adobes in this group were lying on their sides as if they had been intentionally placed there. The dimensions of these adobes are shown in table 2.2).

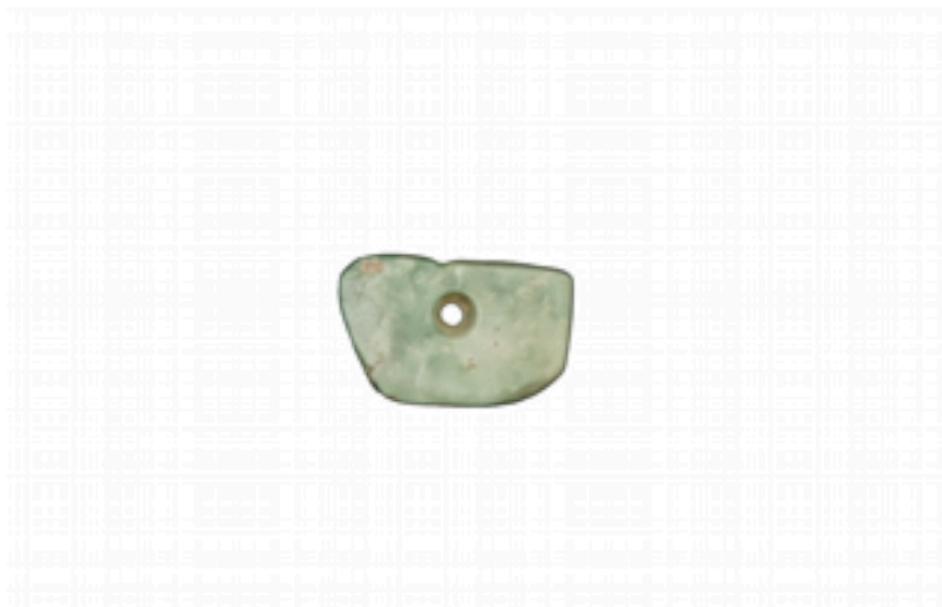
A small, light green, disc-shaped, ornamental bead was recovered from excavation Level 2 (Figure 2.83). It was a fragment that represented perhaps 60% of the original bead. A small recessed hole had been drilled through its center.

Figure 2.83. UE19, a small green bead with a recessed hole through its center.
