HUACA DE LOS CHINOS: THE ARCHAEOLOGY OF A FORMATIVE PERIOD  
CEREMONIAL MOUND IN THE MOCHE VALLEY, PERU

A dissertation submitted to the faculty of the University of North Carolina at  
Chapel Hill in partial fulfillment of the requirements for the degree of Doctor of Philosophy  
in the Department of Anthropology

Chapel Hill  
June 2009

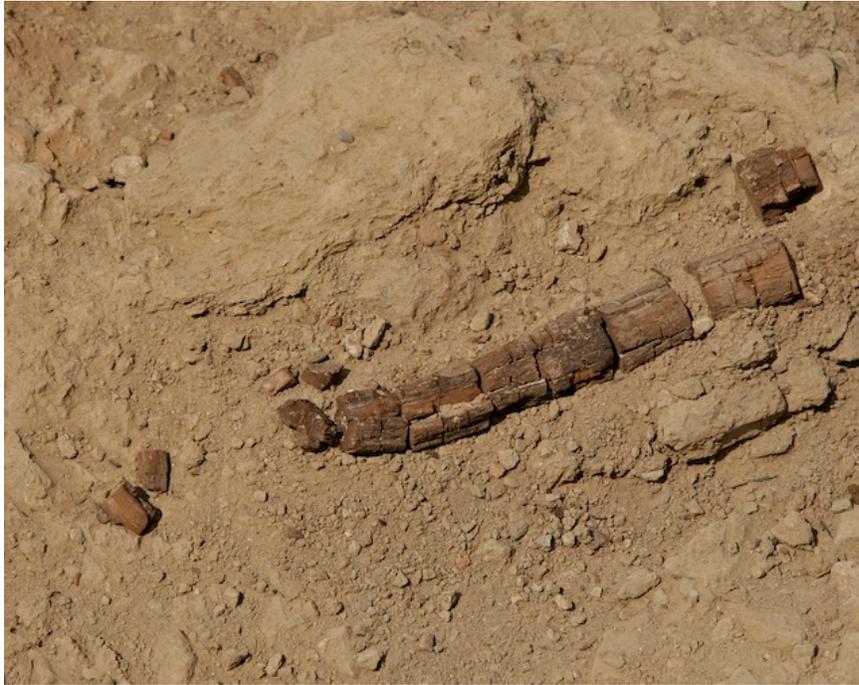
Figure 2.84. UE19, wood found near Column 6.

At the top and bottom of excavation Level 2, four lengths of wood or cane were found close to Column 6 (Table 2.3). Two of these were 10-12 cm above the floor and two were in contact with the patio floor. One piece of wood was found 10 cm above the floor, but it was in seven segments (Figure 2.84). The remaining pieces had disintegrated into a line of fragments (Figure 2.85).

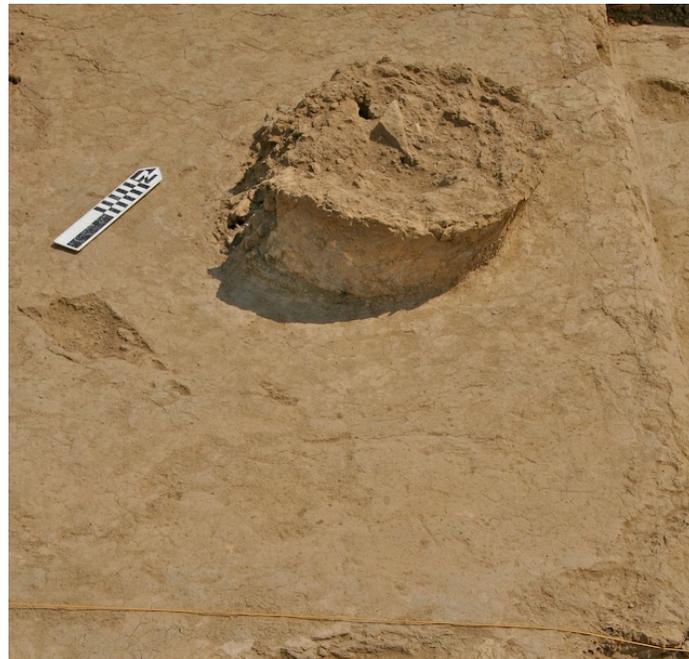
Figure 2.86. UE19, Column 6 (Feature 23).

Column 6 (Feature 23) was exposed 80 cm northwest of Column 5 (UE17; Figures 2.63, 2.81, 2.86). It was approximately 46 cm in diameter and 20 cm in height above the patio floor and appeared to be constructed of mud and stone with an outside coating of a fine plaster. Remnants of black and white paint were present around the circumference of the column (Figure 2.87).

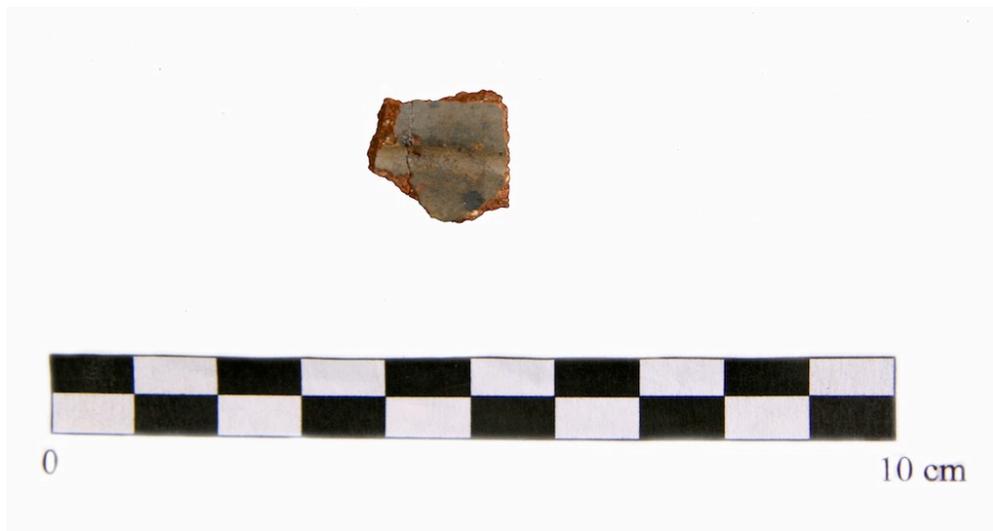
A small diagnostic ceramic fragment was imbedded in the patio floor next to Column 6. It had a broad-line incision, and it was painted with graphite paint over its entire surface and then polished (Figure 2.88). Chronologically it was interpreted as Cupisnique (Middle to Late Guañape phase). Another fragment from the Guañape phase had a fine-line incision on the exterior just below the lip and a band of graphite paint around the exterior of the lip (Figure 2.89). Several Ancón Fine Line fragments from Guañape phase were also found (Figure 2.90). In total, 32 diagnostic ceramic fragments were found in UE19. Most came from the last 10 cm above the patio floor or were in contact with it. Chronologically, 30 appeared to be associated with the Guañape phase. Several fragments of red pigment were present in the last 10 cm above the patio floor (Figure 2.91).

Figure 2.88. UE19, a diagnostic fragment 1265 found imbedded in the patio floor next to Column 6. It appears to have a broad-line incision and be painted with black paint or graphite.

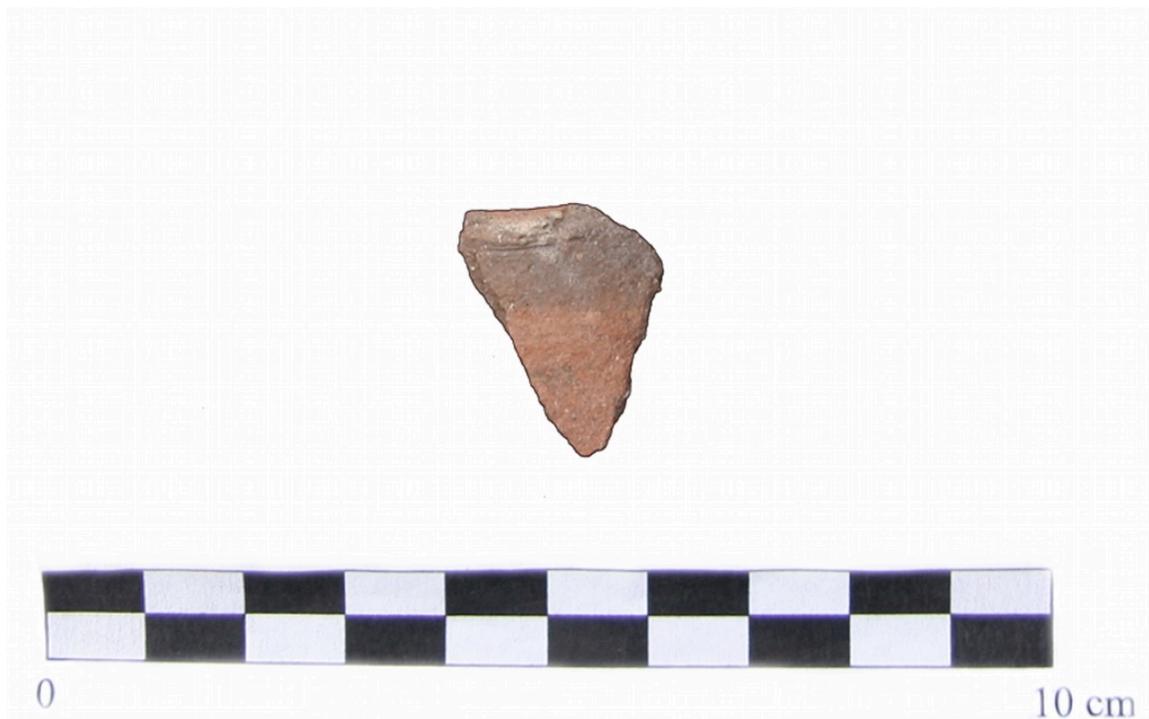
Figure 2.89. UE19, a ceramic fragment decorated with an incision around the lip and a band of graphite paint or black slip just below the lip.

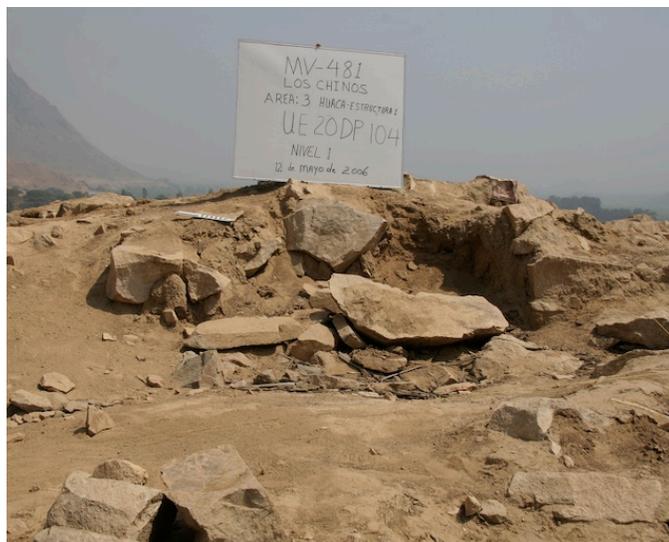
Figure 2.92. UE20 before excavation.

UE20 was established adjacent to UE14 and UE19 with dimensions of 2.5 x 2 m, and it was excavated in two levels (Figures 2.92, 2.93). The objective of this excavation was to continue to expose the architecture of the patio. Key evidence recovered from this unit included two more columns (Features 24 and 25), ornamental beads, a gold ornament, red pigment, a ceramic penis, the second half of the drain, fragments of the roof and/or walls, a circular hole beside Column 7 (Feature 24), diagnostic ceramic fragments, and evidence that *Est 1* burned.

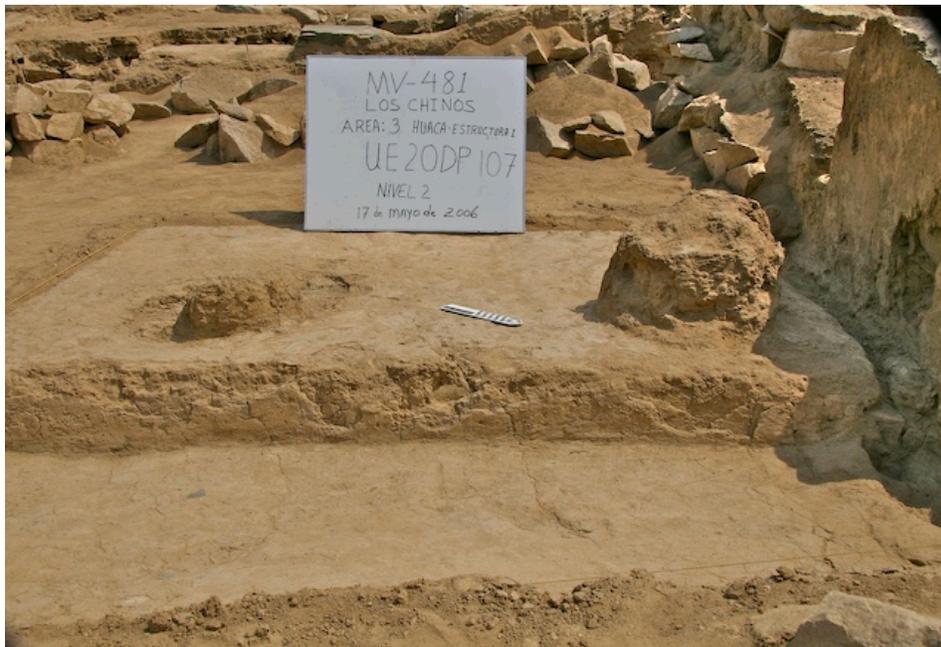
Figure 2.93. UE20 after excavation.

Columns 7 and 8 (Features 24 and 25; Figure 2.93) were exposed in line with those found in UE17 and UE19, which complete a second line of four columns 2 m to the northeast of the line found in UE13 and UE14. Column 7 was almost destroyed by past looting activity (Figure 2.94). Only a small part on the northeastern side of the column remained above the level of the patio floor. Although most of the column was level with the patio floor, an outline of its circumference was clearly visible. Traces of black paint were visible around the base of the portion of the column that rose above the patio floor (Figure 2.95). Column 7 was 46 cm in diameter.

The remains of Column 8 were situated approximately 78 cm northwest of Column 7. It measured 46 cm in diameter, and rose 30–40 cm above the patio floor (Figures 2.93, 2.96). Remnants of black paint were visible at various points around its circumference and base, but especially on its west side (Figure 2.96). This column and others that formed the line of columns toward the front of the patio are parallel to the line of columns across the back part

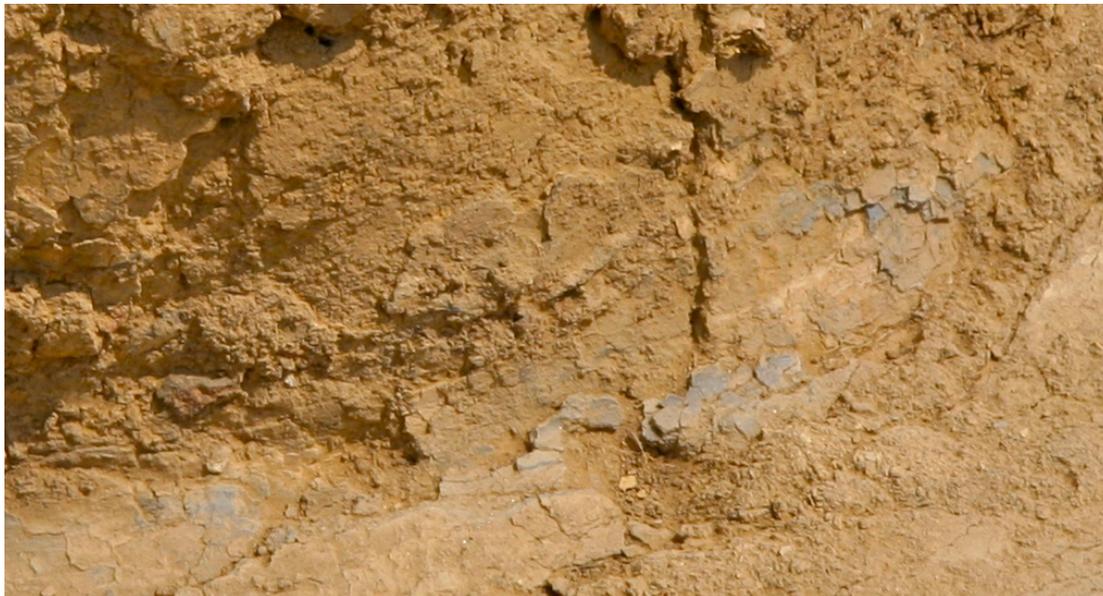
Figure 2.95. UE20, Column 7 showing traces of black paint around its base.

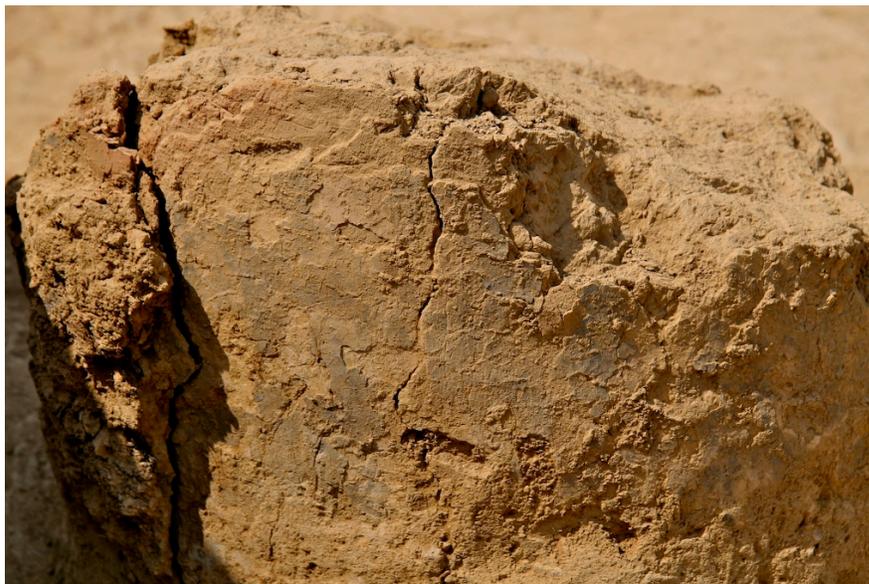
Figure 2.96. UE20, the remains of black paint on Column 8 (Feature 25).

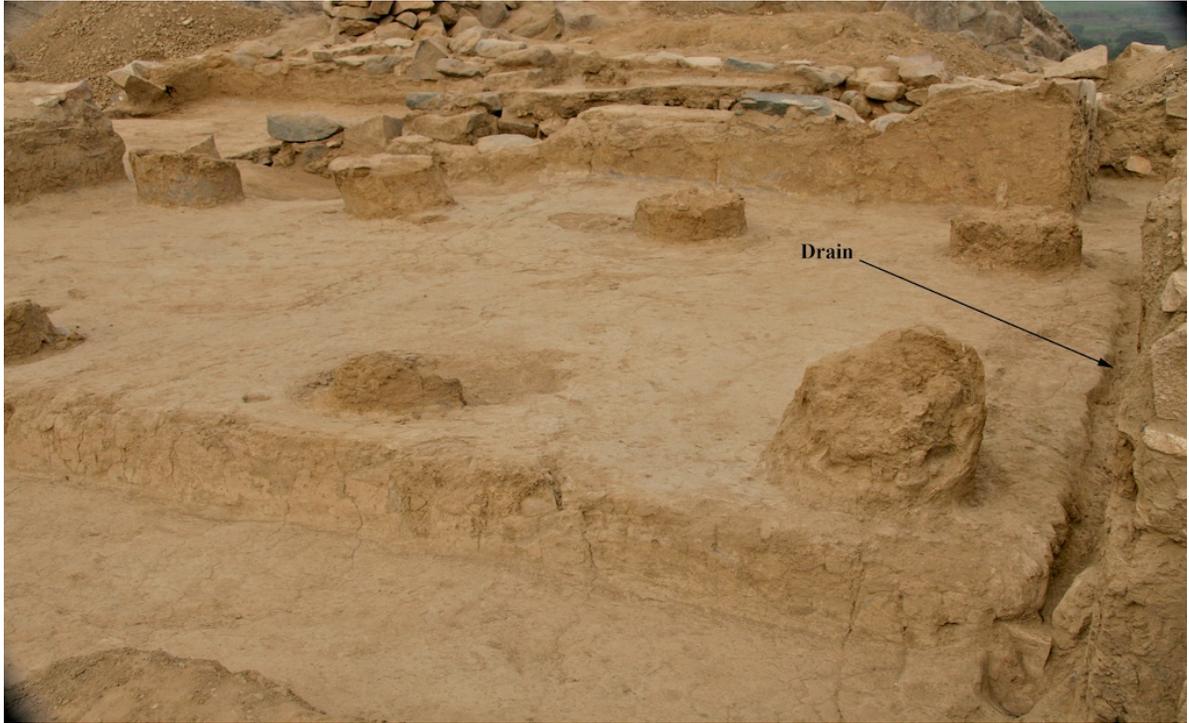
Figure 2.97. UE20, the drain on the northwestern edge of the patio.

The northeastern half of the drain mentioned in the section describing UE14 was exposed during UE20 excavation (Figure 2.97). It was cut into the northwestern side of the patio and ran approximately 3 m in length from the entrance to Room 3 to the front edge of the patio (Figure 1.5). In front of the northeastern end of the drain, there is a curved raised area that projects about 50 cm onto the platform in front of the patio (Figures 2.99). Its function appeared to be for channeling water off of the patio, around Room 5 and over the northwestern side of *Est 1*. The drain's construction was much less precise and elaborate than the rest of Episode 2 construction. Perhaps it was built quickly during a period of heavy rain such as an El Niño event.

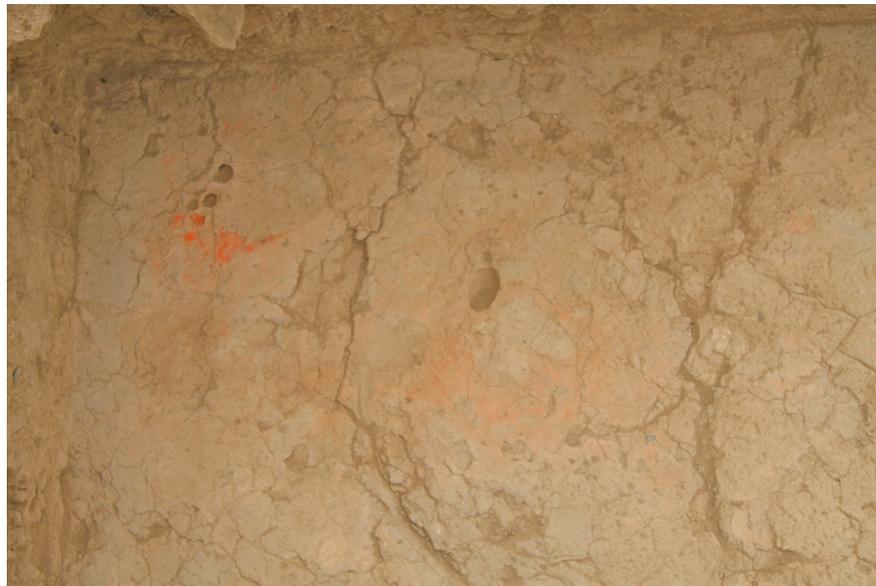
Figure 2.99. UE20, area with red pigment on the platform in front of the drain.

A large area of red paint or pigment was located on the front platform in front of the drain on the northwestern corner of UE20 (Figure 2.99). It appeared to be the remains of a portion of the floor of the platform that had been painted red.

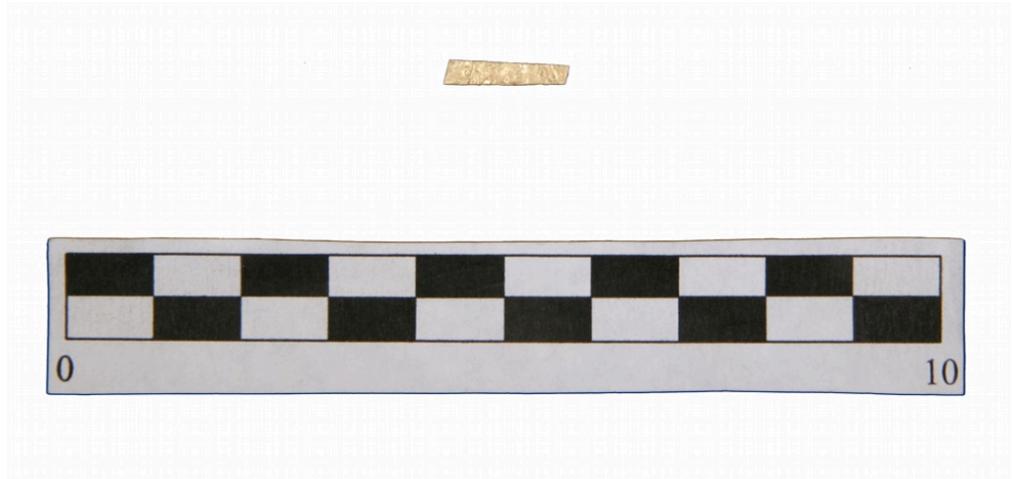
A small, rectangular, gold ornament was recovered from Level 1 of UE20 (Figure 2.100). It measured 10 mm x 3 mm.

Figure 2.100. UE20, a rectangular gold fragment, embossed. It measured 10 mm x 3 mm (scale in cm).

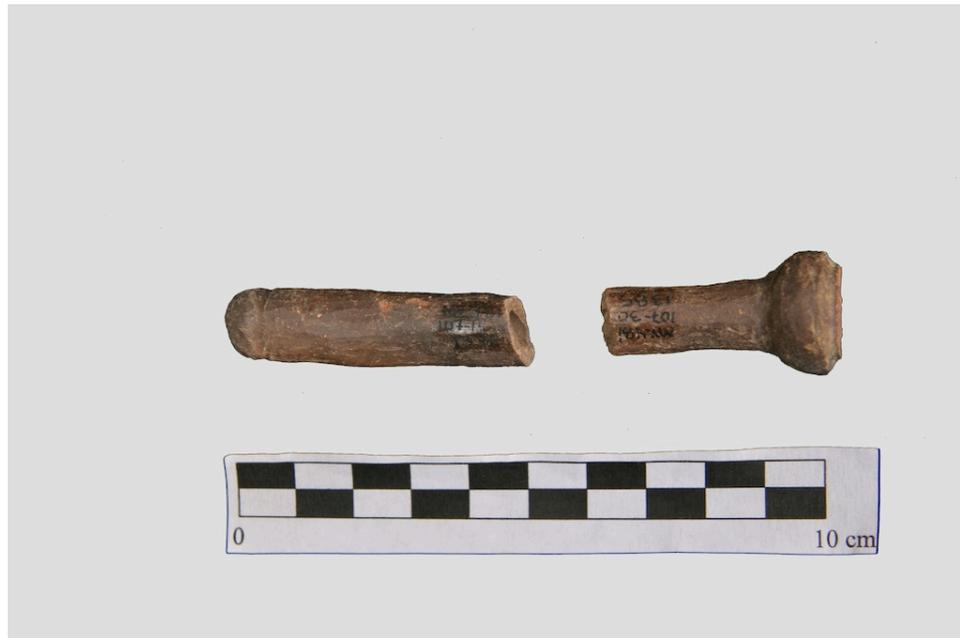
Figure 2.101. UE20, two fragments of a ceramic penis found 10 cm above the patio floor.

Two parts of a ceramic penis were recovered from the bottom of excavation Level 1 about 10 cm above the patio floor (Figure 2.101). It was broken in half and most likely had been broken off from a larger vessel which we did not find. It was lying horizontally and parallel to the patio floor as if it had been intentionally placed rather than randomly falling into this position. The artifact appeared to be painted with a black slip and polished.

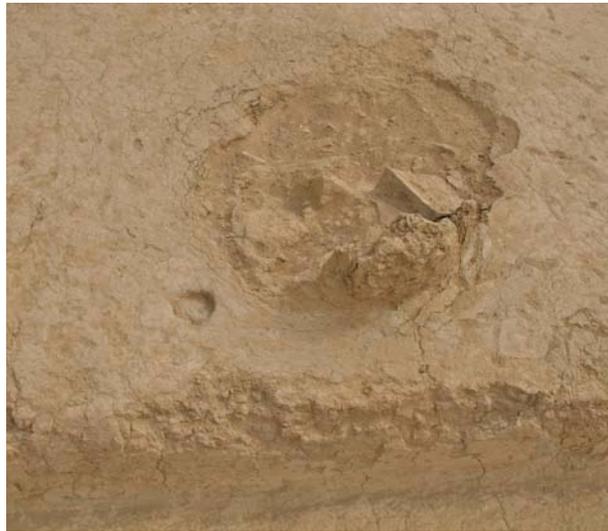
Figure 2.102. UE20, a small circular hole next to Column 7.

About 13 cm from the northeastern side of Column 7 (Feature 24) was a small circular hole 5 cm in diameter and 4 cm deep (Figures 1.5; Figure 2.102). There is no evidence to support its function; however, it appears to be a hole that supported something that was placed inside of it. The location was at the entrance to *Est 1* and next to its central axis. Its position almost assured that the object placed there would be seen by everyone who passed between columns 6 and 7 after they had ascended the main staircase of *Est 1*. Perhaps some type of culturally meaningful, small object, such as a figurine, was placed there, since the hole is not deep enough to support something tall.

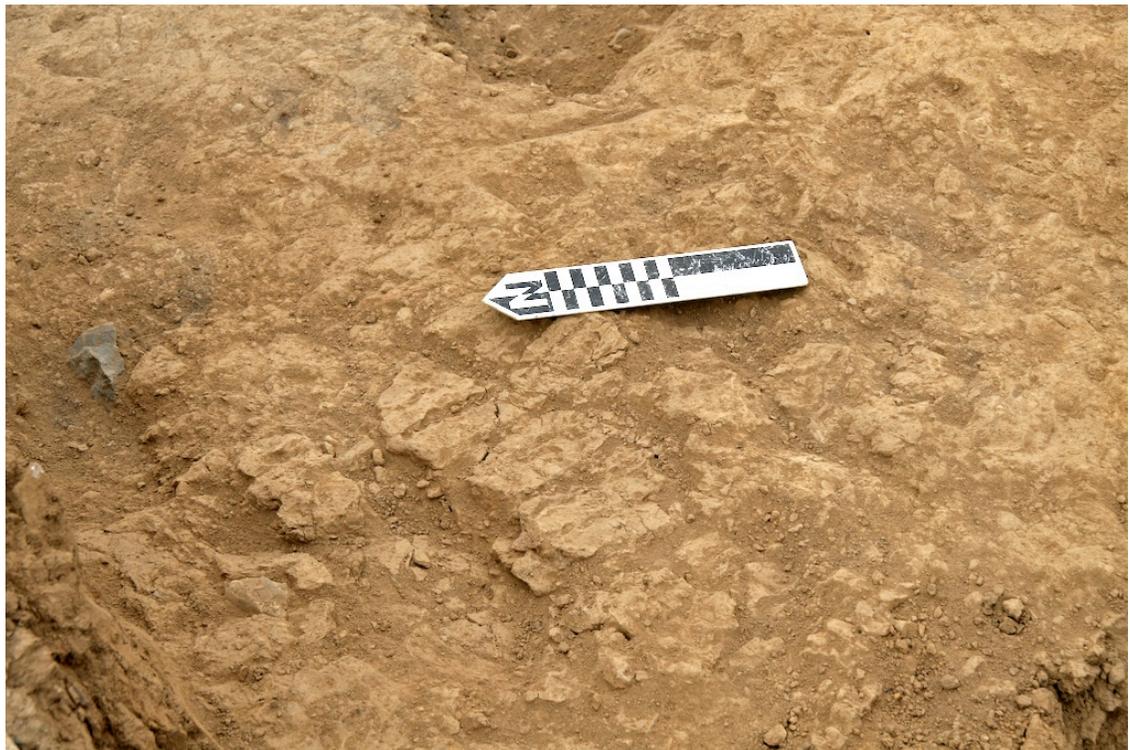
Substantial evidence was observed and recovered in this unit that *Est 1* had been burned. This evidence included burned portions of the room and floor, large portions of the roof that had collapsed onto the floor, burned cane, and substantial amounts of charcoal between the roof or wall and the floor (Figures 2.103, 2.104, 2.105). The evidence from this excavation unit corroborates the evidence from UE14 that *Est 1* was burned.

Figure 2.103. UE20, a portion of the roof or wall of *Est 1* that had collapsed onto the floor of the patio. The impressions of cane are visible.

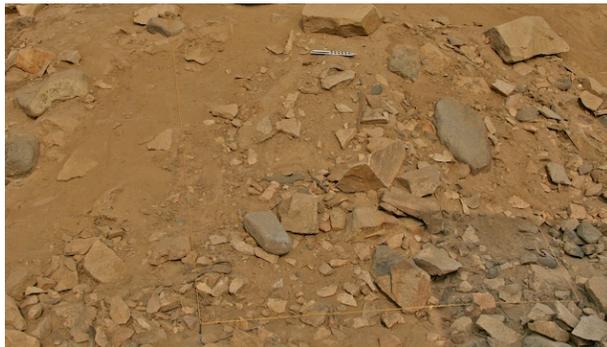
Figure 2.106. UE21 before excavation.

UE21 was located on the southeastern corner of the northeastern side (front) of *Est 1* (Figures 2.32, 2.106, 2.107). It measured 1.2 x 5 m, and was excavated by halves—northeastern and southwestern. Each half consisted of two excavation levels. The objective was to expose a portion of the facade of *Est 1* so its original architecture could be examined.

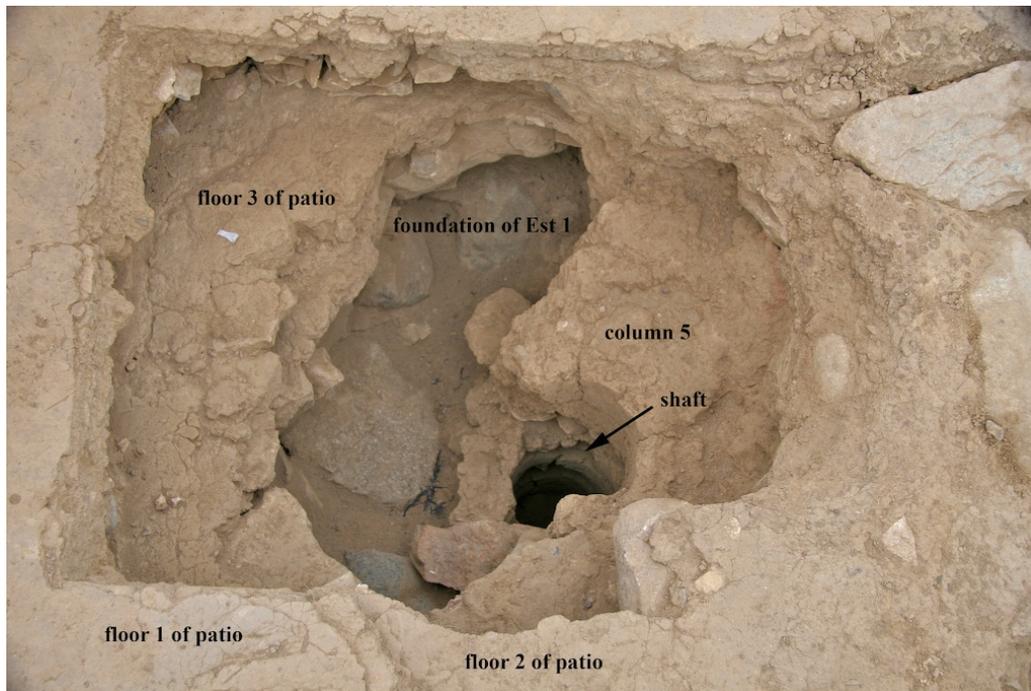
Figure 2.109. UE22 after excavation. Floors 1, 2, and 3 of the patio, half of Column 5, and the large stones of the *Est 1* foundation are visible in the photograph.

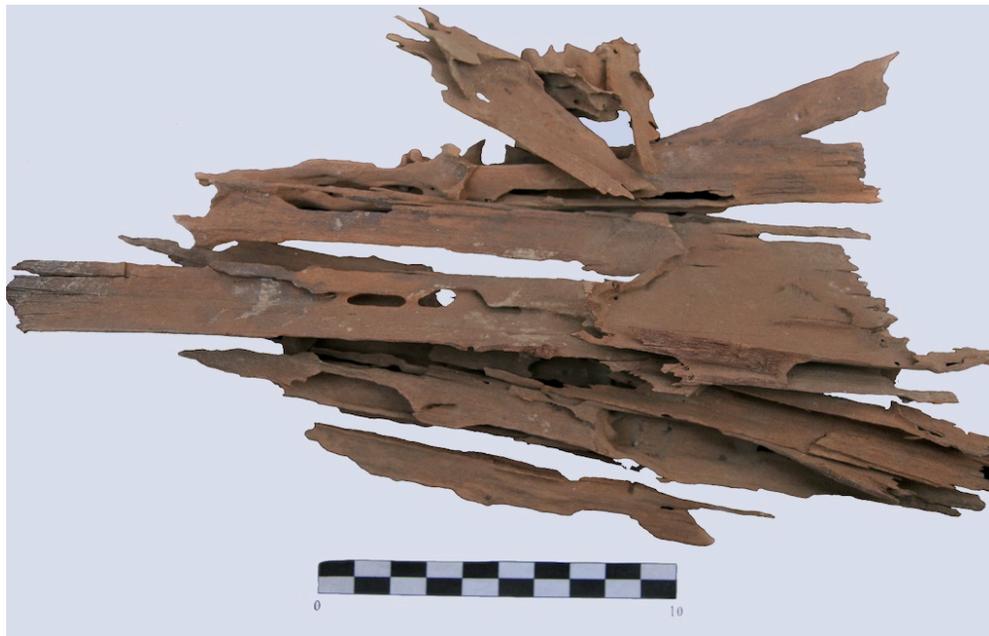
Figure 2.110. UE22, remains of wooden post recovered from the bottom of the shaft in the center of Column 5 (scale in cm).

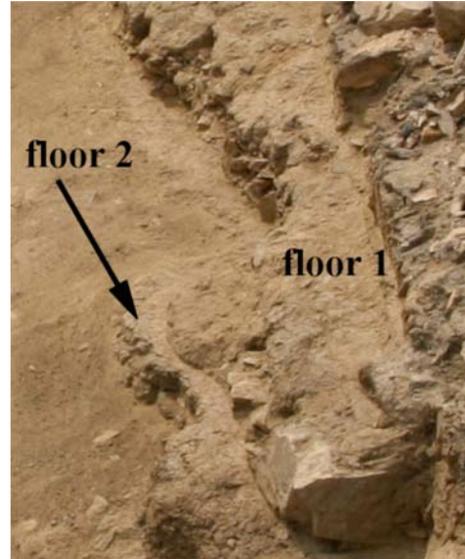
The excavation of Room 6 revealed the existence of two plaster floors (Figures 2.112, 2.113). These are visible on both sides of the excavation unit. Floor 1 construction included a substantial layer of small stones as a foundation. This suggested two construction episodes associated with this feature. Past looting activity had destroyed a large area of both floors down the middle of the excavation unit, as well as most of the southwestern wall of this room.

Figure 2.112. UE23 after excavation. The top image shows the entire excavation unit. The bottom two images show a close up of the floors. The remnant of a plastered patio floor is visible outside of the southwest wall of UE23 (Figures 2.113, Figure 2.117).

Just outside the southwestern wall of Room 6 is the remnant of a plastered floor that extended to the southwestern for about 30 cm (Figure 2.117). The area between Room 6 and

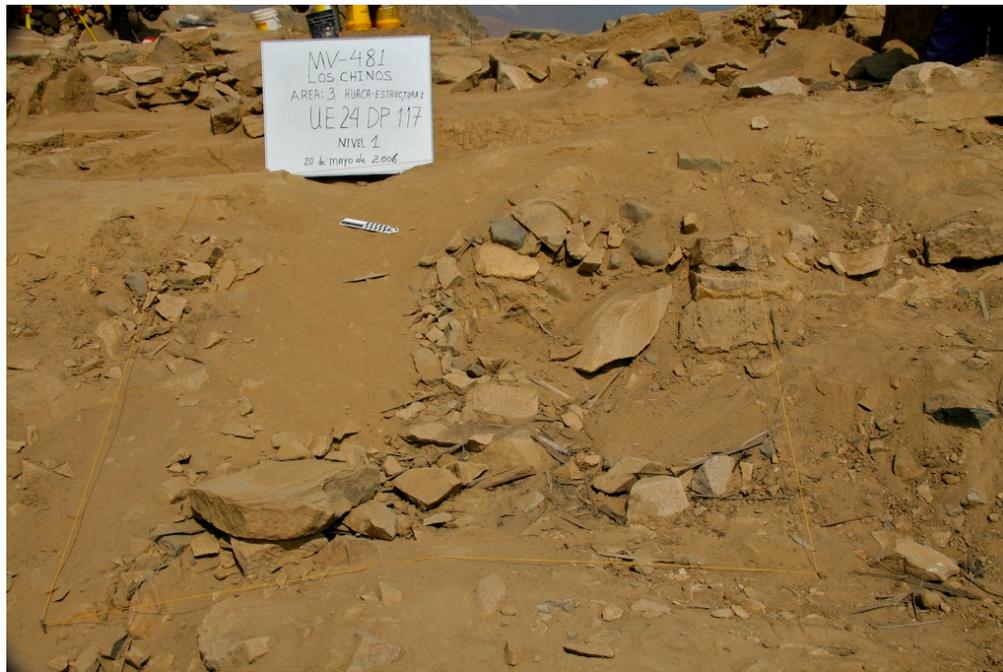
Figure 2.118. UE24 before excavation.

These two units were located in the center of the facade of *Est 1*, and they were designed to expose the main access path onto *Est 1*. Each excavation unit had overall dimensions of 2 x 2.5 m, and each was excavated by halves: southwestern and northeastern. Each half consisted of two excavation levels (Figures 2.118, 2.119).

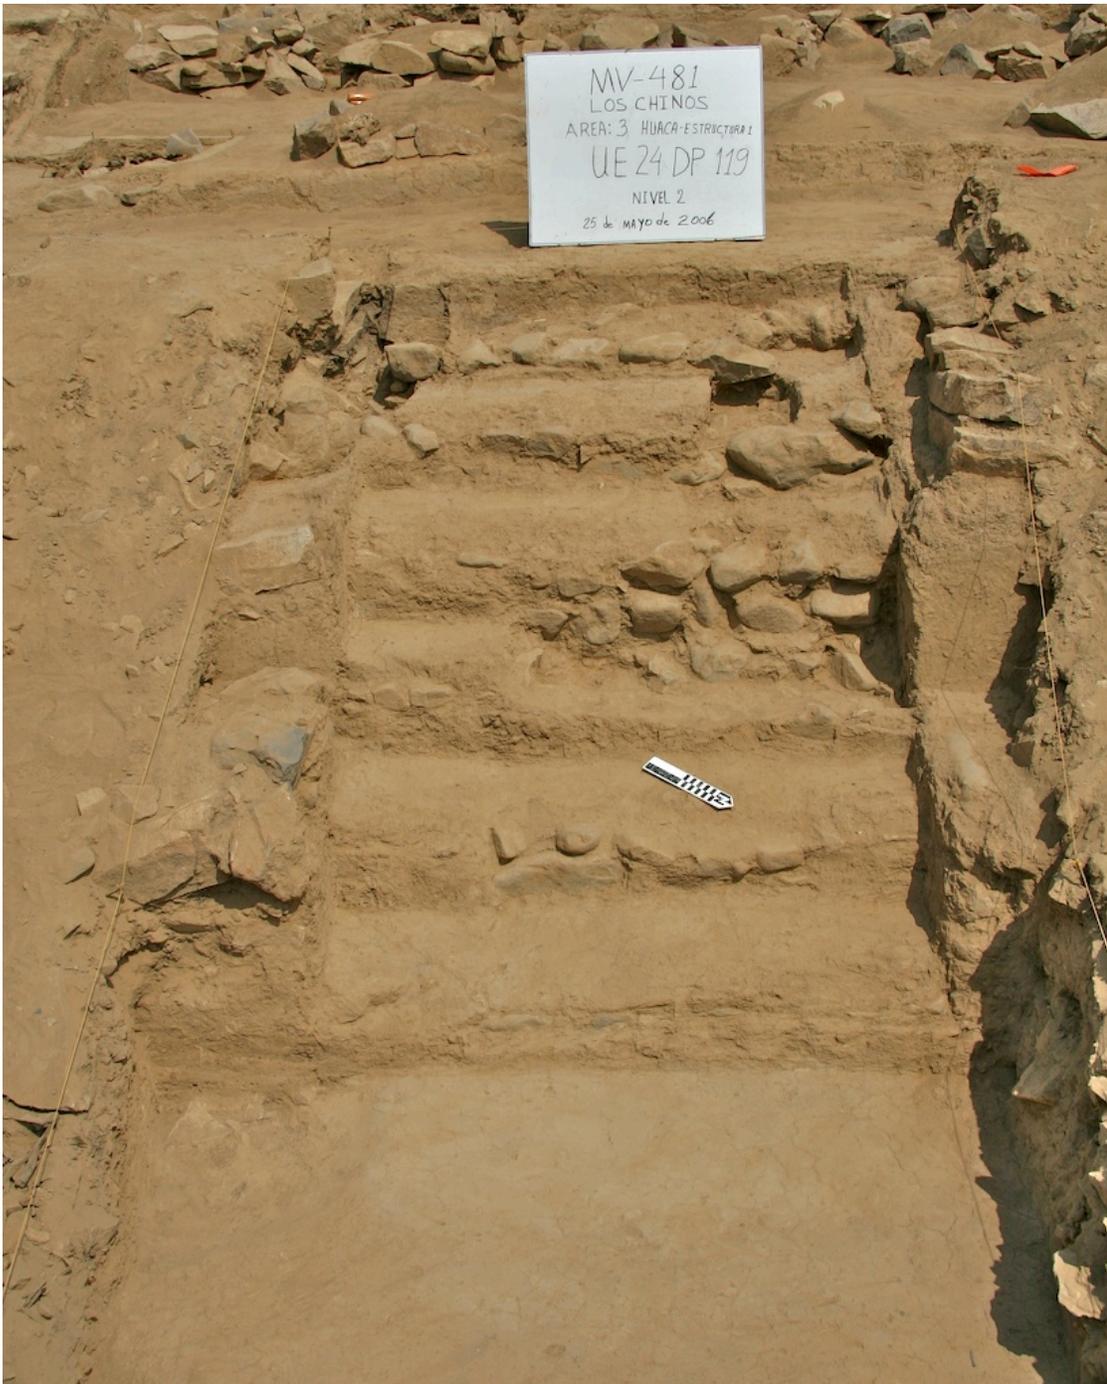
Figure 2.120. UE24 and UE25, the entrance to *Est 1*. Remains of a newel wall is visible along each side of the staircase.

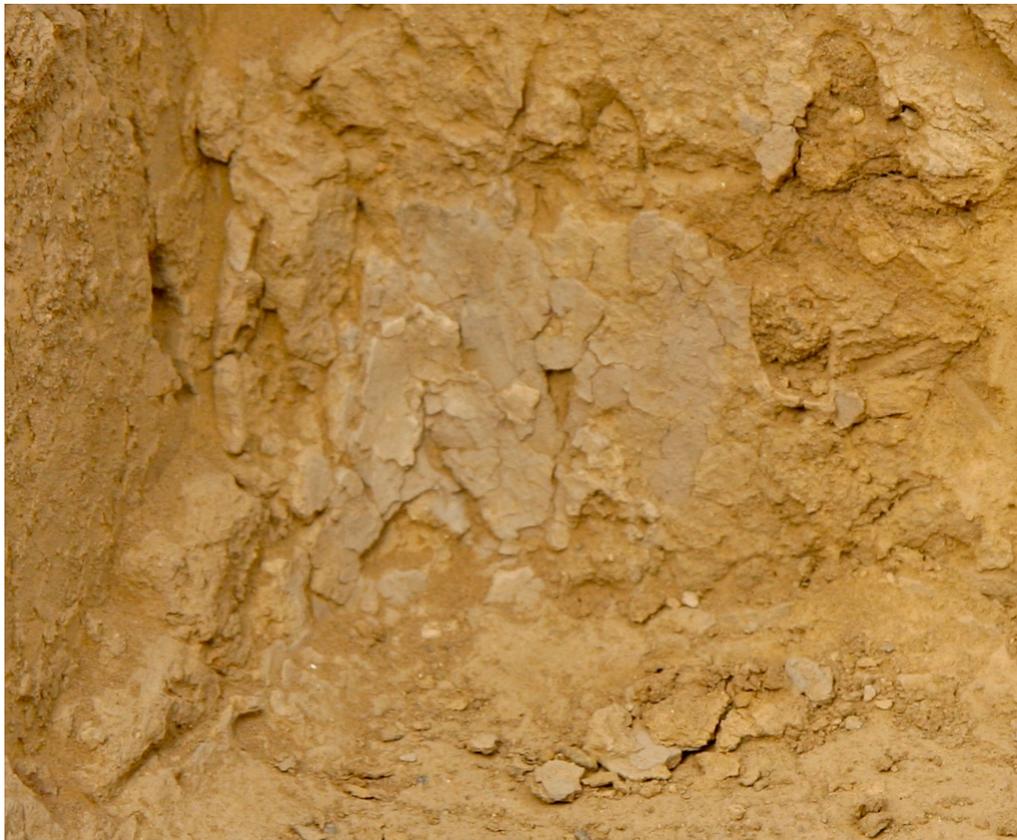
The excavations revealed a 1.5 m-wide staircase with six steps that ascended from the level of the floor of plaza E to the platform in front of the patio of *Est 1* (Feature 31; Figure 2.120). They were constructed of stone and covered with a layer of fine plaster. A newel wall delimited each side of the staircase. There was abundant evidence that the staircase was painted black (Figures 2.121, 2.122).

Figure 2.121. UE24 and UE25, paint on the riser of step 2, entrance to *Est 1*.

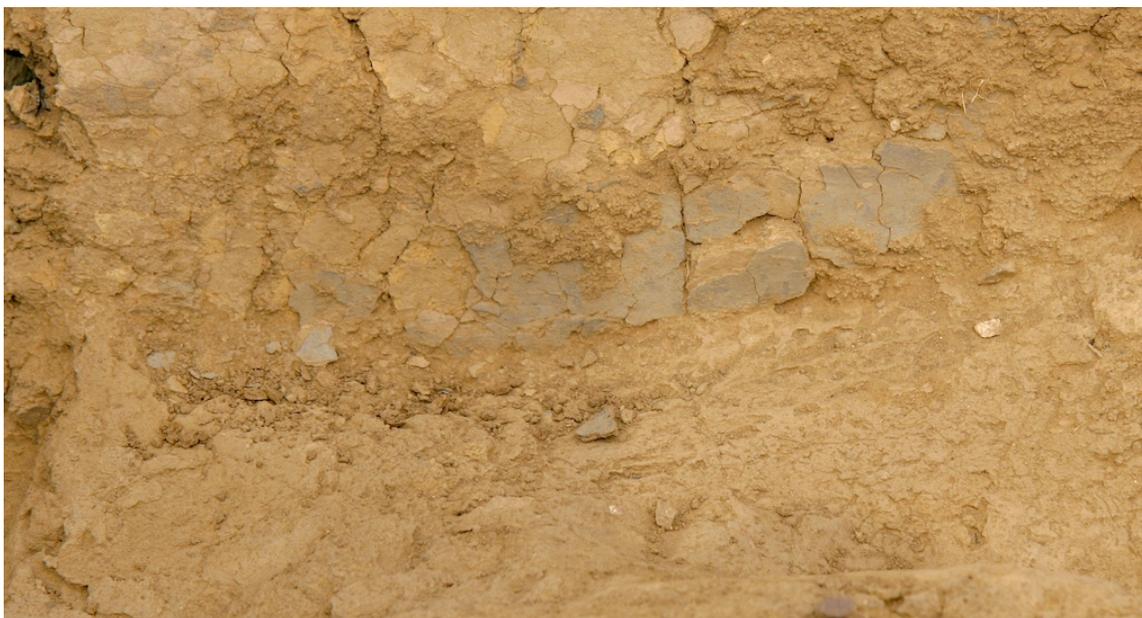
Figure 2.122. UE24 and UE25, paint on the riser of step 7, entrance to *Est 1*.

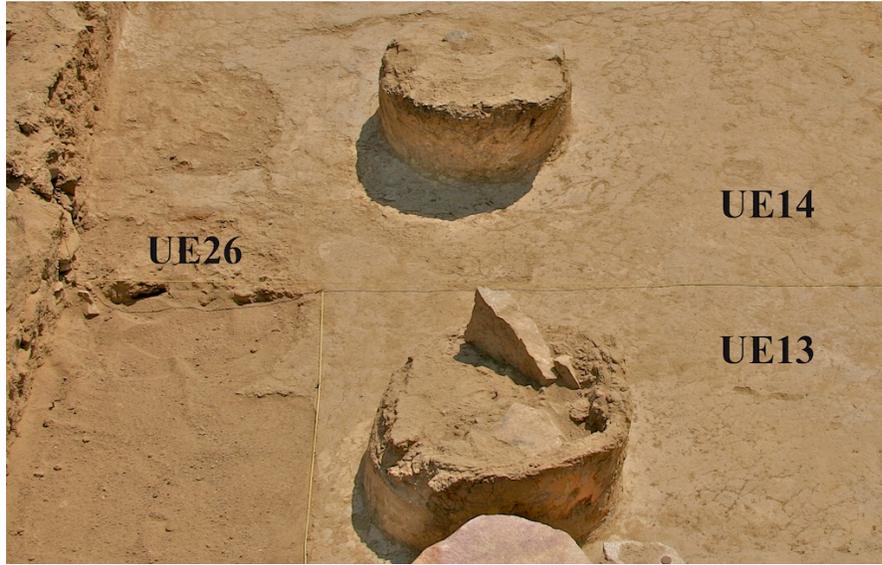
Figure 2.124. UE26 before excavation.

The objective of UE26 was to explore a small oval-shaped area (Feature 32) in the floor of the patio that was located near the central axis and directly in front of the northeastern wall of Room 1 (Figures 2.124, 2.125). This feature was situated on the border of UE13 and UE14 and overlapped into both units; therefore, it was processed as a separate unit and feature rather than as a sub-level and sub-feature. The excavation unit was 60 x 60 cm, and it was excavated in three levels. A small disturbed area was present in its southeastern portion, which was attributed to past looting activity.

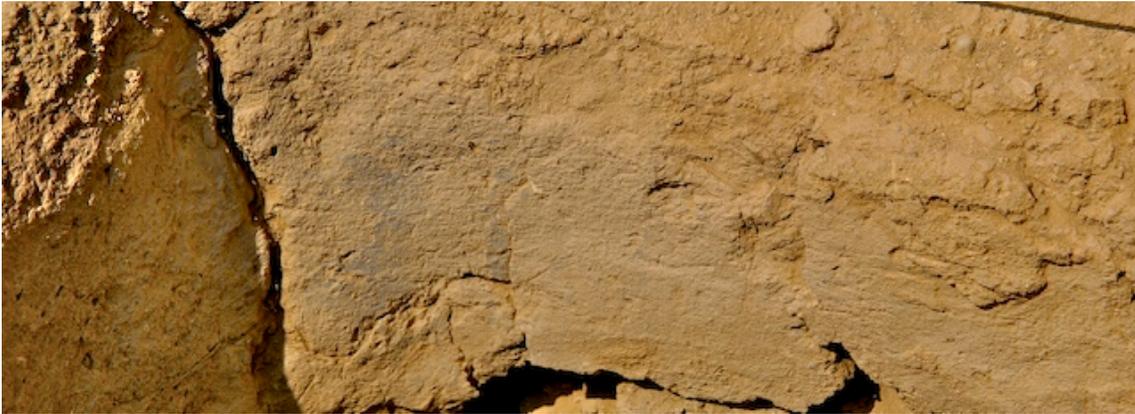
The interior walls and bottom of the feature were coated with a fine plaster, and the remains of black paint were still visible on one side (Figure 2.126). Its location close to the entrance to Room 1 and the central axis may suggest an important role (i.e., an offertory); however, its function remains unclear.

Figure 2.126. UE26, interior surface of the offertory showing the remains of black paint.

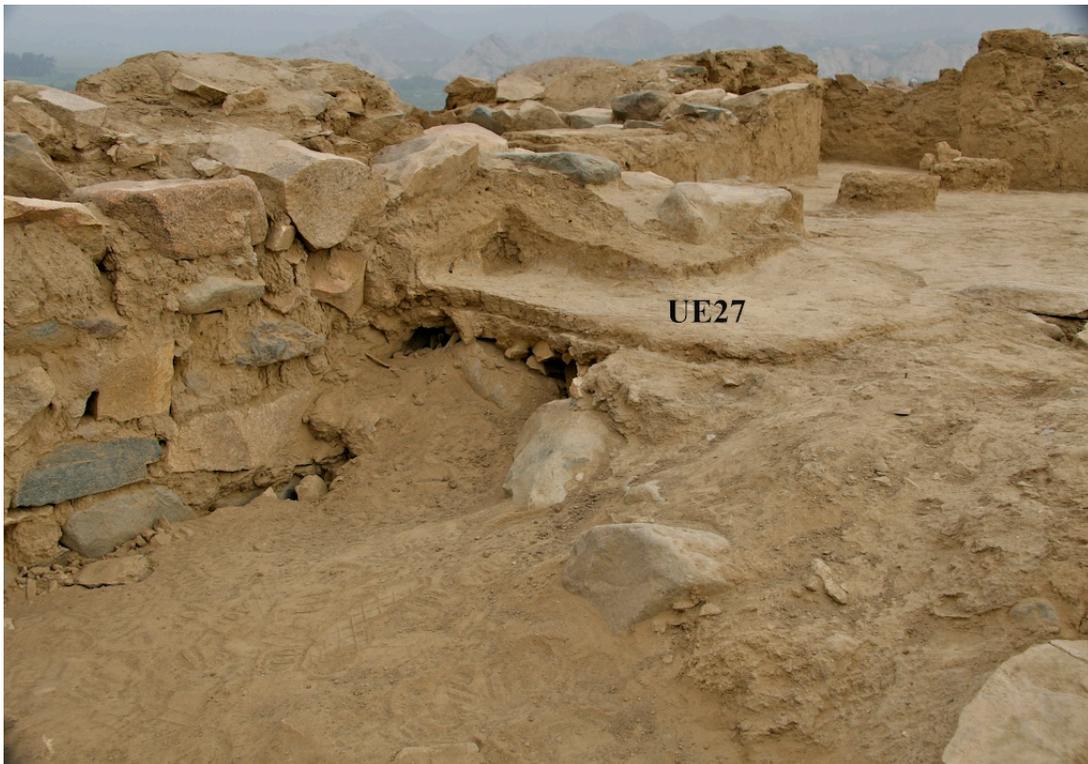
Figure 2.127. UE27 after excavation.

Three finely plastered floors were exposed (floors 1, 2, 3; Figure 2.127). Floors 1 and 2 were associated with the second construction episode of *Est 1*. Floor 2 was 4 cm below Floor 1, and there was no supporting foundation between the two floors, which was consistent with a remodeling event. The level of Floor 3 of this room corresponded to Floor 3 (the original patio floor) in Room 2 (UE15), as well as Floor 2 in Room 1 (UE16). The remaining area inside Room 4 had been destroyed by looters.

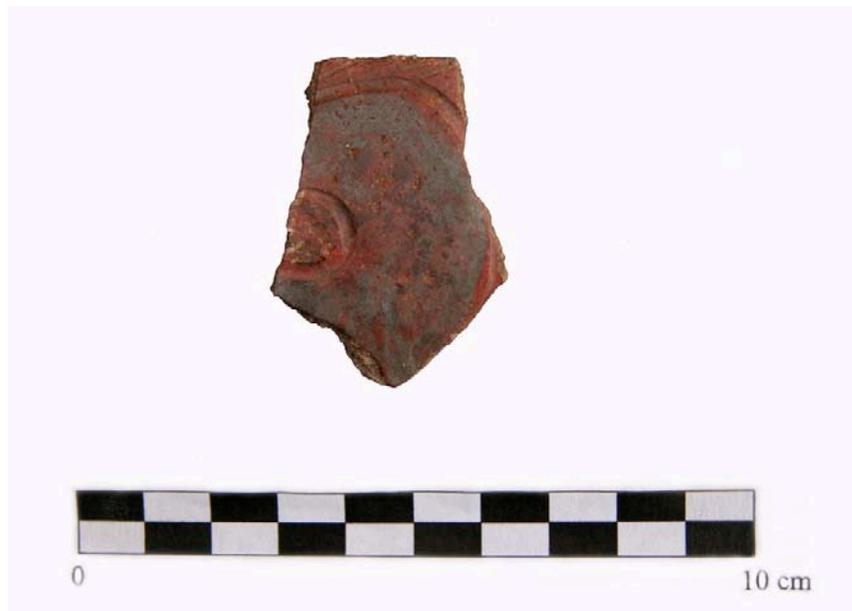
appeared to be from the same vessel, and they were interpreted as Guañape Black Plain type from the Late Guañape phase. The diagnostic sherds were interpreted as Guañape Zone Red from the Late Guañape phase (Figures 2.129, 2.130).

Figure 2.129. UE27, Guañape Zone Red fragment found near Floor 1 has two zones created by broad-line incisions. The inner and outer zones contain punctations and black or graphite paint.

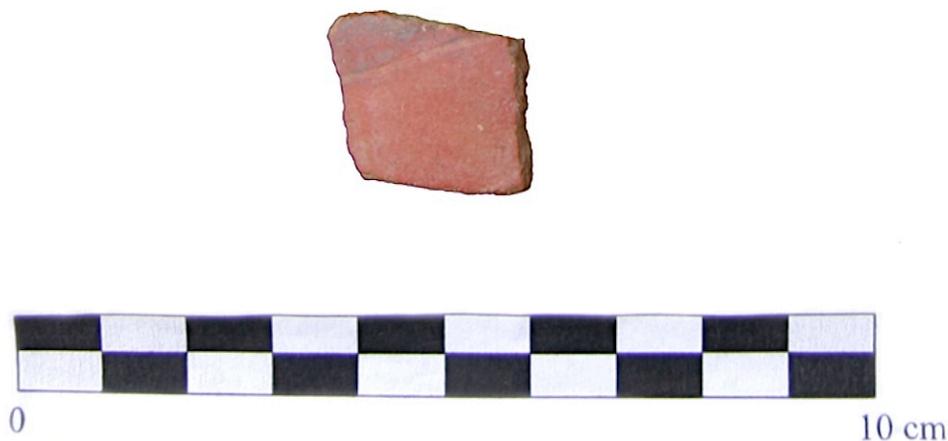
Figure 2.130. UE27, exterior surface of a Guañape Zone Red fragment found near Floor 1. A fine-line incision creates two zones. The exterior surface was covered with a red paint or slip, and the smaller zone also has traces of a black or graphite paint.

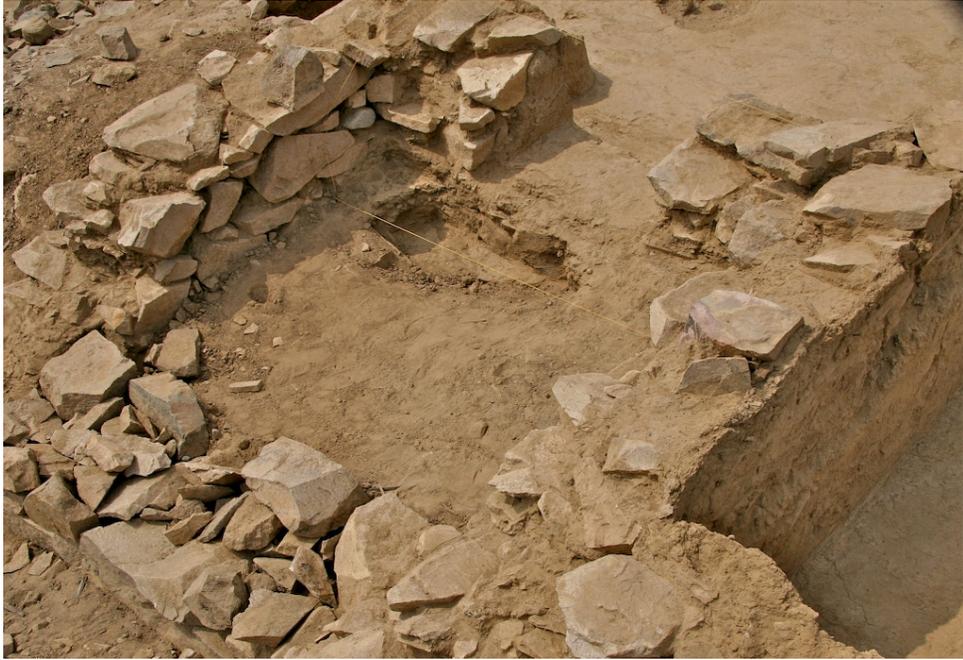
Figure 2.131. UE28 after excavation.

Room 5 (Feature 29) was located on the southwestern side of *Est 1* directly across the patio from Room 4 (Feature 28; Figures 2.32, 2.131). UE28 measured 100 x 85 cm.

Three floors in Room 5 were exposed (floors 1, 2, 3). Floors 1 and 2 were at the same elevation as floors 1 and 2 in Room 4 (UE27). The elevation of Floor 3 corresponded to Floor 3 (the original floor) in Room 2 (UE15) and the patio (UE17), as well as Floor 2 in Room 1 (UE16). The remaining area inside Room 4 had been destroyed by past looting activity.

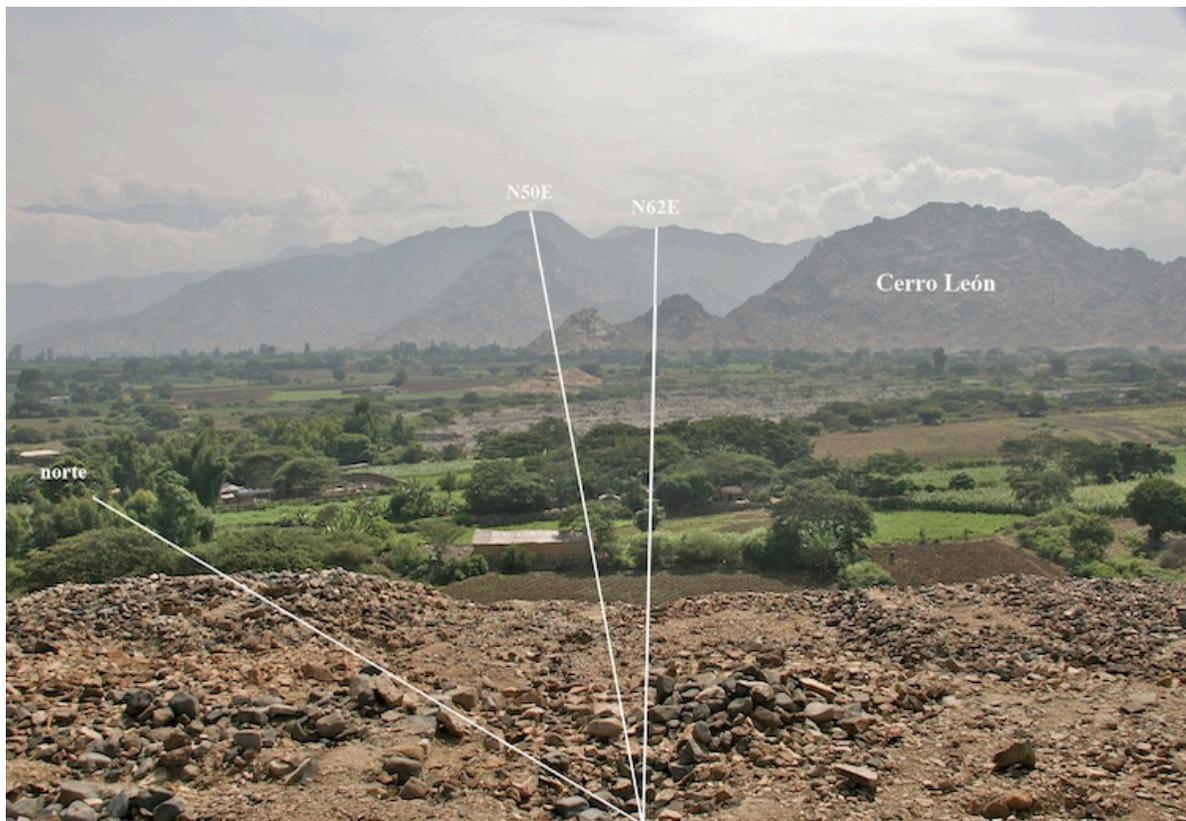
The orientation of Huaca de los Chinos proved to be surprising and interesting. After excavations UE13–UE25 were completed, it was obvious that the orientation of Huaca de los Chinos and the summit structure were different. The huaca's orientation is N62°E, which is directly toward the second small hill that comprises the northwestern end of Cerro León and a mountaintop on the horizon (Figure 2.132). However, the orientation of *Est 1* is N50°E, which is directly toward the flat summit of a mountain in the distance beyond Cerro León. Although I suspect that one or both of these orientations may be oriented toward one of the solstices, no astronomically significant correlations have been established yet.

Figure 2.132. Orientation of Huaca de los Chinos and *Est 1*.
