HUACA DE LOS CHINOS: THE ARCHAEOLOGY OF A FORMATIVE PERIOD  
CEREMONIAL MOUND IN THE MOCHE VALLEY, PERU

A dissertation submitted to the faculty of the University of North Carolina at  
Chapel Hill in partial fulfillment of the requirements for the degree of Doctor of Philosophy  
in the Department of Anthropology

Chapel Hill  
June 2009

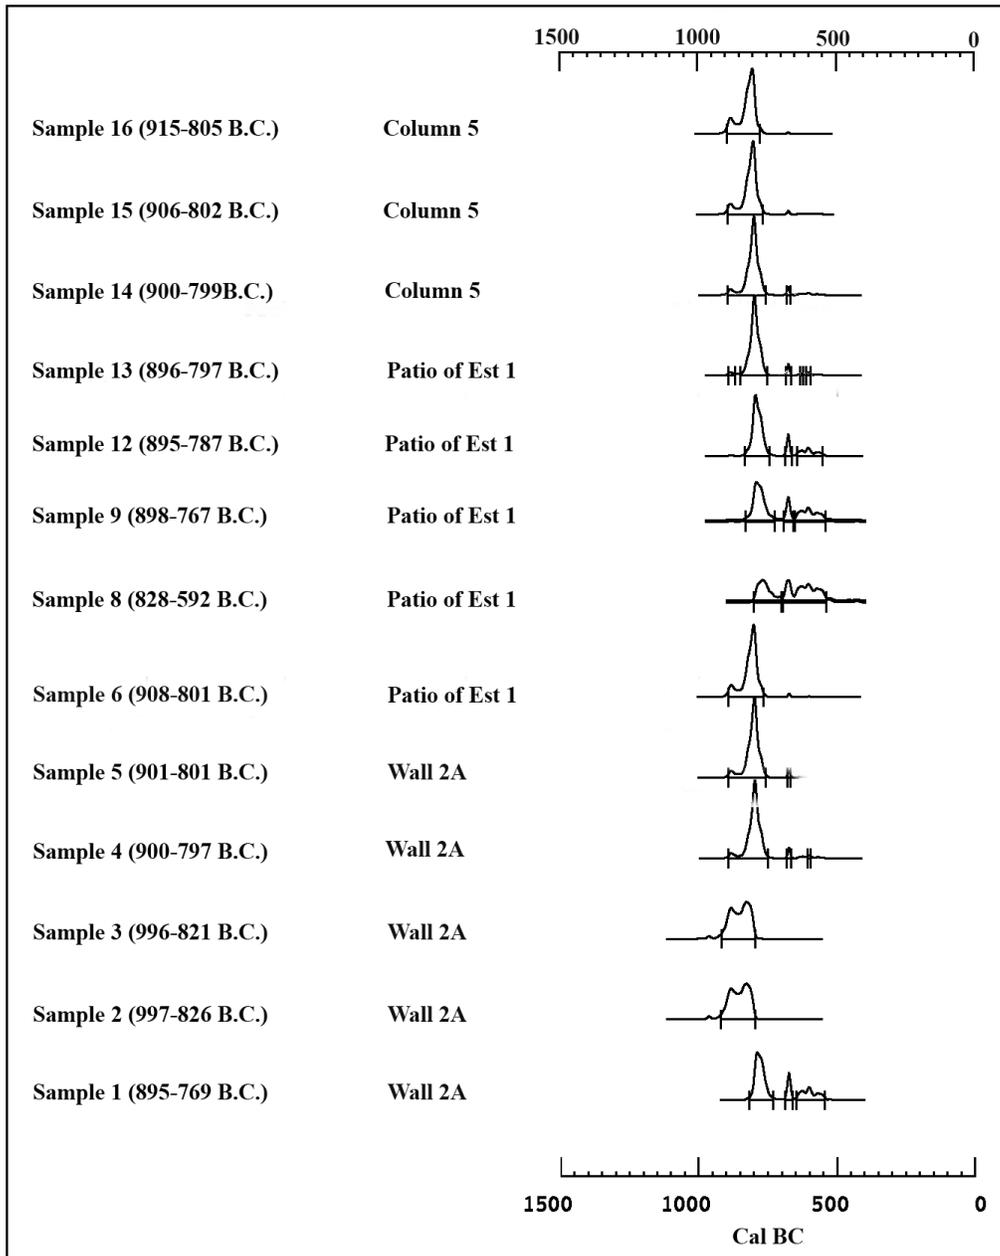
Figure 2.133. Calibrated (2 sigma) radiocarbon dates, contexts, and probability distributions for samples 1-6, 8-9, and 12-16. Calibrated dates were by the AMS at the University of Arizona; probability distributions were *CALIB 5.0.2* software (Stuiver and Reimer, 1993).

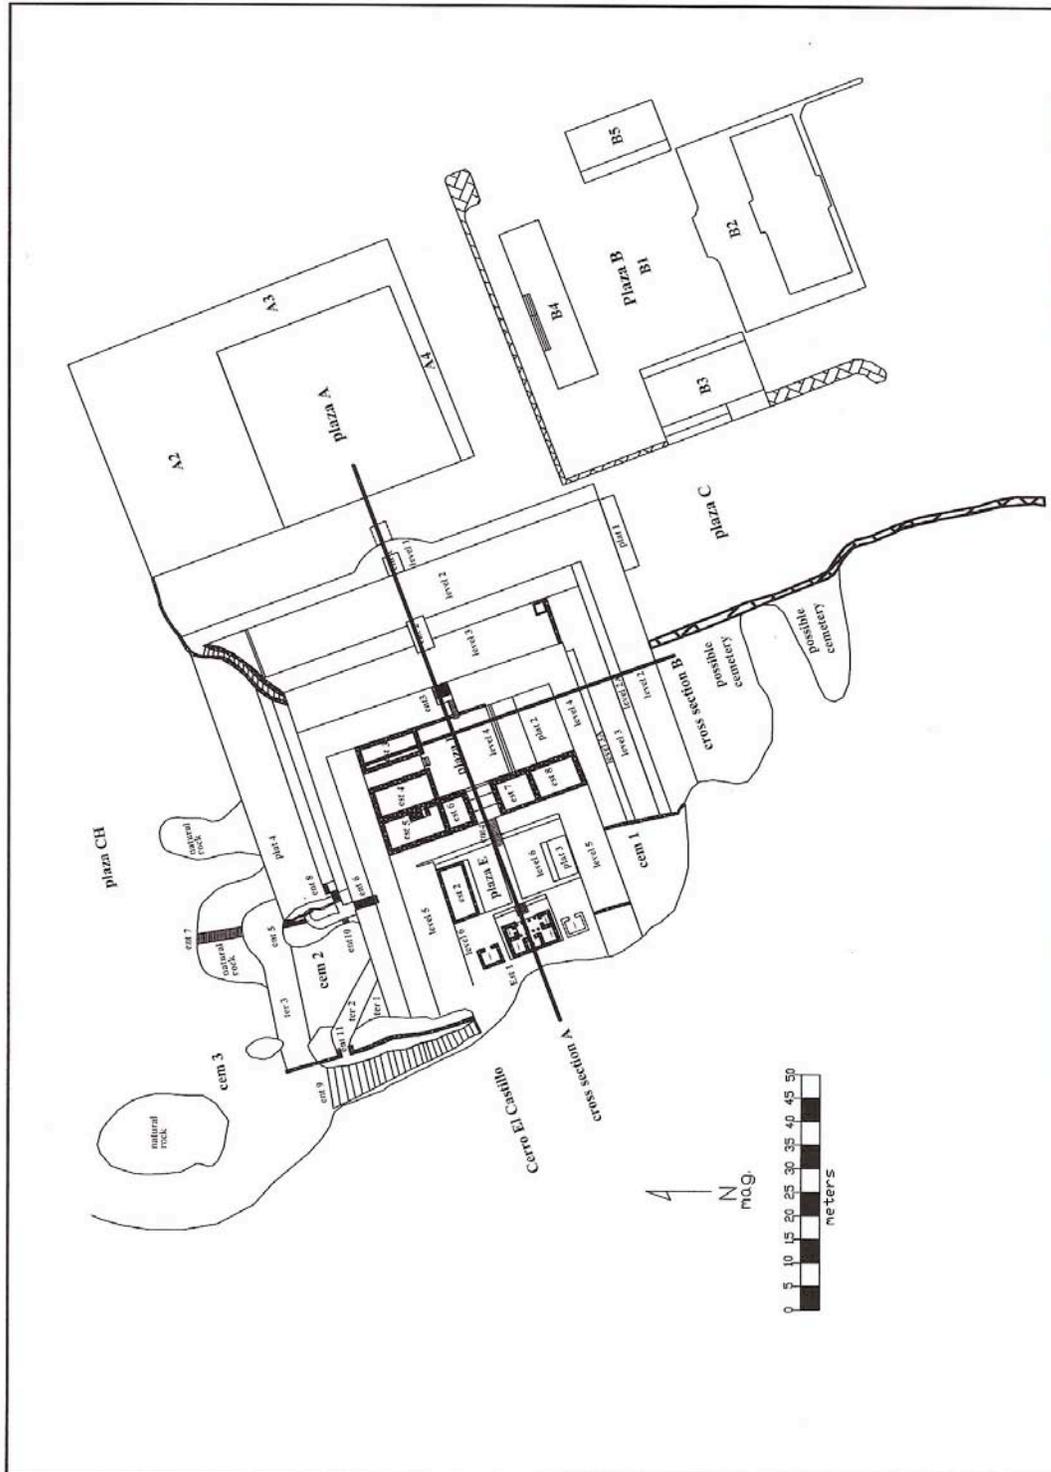
Figure 2.134. A planimetric drawing of Huaca de los Chinos showing the locations of cross-sections A and B (Figures 2.135, 2.136).

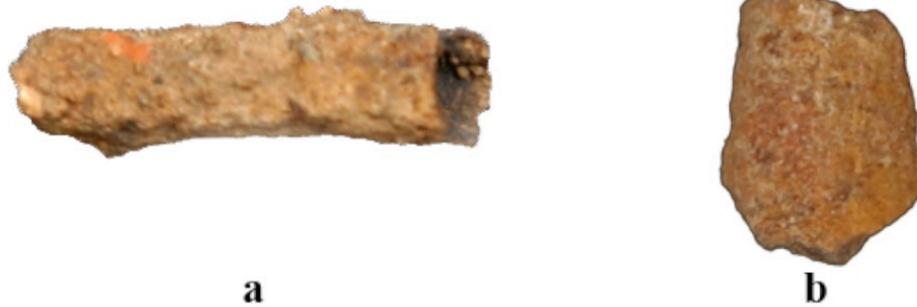
Three non-gold metal artifacts were recovered from the excavations of Room 2 (UE15), Room 3 (UE18), and Room 6 (UE23). They included a metal bead, the fragment of a tube, and a 2 cm long tube (Table 2.13; Figures 2.48, 2.138).

Figure 2.138. Non-gold metallic artifacts. a - tube, b - tube fragment.

DP #	EC #	UE #	Artifact Description	Form	Figure #
84	7	15	metal bead	spherical	Fig. 2.48
98	8	18	fragment of a tube	tubular	Fig. 2.138
114	12	23	tube	tubular	Fig. 2.138

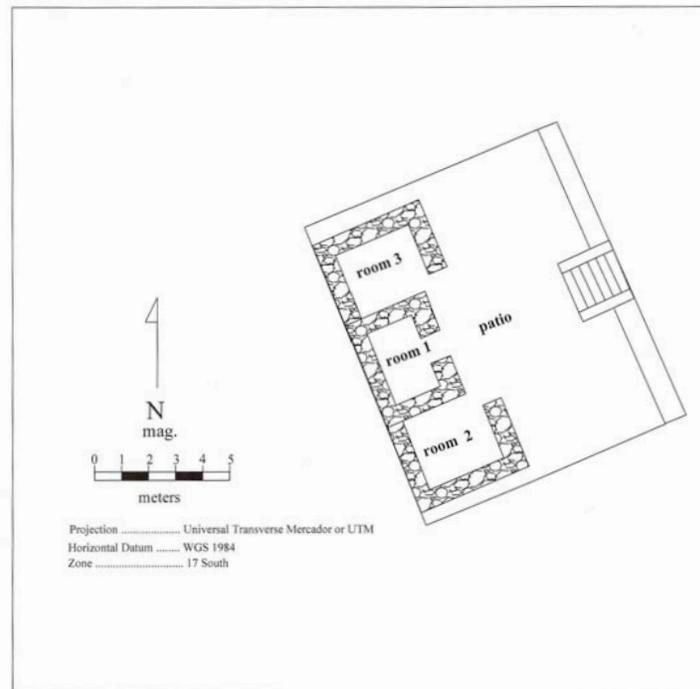
Figure 2.140. Drawing of the original construction of *Est 1* (Episode 1).

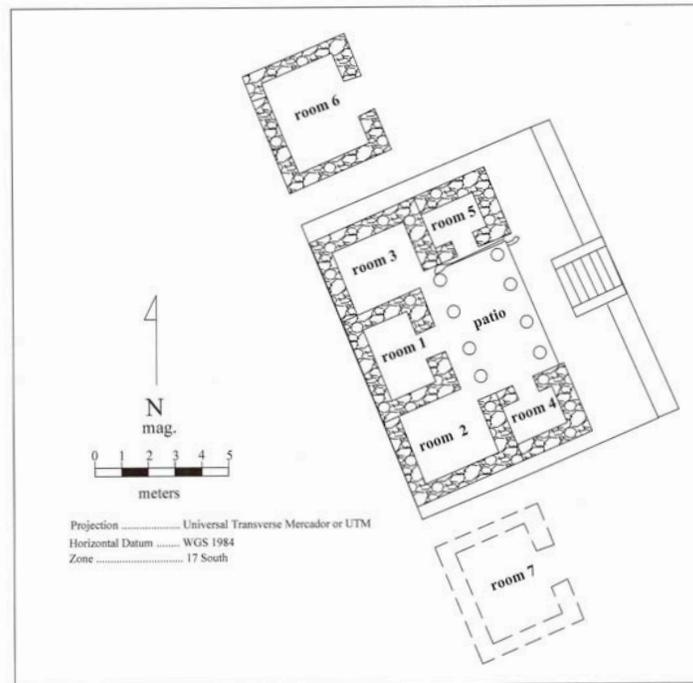
Figure 2.141. Drawing of *Est 1* after construction Episode 2.

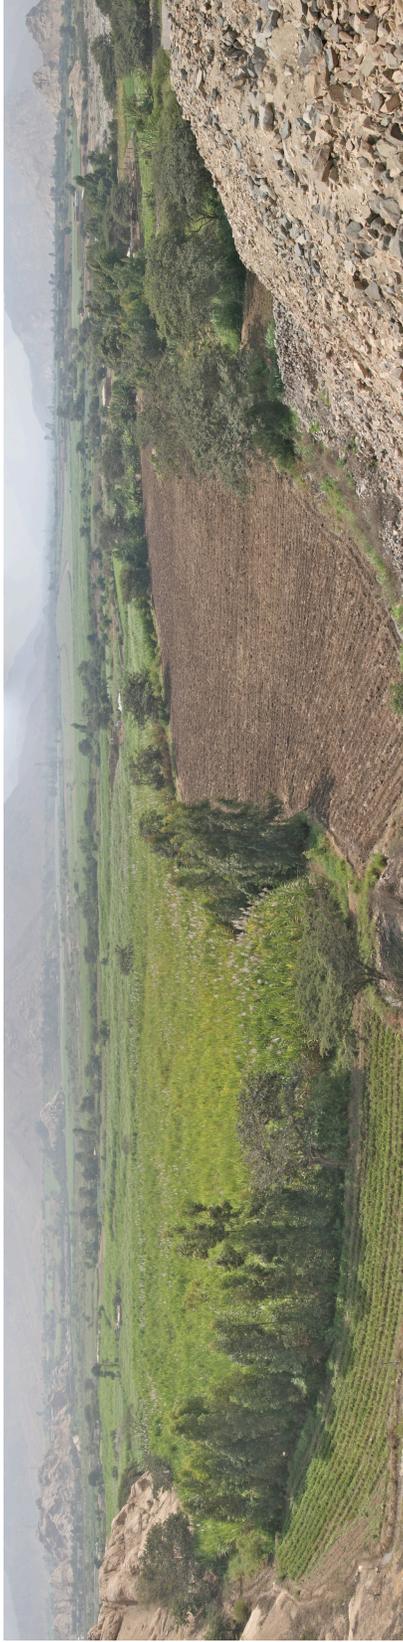
*Plaza CH* is the designation that I have given to the expansive area adjacent to the northwestern side of the huaca. It covers an area of roughly 9,000 m<sup>2</sup> (83 x 109 m; Figures 4.6, 4.7). I have designated it a plaza because it is located in front of Platform 4 (*Plat 4*), which is 60 m long and 10 m wide. A platform this large and 2 m above ground level most likely would have been associated with formal ritual activity directly in front of it. I hypothesize that a large formal plaza existed in front of *Plat 4* and that the remainder of the area in front of the northwestern side of Huaca de los Chinos may have also been a very large

Figure 4.7. Panoramic view of *Plaza CH*.

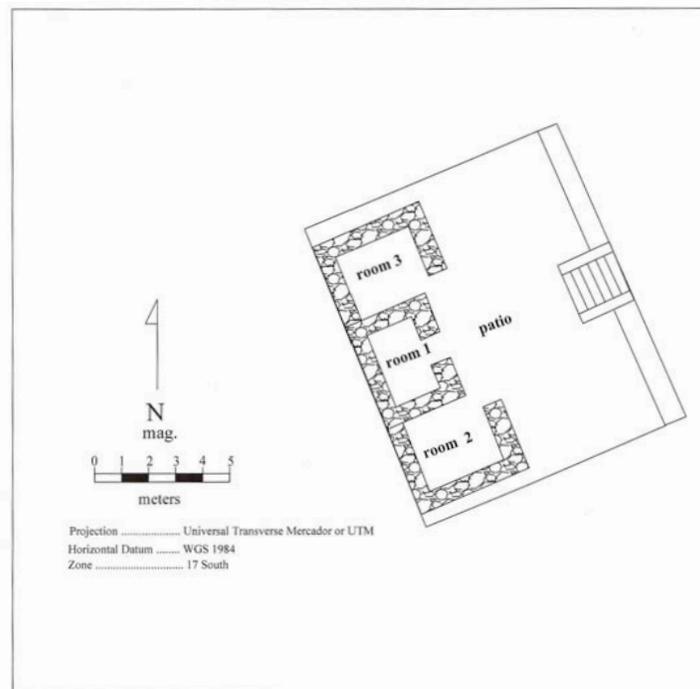
Figure 5.1. Drawing of the original construction of *Est I* (Episode 1).

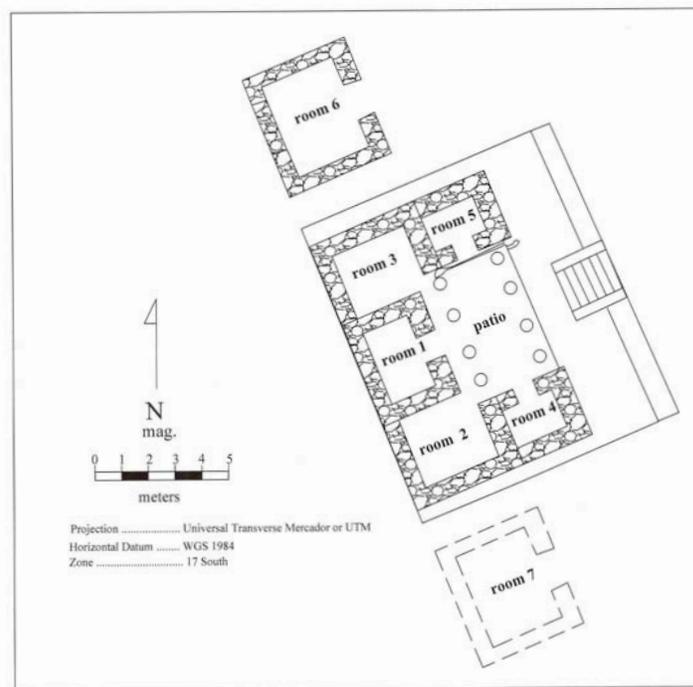
Figure 5.2. Drawing of *Est 1* after construction Episode 2
